Examination of Surface Wear on the Timing Chain Tensioner Depending on the Engine Oil Contamination

Petra Kováčiková, Andrej Dubec, Daniela Košťaliková, Mariana Janečková

Faculty of Industrial Technologies in Púchov, Alexander Dubček University of Trenčín. I. Krasku 491/30, 020 01 Púchov. Slovakia. E-mail: petra.kovacikova@fpt.tnuni.sk

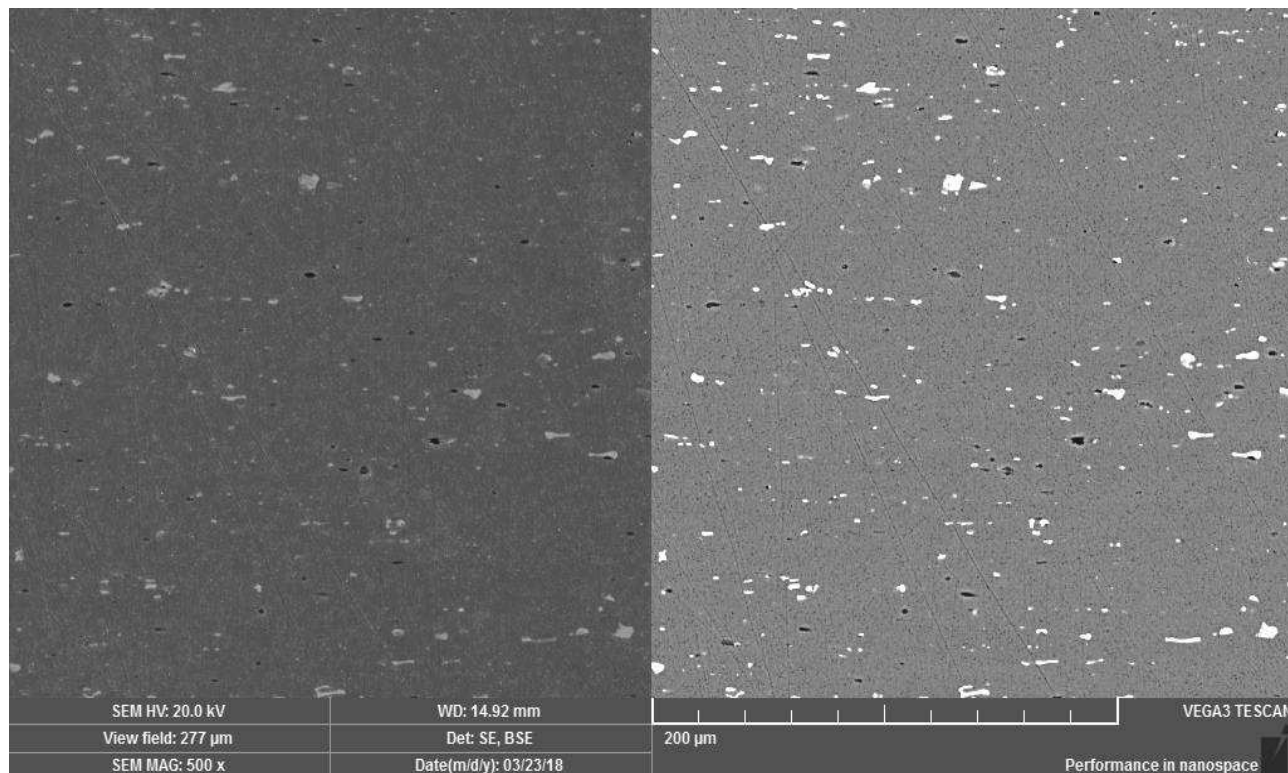
The microstructure of the tensioner (Fig. 1) is created by aluminum matrix in which two types of phases are present. These two phases based on the elements Al, Fe, Mn (Fig. 2) and Al, Si, Mg (Fig. 3) [3]. In a detailed view, the rounding of the edges of both types of phases is visible. This indicates that the material has been heat treated prior to further processing [4]. Heat

treatment is applied to improve the properties of the alloy. A semiproduct for the tensioner was made by the forming technology because the directed phases are present in the microstructure. Thanks to its microstructure, this material is suitable for dynamically loaded applications [5].

Fig. 1 The microstructure of the tensioner, longitudinal section

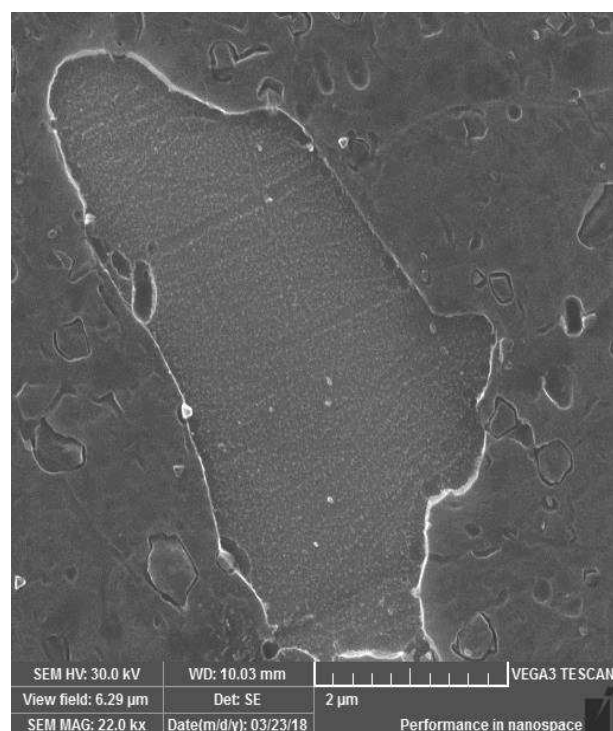
Fig. 2 Phases based on the elements Al, Fe, Mn

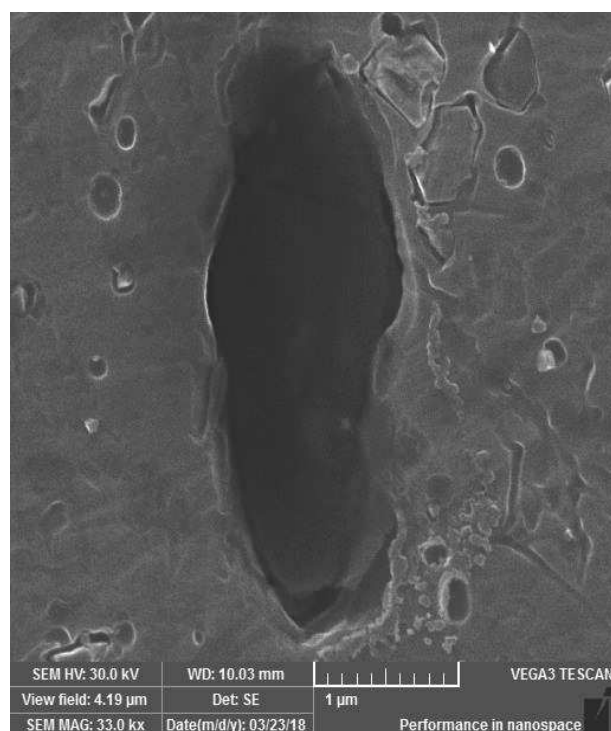
Fig. 3 Phases based on the elements Al, Si, Mg

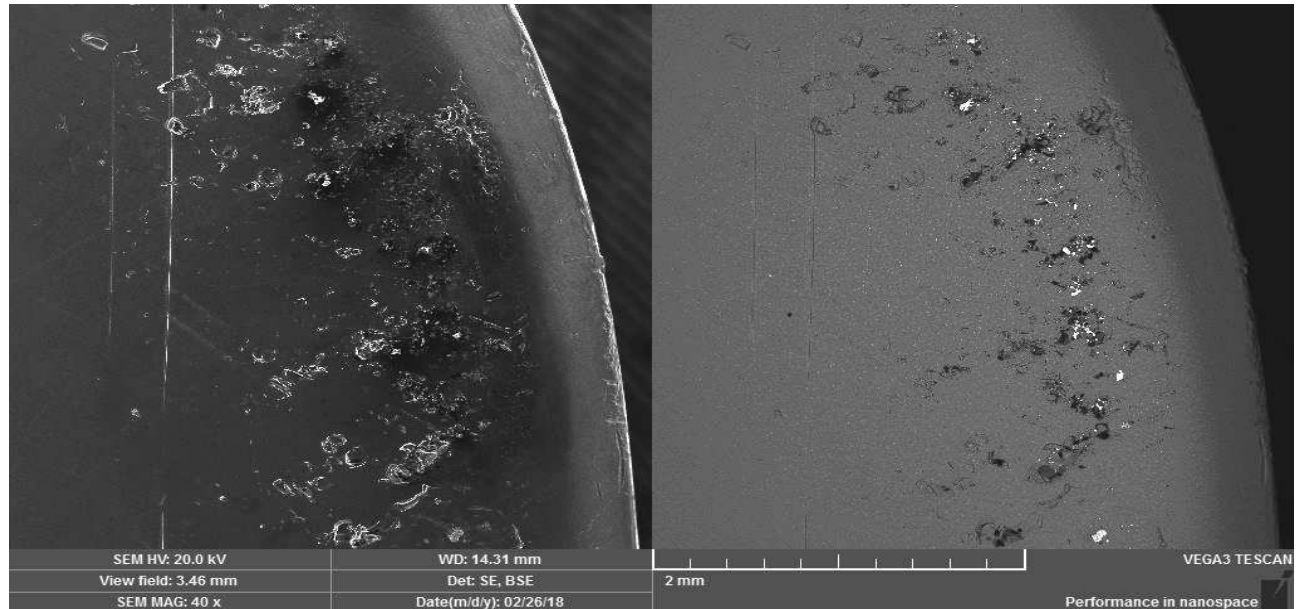
The front of the tensioner forms a contact surface with the guide which causes it to wear due to cyclic force transmission depending on the timing chain movement. Surface wear resulting from 180 hours of operation was evaluated by SEM and EDS methods. The significant microrelief is visible on the surface of the tensioner face at its edge part in secondary electron

mode. This microrelief is caused by the pressing of foreign particles. In the back scattered electron mode, the material contrast of these particles is observable, which are formed by chemical elements with a larger atomic number than the base material of the produced tensioner (Fig. 4). Superficial scratches were also observed at the front of the tensioner. These surface defects are caused by contaminating particles with greater hardness than the base material (Fig. 5) [5,6].

Fig. 4 The front of the used tensioner shaft

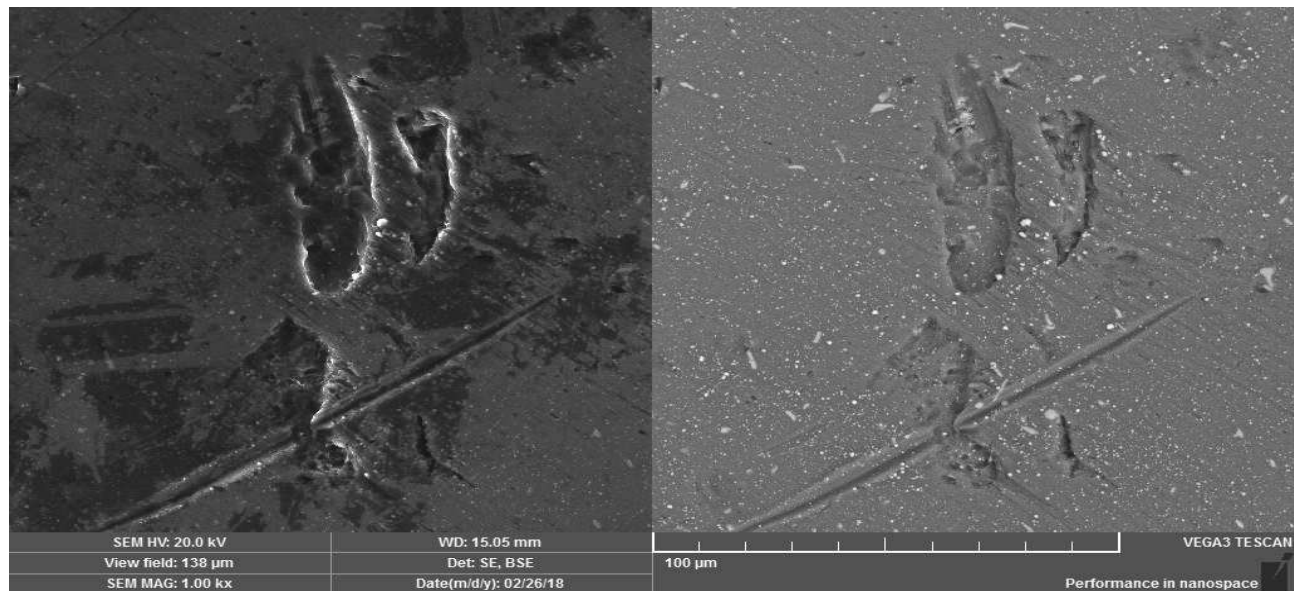
Fig. 5 Superficial scratches at the front of the tensioner

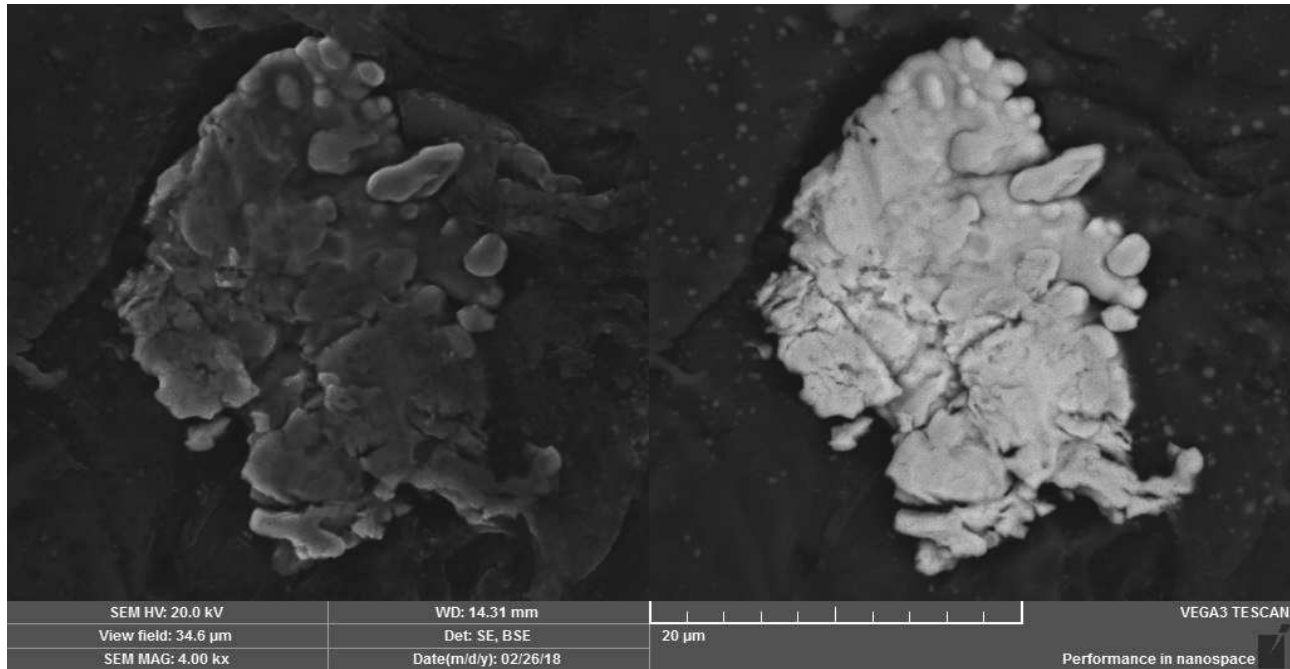
There were also small particles pressed into surface containing nickel, copper and zinc on the edge of the tensioner face. Oil filling of this type of engine serves for lubrication of crankshaft parts and at the same time in the gearbox part of the engine. The particles carried by the engine oil could be released from any parts exposed to abrasions located in these areas. The particles were pressed into the material of tensioner

front face by tapping the timing chain guide [7].

The nickel particles (Fig. 6) could be released from the surface of the parts that had been modified to increase surface hardness or to improve sliding properties. This may be due to abrasion of the surface layer of the cylinder, this layer being called Nikasil. The copper-zinc-containing particles (Fig.7) could in turn be

Fig. 6 Particle containing Ni, Cu, Zn

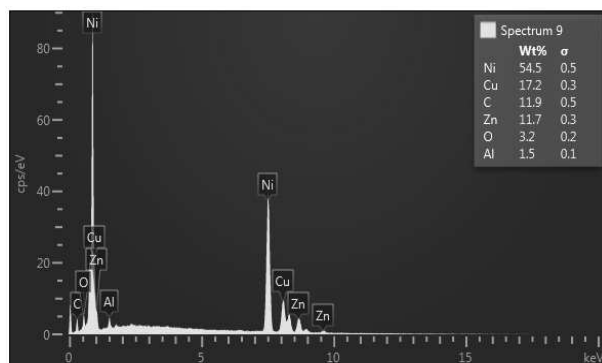
released from the brass components. Such components are pins located on the control cylinder. They serve for sensing the engaged gear, from the exchange

drum pin in the shift mechanism, the gear housing in the starter lever mechanism, the connecting rod shim, or the connecting rod eye housing [7, 8].

Fig. 7 EDS analysis of particles

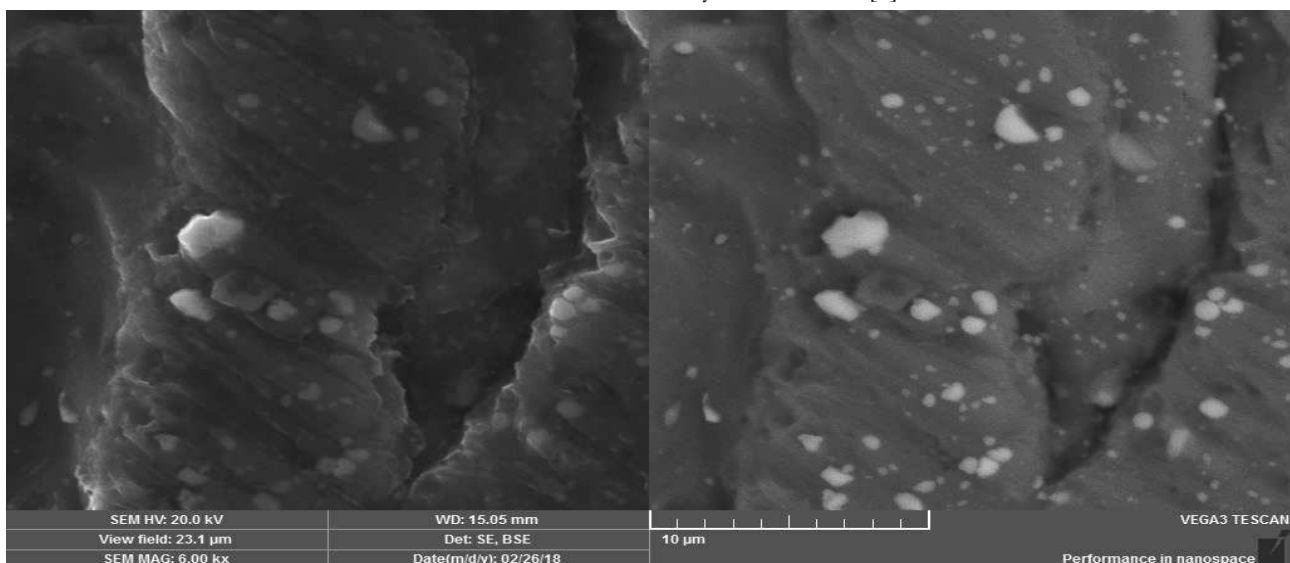
A local presence of particles composed primarily of Cr was observed on the shaft head (Fig. 8, 9). These particles were also embedded in the shaft head material. Because of their greater hardness and smaller dimensions, they were pressed into the surface of this material. There is an intermittent contact between the front end of the tensioner and the timing chain guide. Particles on the surface appeared as part of the tensioner material during evaluation in secondary electron mode. The particles could be released from any worn-out engine component present in the engine oil-lubricated area. These components have a chrome layer on surface [8].

Fig. 8 Particles composed primarily of Cr

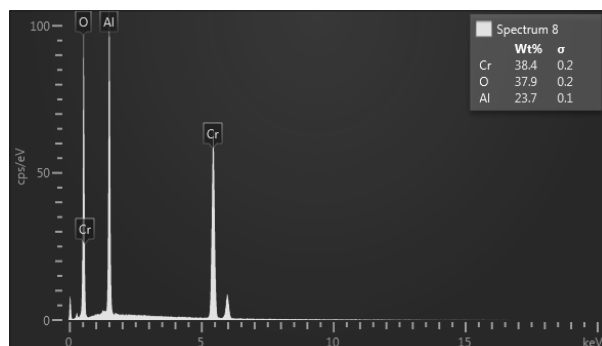
Fig. 9 EDS analysis of particles
