Changes in Steam Pipeline Properties after Long-term Exposure

Jaroslava Svobodova, Libor Benes, Jaroslav Brabec

The article deals with a practical problem solution of the steel 15 128 steam pipeline properties change after prolonged exposure. Steam pipelines made of steel are stressed for a long time at higher temperatures and pressures and under conditions that are not constant throughout the pipeline operation. During operation, it occurs in the degradation processes, which are accompanied by changes in structure and mechanical properties. In terms of mechanical properties, it is mainly important the impact strength. The paper examines steam pipeline after long-term exploitation and results from microstructure evaluation, fractographic analysis, and comparison of impact strength test results.

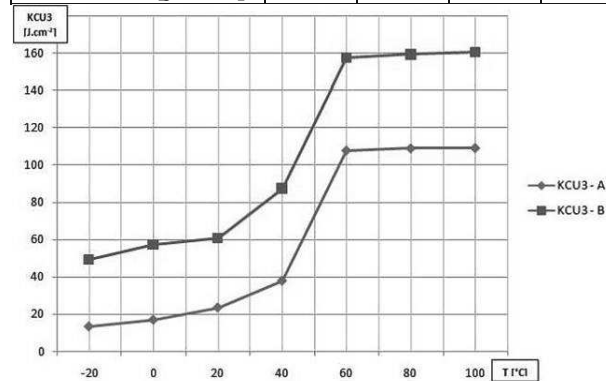
Transit curves for both states are shown in Figure 1. If we set the standard of 50 J.cm⁻² as the criterion for the transition from tough to brittle state, then it can be stated that steel after 186.728 hours of exploitation is brittle up to temperature 40 °C and the steel does not comply with the specification of the cited standard for value KCU3 at temperature 20 °C. On the other hand, the steel after heat treatment listed

above, whose structure corresponds to the initial state, is still in a ductile state even at temperature -20°C .

Fig. 1 Dependence of KCU3 on temperature

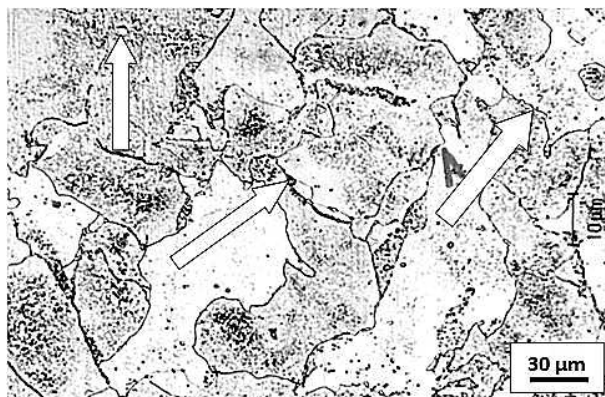
Structural analysis was carried out both for steam pipeline after long-term exploitation and steam pipeline after heat treatment. An important finding was that there was no evidence of cavities in the steel structure after 186.728 hours indicating an advanced stage of degradation due to creep processes. The typical character of the ferrite-carbide structure of the steam pipeline after 186.728 hours of exploitation with eliminated carbide particles at grain boundaries is documented in Figure 2. The presence of lamellar perlite was detected.

Fig. 2 Character of the 15 128 steel structure after 186.728 hours of exposure at 600°C and 10 MPa pressure

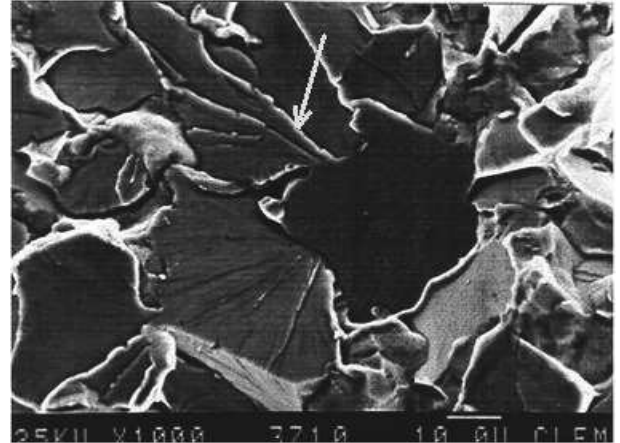
Fig. 3 Fragile area, river facets of the cleavage failure, sample A, KCU3 = $13.2\text{ J}\cdot\text{cm}^{-2}$, $T = -20^{\circ}\text{C}$

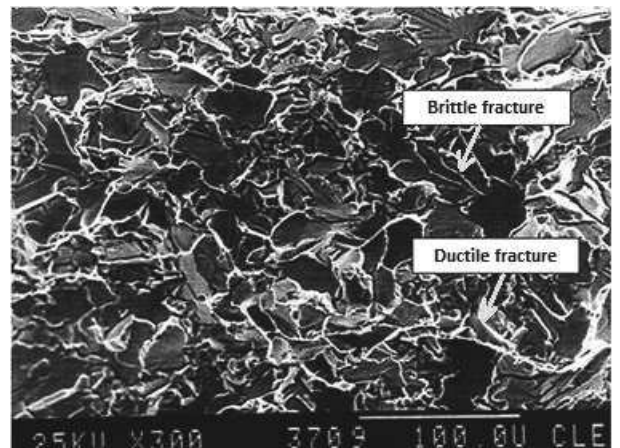
Fig. 4 Transit area, brittle and ductile failure, sample A, KCU3 = $37.5\text{ J}\cdot\text{cm}^{-2}$, $T = 40^{\circ}\text{C}$

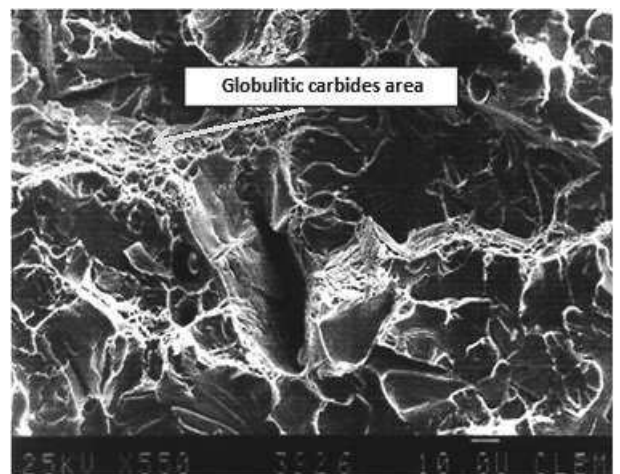
Fig. 5 Tough area, ductile failure, sample A, KCU3 = $108.9\text{ J}\cdot\text{cm}^{-2}$, $T = 80^{\circ}\text{C}$

Figure 5 represents the fracture area of the ductile failure with the local region of the Fe_3C globulitic carbides presence as a result of the changes in the surface tension of the original cementite lamellas in the pearlite grain.

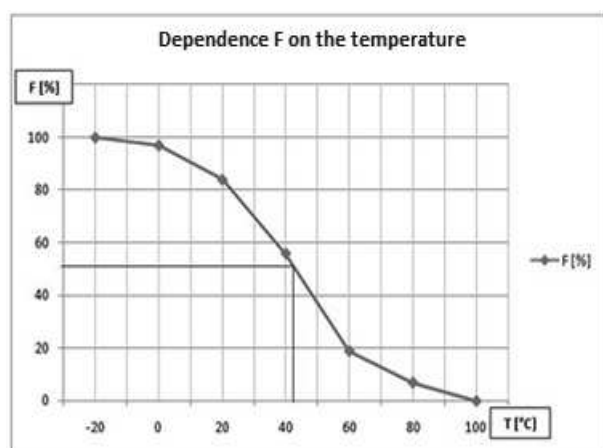
Fig. 6 Dependence of cleavage facets on the temperature

If the criterion for determining the transition temperature from brittle to the ductile state taking 50% portion of cleavage facets on the fracture surface, then we can determine the transition temperature of this steel after given exposure to approx. 42 °C. This temperature is in good agreement with the KCU3 criterion with a required value of 50 J.cm⁻², Figure 1, where the transit temperature was determined approx. 40 °C. The measured impact strength samples values of 15 128 steel after heat treatment are in good agreement with the published values for carbon steel with 0.2 % C in the normalized state, Figure 7.

Using statistical fractographic analysis was evaluated the percentage share of cleavage facets F in the fracture area of sample A. The values are shown in Table 4, graphical representation in Figure 6.
