The Microstructural Study of a Damaged Motorcycle Gear Wheel

The main aim of this article is study the cause of gear wheel failure. This component has worked in the motorcycle gearbox. During the operation of the transmission, the gear wheel tooth was broken, which made it impossible to continue running this device. The investigation of the damaged area was focused on determining the chemical composition of the inclusions which are present of gear wheel material as well as detecting changes of material contrast in microlocalities close to the defective areas. The method of energy-dispersive spectroscopy and scanning electron microscopy were chosen for this type of analysis. Furthermore, the micropurity and microstructure of the material were evaluated by methods of optical microscopy and scanning electron microscopy. Using a thermo-emission scanning electron microscope, the microcrack area was evaluated in the mode of secondary electrons and also in the mode of backscattered electrons. In this way, the fracture surface was examined in terms of its micromorphology as well as material contrast.

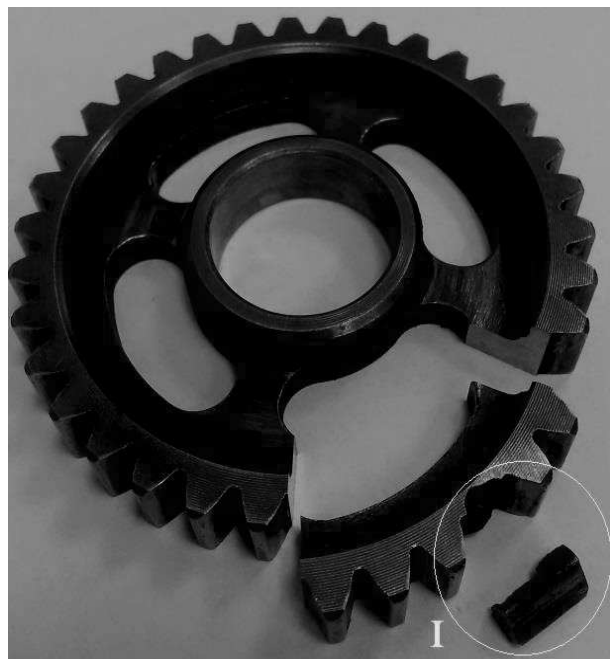
Fig. 1 Marking of the damaged area

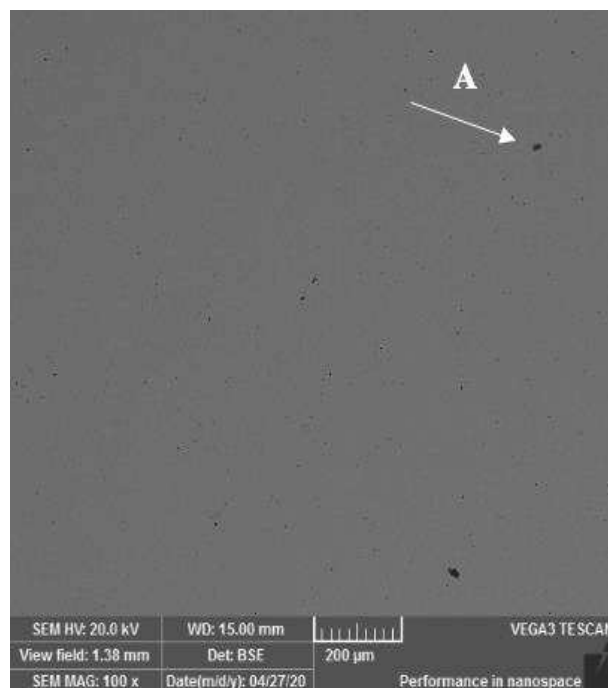
oxides, and aluminum-based mixed oxides is indicated on Fig. 2 [5].

Fig. 2 Location of oxide inclusions

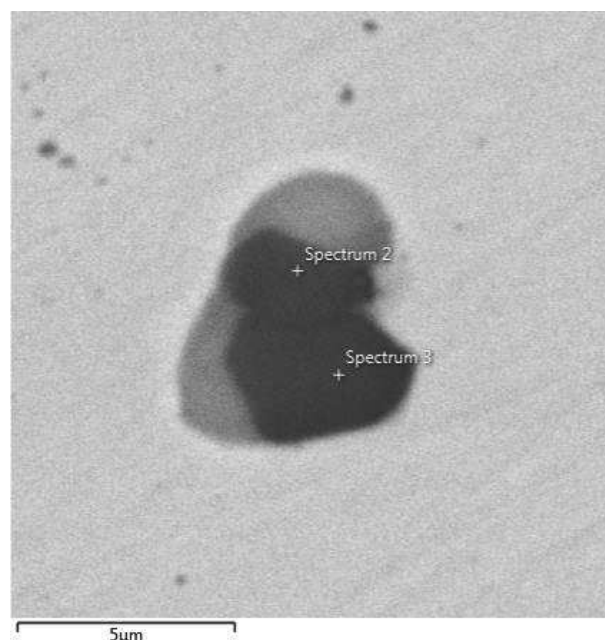
Detailed visualization of this area is visible on the Fig. 3. In this figure we can observe the occurrence of microspace around the inclusions. The chemical base of the inclusions present was confirmed by an EDX detector (Fig. 4, 5).

Fig. 3 Detail of oxide inclusions presence from the place A, source area of the EDX detector

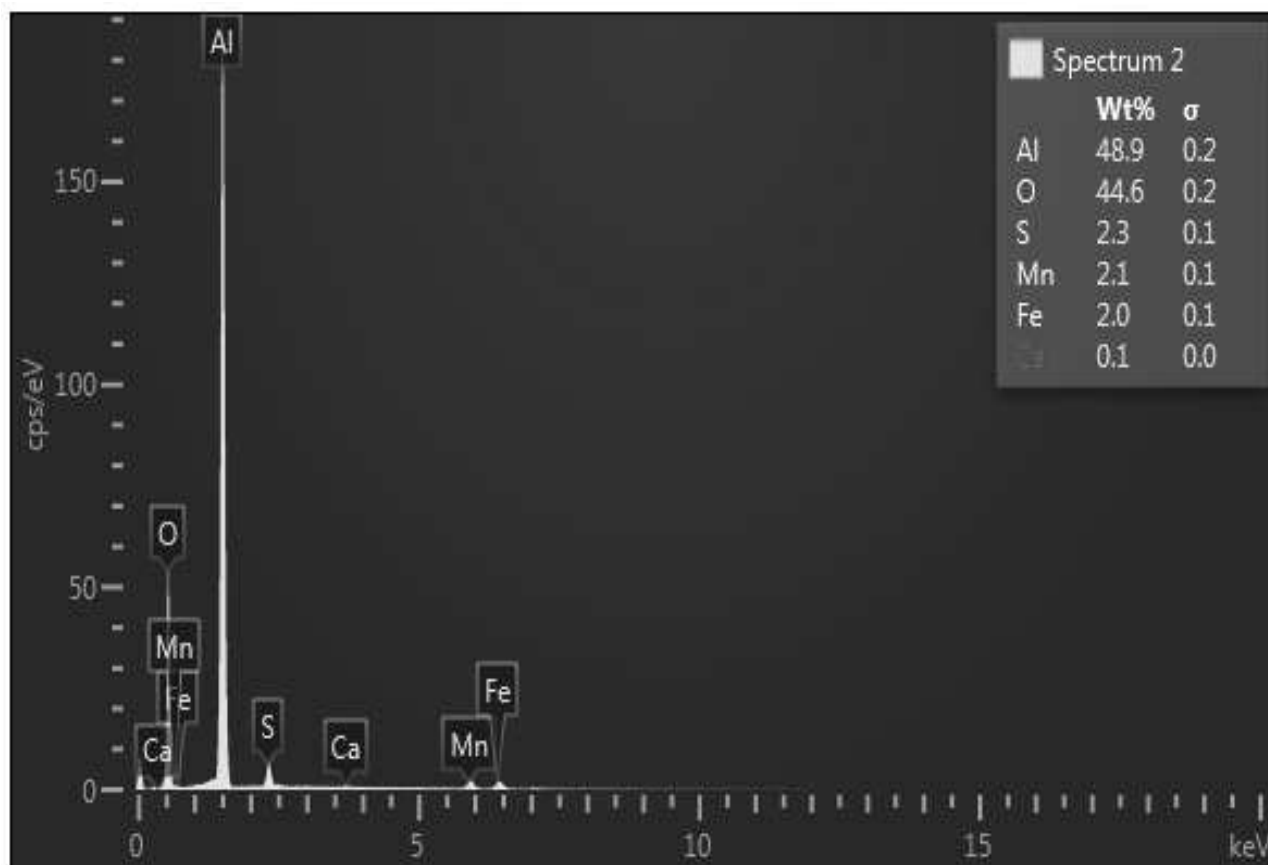
Fig. 4 Chemical spectrum 2 of oxide inclusion

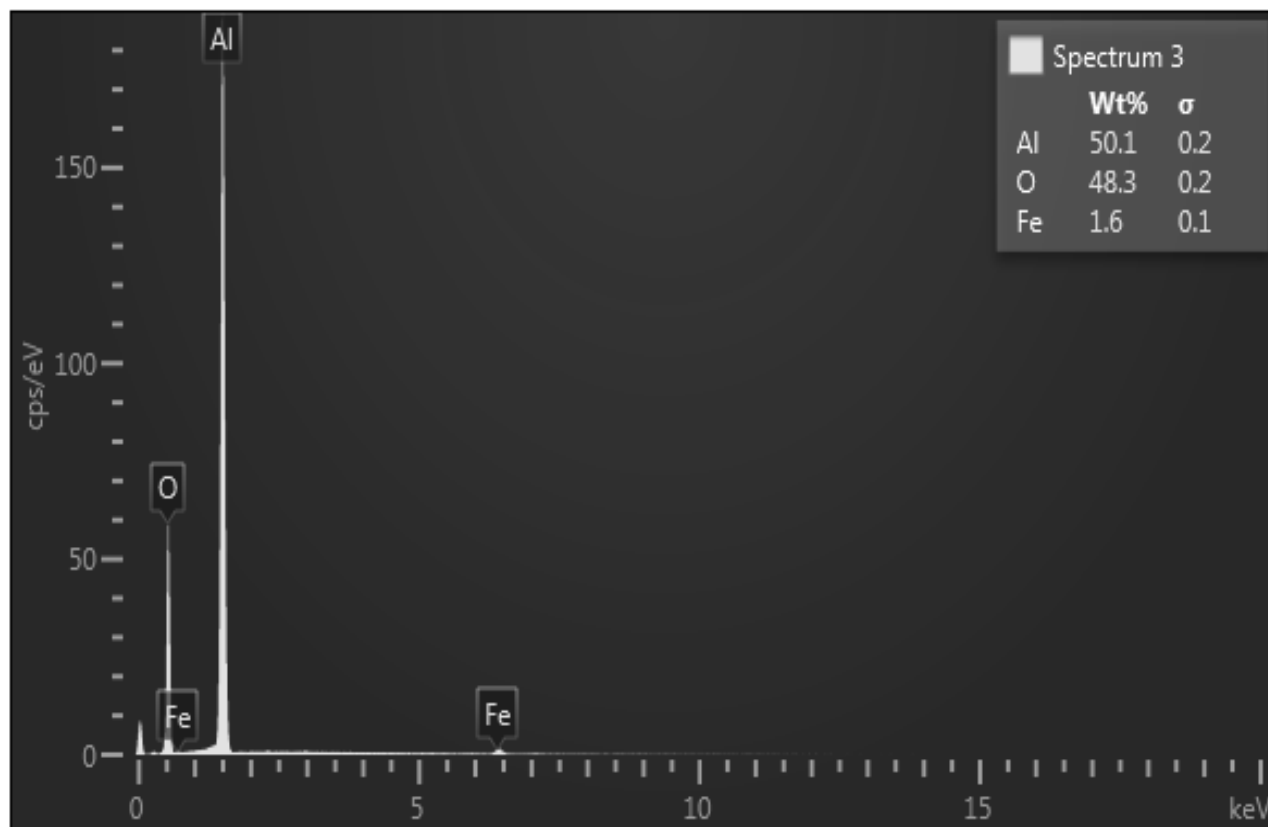
Fig. 5 Chemical spectrum 3 of oxide inclusion

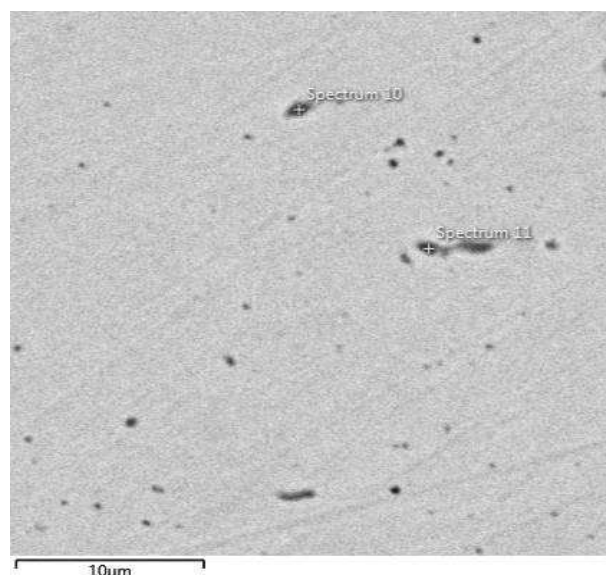
The inclusions size and distribution corresponding of impurities occurrence up to level 1 according to standard STN 42 0471. In metal matrix were observed MnS inclusions (Fig. 6) with elongated shape. The different ratio in the representation of the basic chemical elements is shown in fig. 7, 8.

Fig. 6 MnS inclusions with elongated shape, source area of the EDX detector

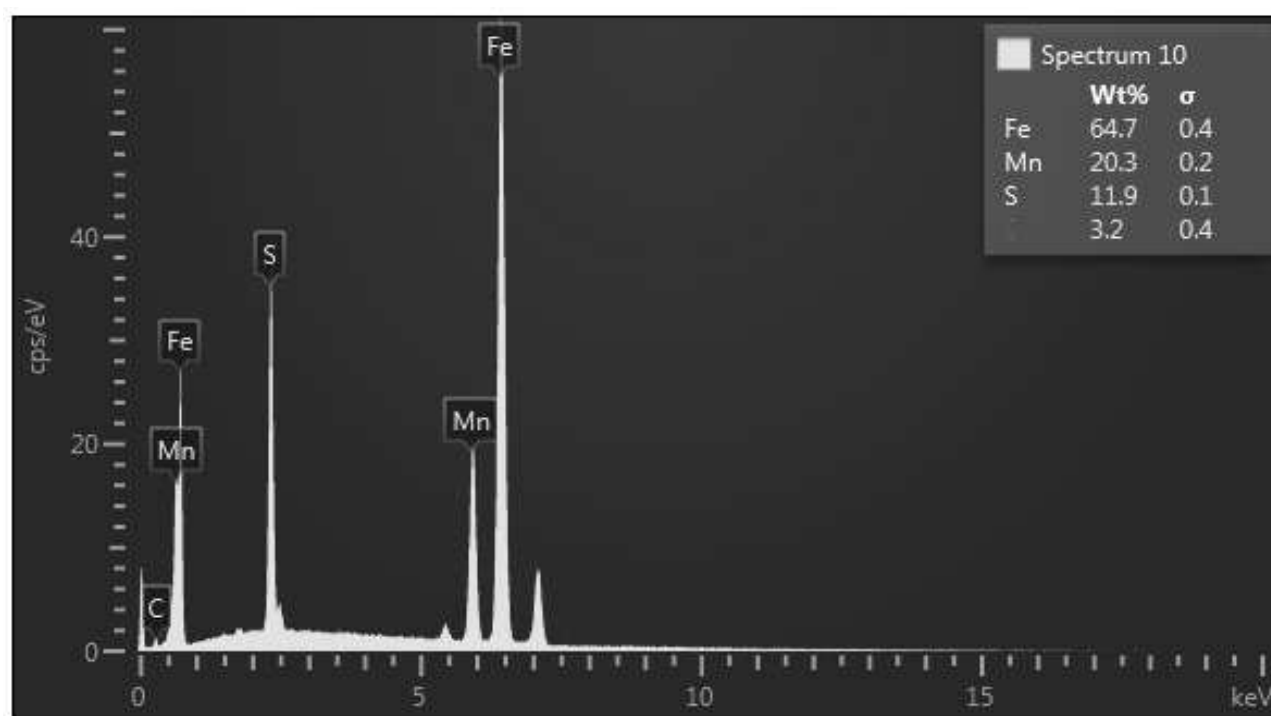
Fig. 7 Chemical spectrum 10 of MnS inclusion

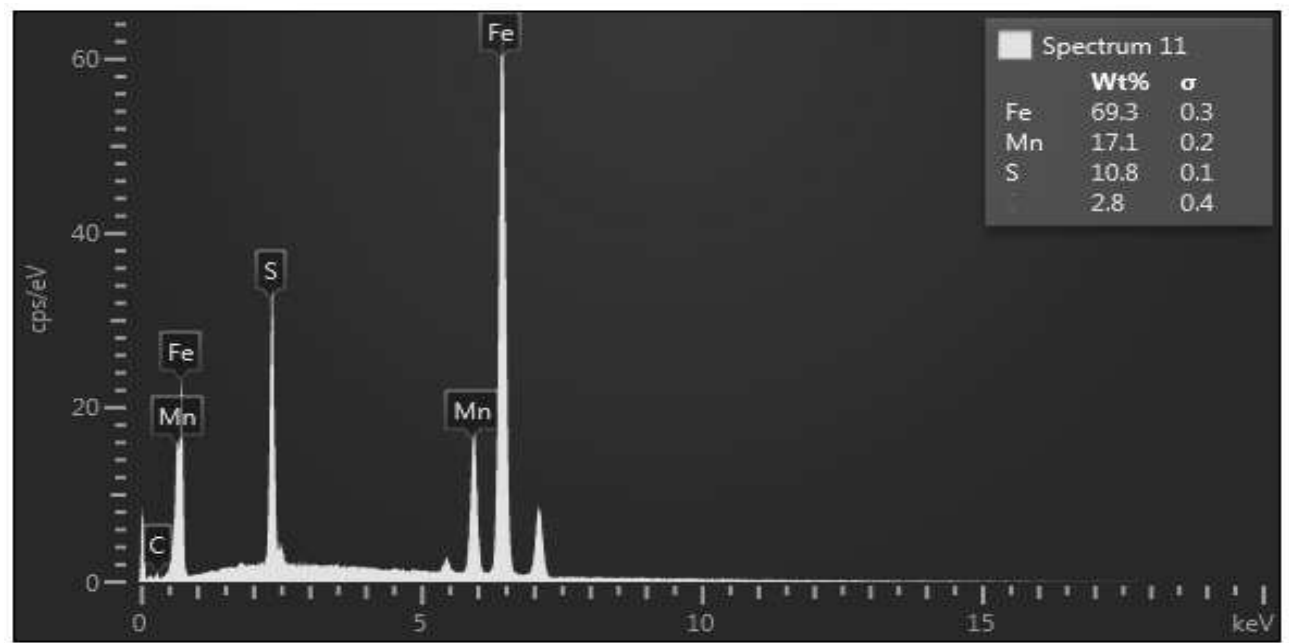
Fig. 8 Chemical spectrum 11 of MnS inclusion

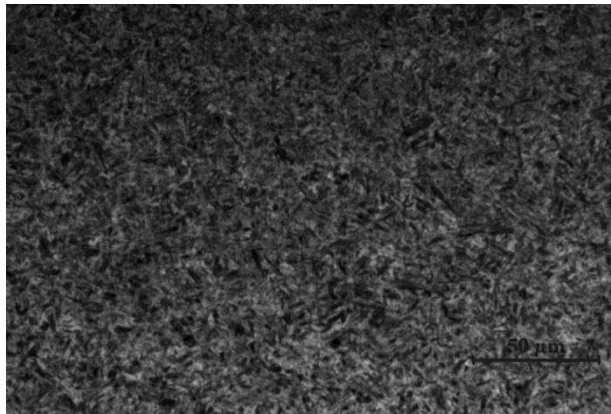
The microstructure of the core was formed by thicker ferritic needles with cementite particles, the presence of carbides were also observed. This microstructure corresponds to the heat treatment after hardening and subsequent high-temperature tempering of martensite up to the upper bainite structure (Fig. 9). The grain size is about 10 μm . The carbide phase is unevenly distributed in the core of the material, there is a visible indication of the carbides distribution along the grain boundaries and also the presence of precipitates (Fig. 10). Carbides were different in size.

Fig. 9 Upper bainite structure of the metal core

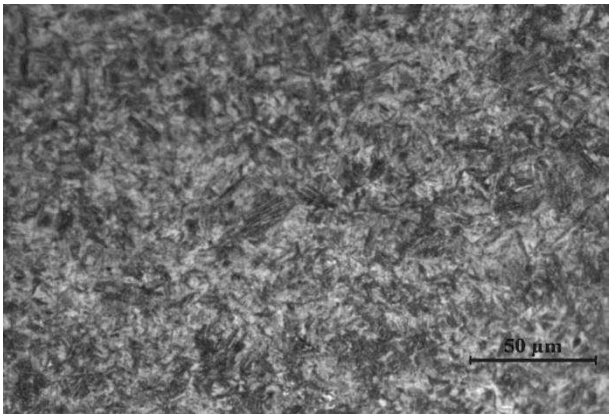
Fig. 10 Distribution of carbides in metal core

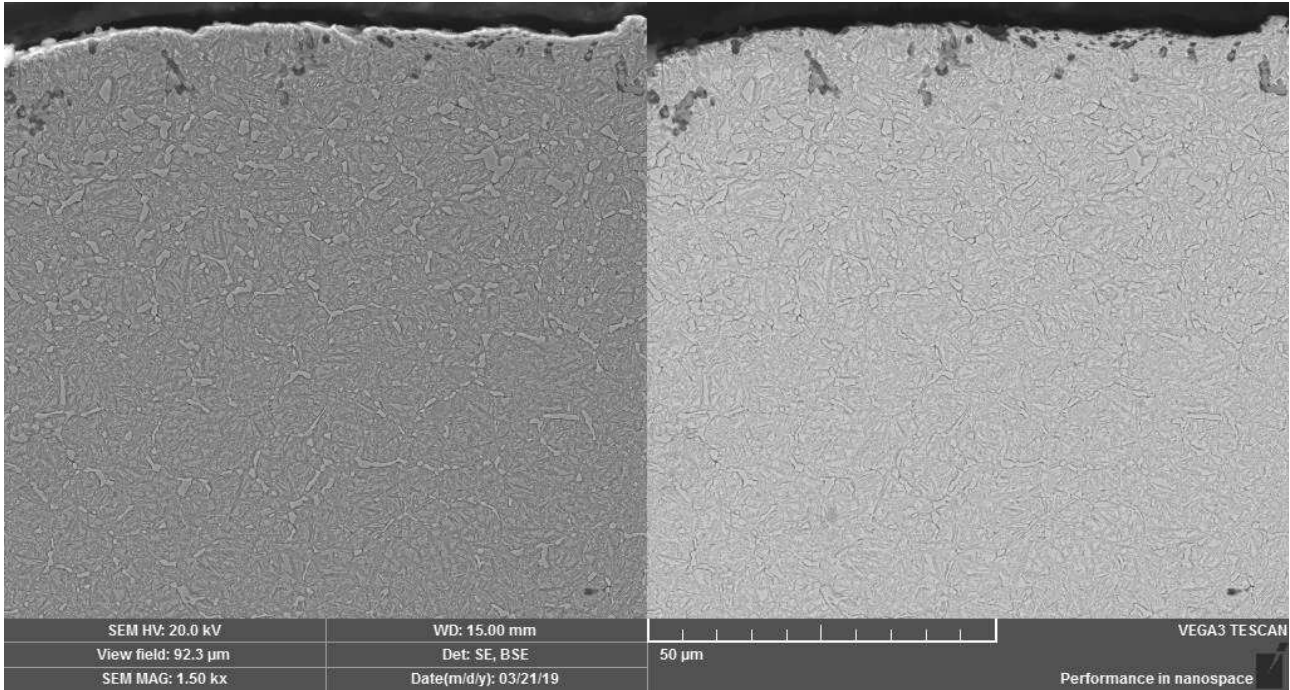
Uneven distribution of the carbide phase along the grain boundaries was visible in the cemented layer. An increased etchant effect was used for visibility of carbides in the microstructure of the cemented layer Nital 2 (Fig 11).

Fig. 11 Distribution of carbides close below the surface of gear tooth

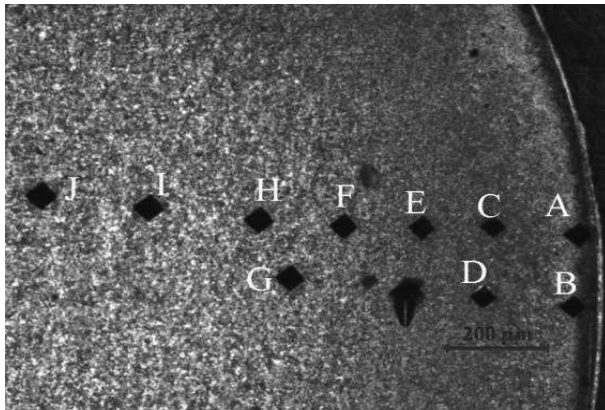
cemented layer reached a depth of 437.5 micrometers. The measured values of Vickers's hardness are shown in the table 1. The hardness measurement process for determining the depth of the cementation layer can be seen in the fig. 12. The measurement of hardness took place from the edge to the core of the material. In all areas marked with the letters A-J, one measurement was performed. Emphasis was placed on adhering to one and a half times the size of individual indentation punctures between adjacent measurements in order not to affect the measurement.

**Fig. 12** The hardness measurement process

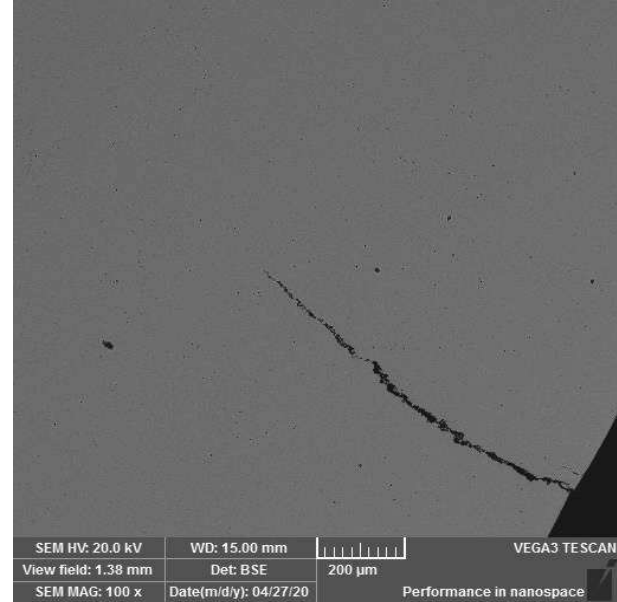
More of surface-initiated microcracks were observed on the heel area of the defective gear tooth, which distributed perpendicular to the core of the material. A representative crack from this area is shown in (Fig. 13). The cracks were analyzed on the backscattered electron mode, as the empty micro space created by the crack distribution creates a significant contrast in the analyzed area. This significant contrast is visible

when using a BSE detector. The distribution of microcracks was visible up to a depth of 0.9 mm. The cracks did not show an increased degree of branching. The microspace created by the decohesion of the material during crack propagation was filled by oxides and material from the preparation of the metallographic cut [6].

**Fig. 13** Distribution of surface microcrack

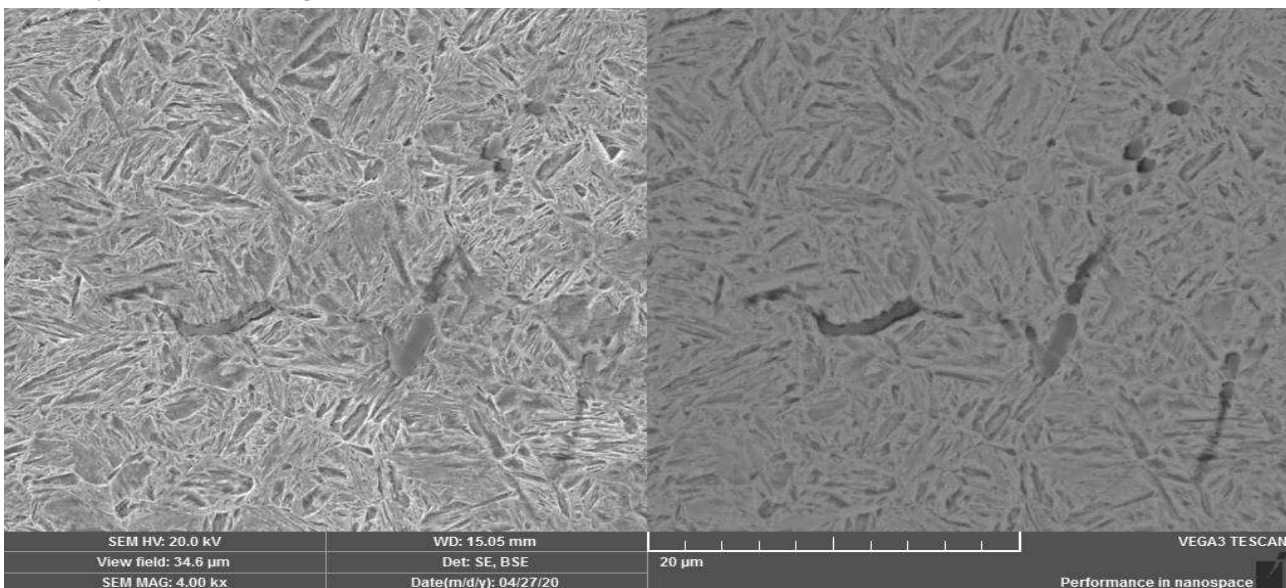
In the analysis of microstructural changes in the surface area of microcrack propagation, the occurrence of inclusions distributed along the grain boundaries was observed. The analyzed inclusions were of the MnS type with longitudinal shape (Fig. 14). Due to their size and shape, they filled the entire area of individual sides of the polygonal grain shape in several places. The material contrast of these inclusions shows that they consisted of doped parts with manganese and contrariwise [7].

**Fig. 14** Distribution of MnS inclusions along the grain boundaries

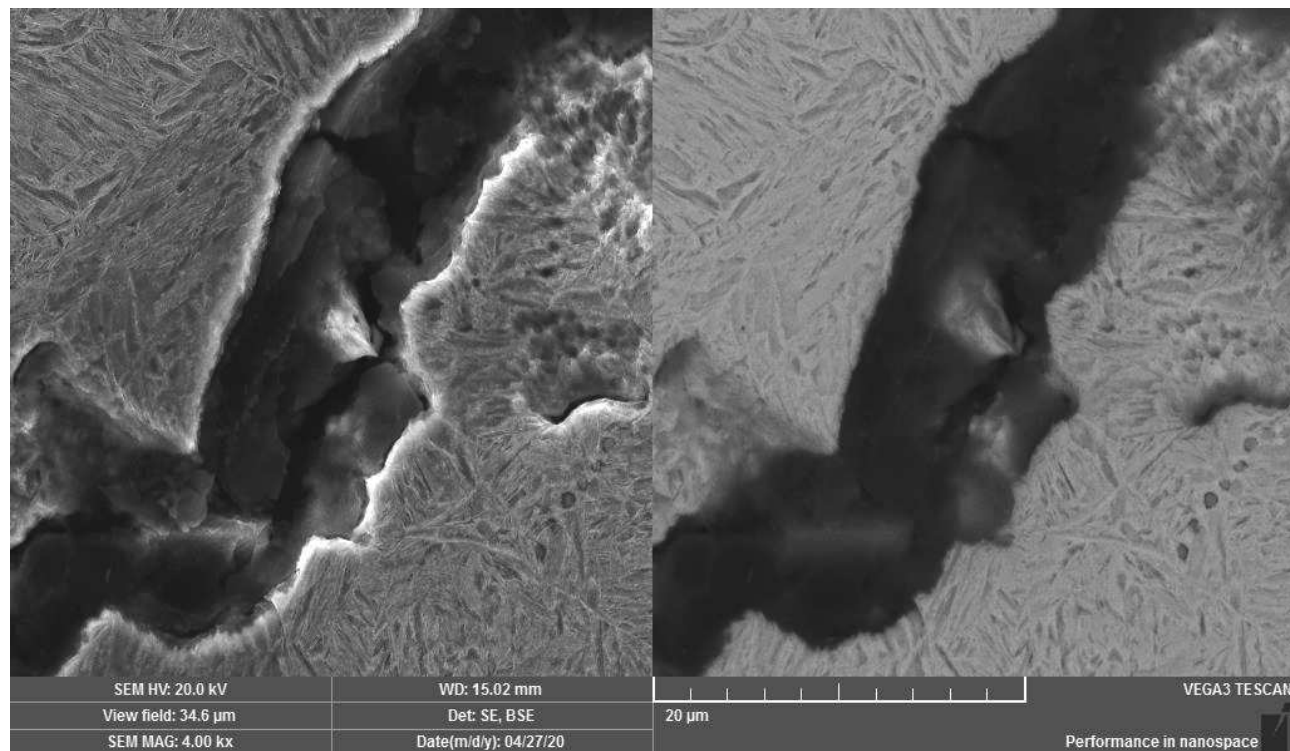
Inclusions of smaller globular-shaped were also observed, which were distributed along the grain boundaries, thereby weakening them (Fig. 15, 16). The weakening of the grain boundaries is also confirmed by the absence of crack distribution towards the grain of the metal matrix. Near the metal matrix, the occurrence of secondary microcracks was observed locally,

which increases the proportion of decohesion between the metal grains [8]. The crack space is filled by the crystalline phase, most likely the presence of oxides and elements that could be introduced into the microcrack space from the sample metallographic preparation process.

Fig. 15 Microspace of crack distribution with inclusions which are formed along grain boundaries

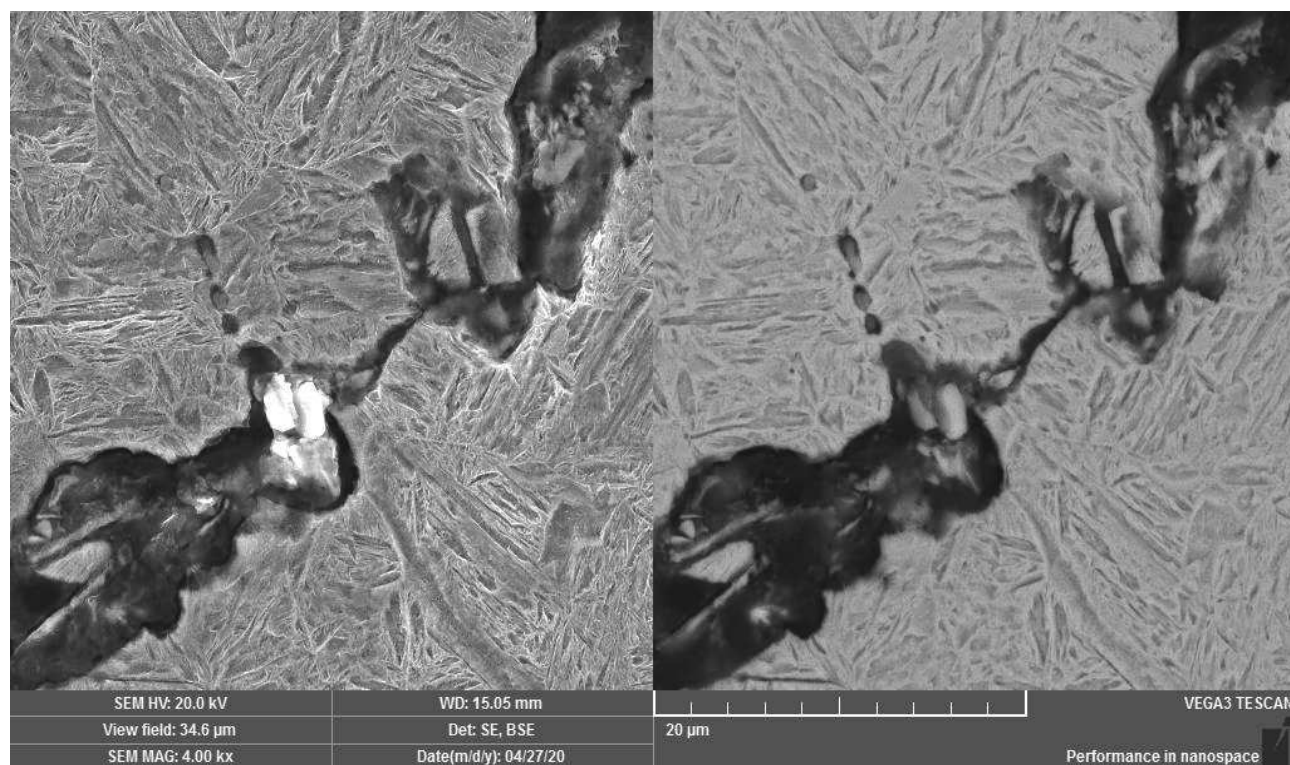
Fig. 16 Distribution of inclusions with globular shape
