Analysis of the Coating Delamination after Laser Beam Cutting

This paper analyses surface after laser beam machining with respect of surface height irregularities, residual stress state as well as microstructure on the low alloyed steel S 235. Surface after laser beam machining is investigated due to its specific nature resulting into coating delamination. This coating delamination can be found especially in the regions in which component shape or/and curvature of the profile is altered. Especially the components corners suffer from the delamination due to extensive surface heating and presence of brittle oxides layer. The thickness of this oxides layer is heterogeneous with respect of the component thickness as well as the component geometry. It was found the oxides layer is the thermally initiated process since in these regions the underlying matrix also exhibits the higher thickness of the heat affected zone and higher degree of the hardening expressed in term of HV0.1. Furthermore, also the compressive residual stresses exhibit higher amplitudes in the region remarkably affected by the thermal cycle.

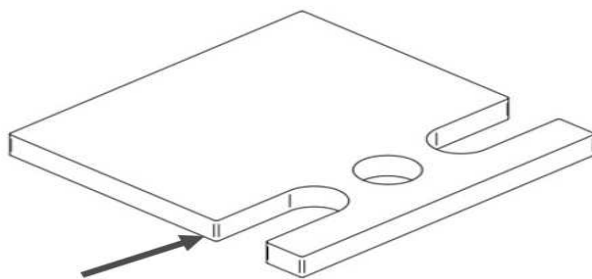
Fig. 1 Component produced by LBM, size of component 60 x 60 mm
(further information about components geometry kept secret)

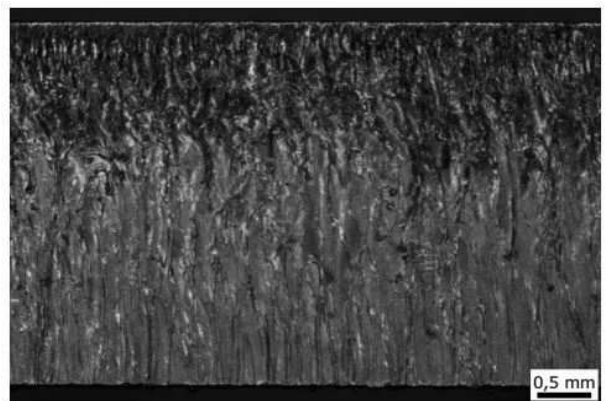
LBM produces the typically non-homogenous surface in which the height of irregularities is increasing from the entering region towards the trailing edge, see Fig. 2. Moreover, it has been already reported that LBM also affects precision of produced parts [14]. In order to quantify these irregularities, the surface after LBM was scanned by the laser confocal microscope and 3D plot of the produced surface was obtained as that depicted in Fig. 3. This scan as well as the linear scans near by the entering and trailing edges as well as in the middle section (see Fig. 4 – 6 as well as Tab. 1) proves that the height of surface irregularities progressively grows from the entering towards the trailing edges. This growth is dramatic especially in the initial region of the laser path through the sample thickness and becomes less steep afterward. Fig. 2 and Fig. 3 demonstrate the typical wavy character of the cut surface after LBM. The height of the waves of higher wavelength dominates in the primary profile.

Fig. 2 Large view of the surface after LBM, the light microscope Zeiss AxioCam MRc5 in Olympus SZx16

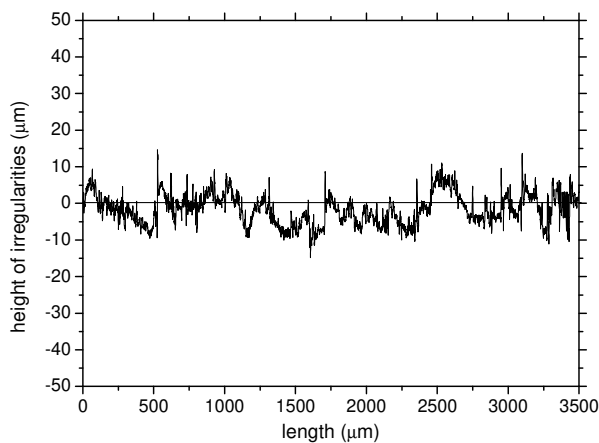
Fig. 4 2D height of surface irregularities – entering region

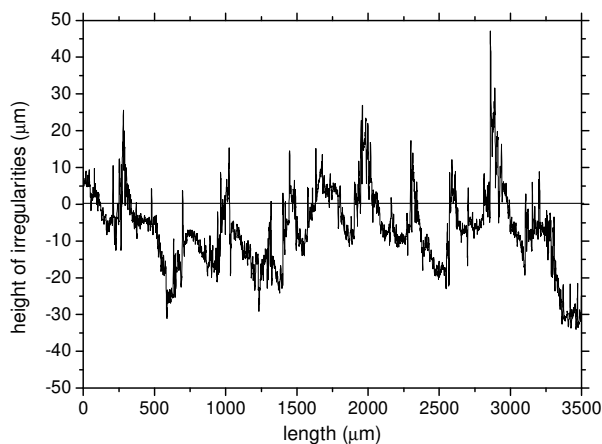
Fig. 6 2D height of surface irregularities – trailing region

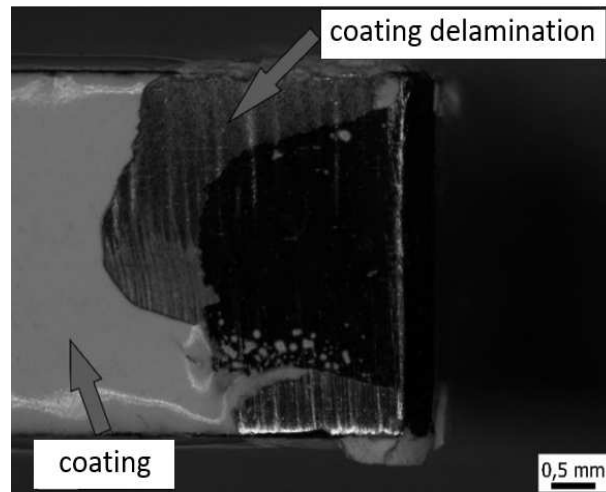
Fig. 7 Coating delamination at the corner of the sample, the light microscope Zeiss AxioCam MRc5 in Olympus SZx16

Quite rough surface after LBM takes certain role in the coating delamination as that depicted in Fig. 7. This figure demonstrates that this delamination can be mainly found in the sample corner. Position depicted in Fig. 7 links with the position indicated by the arrow in Fig. 1. Based on the further experience with staff operated by laser cutting machine, this delamination can occur in positions in which the component geometry is altered (changing curvature, corners, etc.). Measurement of residual stresses along the laser beam path indicates that the compressive stresses are produced as a result of thermal cycle, especially rapid self-cooling. However, the amplitude of these compressive stresses on the linear section of the components is -160 ± 25 MPa whereas higher amplitude -257 ± 22 MPa can be measured near by the components corner. This information indicates higher degree of the heat entering the surface which can be proved the metallographic observation as that illustrated in Fig. 8. This figure clearly demonstrates that the thickness of HAZ which appears darker on the image is less in the linear region as that at the corner.

It is considered that the duration of thermal cycle is longer in the corner region due to process kinematics and the delays in the laser beam motion when the direction of the mutual motion is altered. Moreover, detail of the corner in Fig. 9 also depicts that the surface of the corner section contains the thin oxide layer which usually appears grey in metallographic images [15, 16]. Furthermore, the boundary between grey oxide layer and HAZ contains very thin white layer which is usually reported as the re-hardened very brittle martensite. On the other hand, the dark HAZ is referred as the rough martensite hardened by self-cooling followed after laser beam heating.

Avoiding the coating delamination should be linked with the avoiding presence of thick oxide layer especially at the components corners. Two different strategies should be considered. First one is based on the reduction of heat entering the surface in these critical regions. Such approach can be linked with the alteration of LBM conditions such as laser power, cutting speed, etc. The second way can be viewed in avoiding Fe matrix oxidation by the use of application of suitable assisting laser gas. These strategies would also contribute to the better precision of produced components, elimination of residual stresses of higher magnitude as well as lower thickness of HAZ. Furthermore, it should be also noted that the increasing thickness of cut components will result into increased height of surface irregularities, higher thermal load which in turn means higher thickness of the oxide layer. Also component geometry should be considered as well. Especially the low angle passes might be critical. Matrix cooling in these positions would be delayed and thermal energy consumption increased with the negative role with respect of surface state.

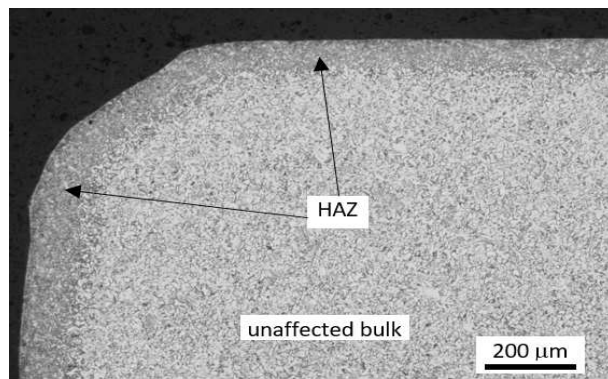
Fig. 8 Metallographic image of HAZ after LBM, entering region

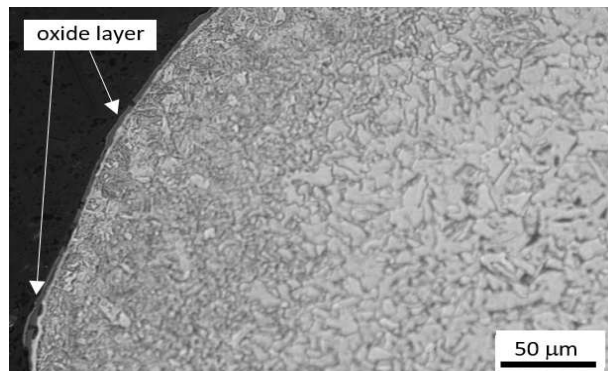
Fig. 9 Metallographic image of HAZ after LBM, entering region, detail

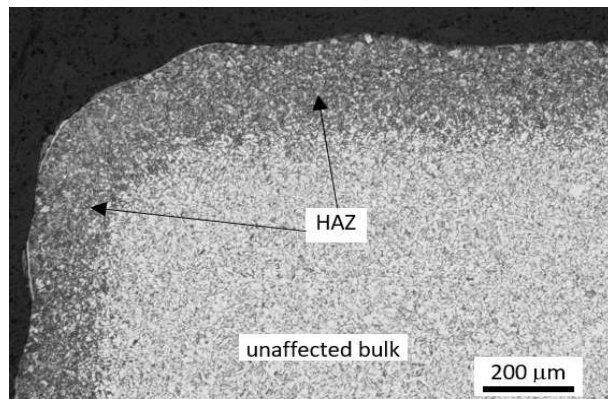
Fig. 10 Metallographic image of HAZ after LBM, trailing region

Fig. 10 depicts that the thickness of the HAZ at the trailing edge is more as that at the entering edge. Thickness of HAZ at the entering edge is about 0.1 mm and this thickness is approx. twice as higher at the trailing edge. Fig. 10 also proves the higher height of surface irregularities at the trailing edge as compared with the entering one. It can be clearly demonstrated that the surface on the metallographic image in Fig. 8 is more or less smooth and becomes remarkably wavy at the trailing edge. The detail of the trailing edge also demonstrates that the thickness of oxide layer as well as the white re-hardened layer are remarkably more as those at the entering edge.

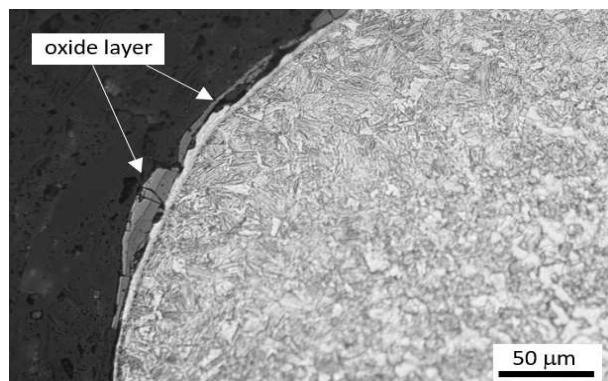
Fig. 11 Metallographic image of HAZ after LBM, trailing region, detail

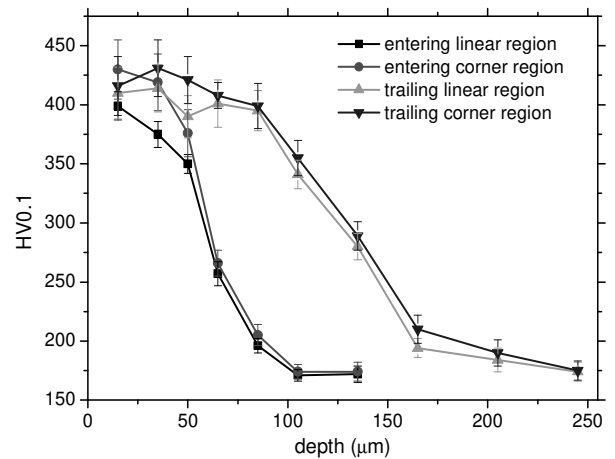
Fig. 12 HV0.1 depth profiles in the different regions

Hardening effect on the component surface due to thermal cycle can be proved by the microhardness measurement HV0.1. This figure depicts that the degree of hardening at the entering and trailing edges is similar. However, its extent is more at the trailing edge which is consistent with the higher thickness of HAZ. The difference in HV0.1 profiles between the liner and the corner sections is only minor. Finally, the reasons of the coating delamination as that illustrated in Fig. 7 should be indicated. The main clue can be linked with Fig. 11 in which quite thick oxide as well as white re-hardened layer is found on the dark HAZ. These layers are quite brittle and hard [7, 10, 11] and can easily delaminate. Moreover, the oxide layer misses the direct contact with the underlying surface in many positions. Having sprayed coating as that depicted in Fig. 7, its delamination can be directly linked with presence of the thick oxide layer which occurs mainly on the components corners. Delamination of coating is therefore a result of the oxide layer poor contact with the underlying surface and its poor malleability. It is worth to mention that the oxide layer as well as white re-hardened layers occur on the linear region of component as well. However, these layers are discontinuous and their thickness is much lower as that found at the component corners.
