## Microscopic Wear Analysis of Indexable Inserts after Machining of 34CrNiMo6 Steel

Machining is an important part of the manufacturing process in the engineering field. Turning is one of these areas. At present, almost exclusively exchangeable cutting inserts are used in production machining. The article describes the research in the field of their wear, where the electron microscopy was used to evaluate the results. Electron microscopy is a very important aid in research in many areas not only of human activity and also is the important aid in the field of mechanical engineering and manufacturing technologies. The results thus obtained can make in a given area it clearer and better document the resulting situation. Within the experiments, selected cutting inserts (WPP10S, WPP20S) were used and the given material was machined (34CrNiMo6 steel). The cutting speed was different depending on the type of insert (WPP10S 120 and 140 m·min<sup>-1</sup>, WPP20S 80, 100 and 120 m·min<sup>-1</sup>). The electron microscope Tescan Vega 3, which is available in the workplace where the experiment was conducted, was used to evaluate the resulting tool wear. As part of experiments was also rea

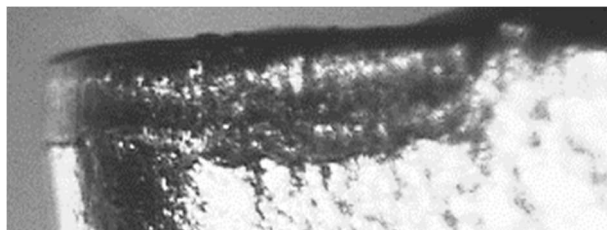
**Fig. 9** Final tool wear, WPP10S,  $120 m \cdot min^{-1}$

For this speed, the tool life of the insert was 21.6 min, ie after this machining time the tool wear was  $VB_{\max} = 0.3 \text{ mm}$ , how it was determined by experiment (in according with standard ISO 3685).

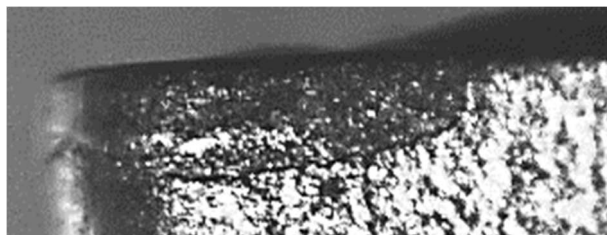
**Fig. 10** Final tool wear, WPP10S,  $140 m \cdot min^{-1}$

For this speed, the tool life of the insert was 12.4 min, ie after this machining time the tool wear was  $VB_{\max} = 0.3 \text{ mm}$ , how it was determined by experiment. (Figs. 20, 21).

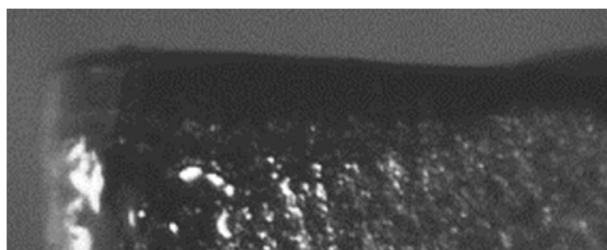
**Fig. 11** Final tool wear, WPP20S,  $80 m \cdot min^{-1}$

For this speed, the tool life of the insert was 20.5 min, ie after this machining time the tool wear was  $VB_{\max} = 0.3 \text{ mm}$ , how it was determined by experiment (Fig. 22, 23).

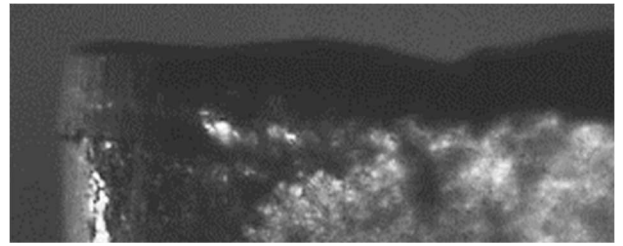
**Fig. 12** Final tool wear, WPP20S,  $100 m \cdot min^{-1}$

The cutting insert WPP20S at a cutting speed of  $100 \text{ m} \cdot \text{min}^{-1}$  achieved wear  $VB_{\max} = 0.3 \text{ mm}$  after 10.7 minutes of machining. (Fig. 24, 25). The face of the insert is worn down to the depth of the lower coating layer at two points, on the main cutting edge near the tip and on the end of the cutting edge of the secondary cutting edge. The main blade bears signs of abrasive wear, which remains at the level of the first  $\text{Al}_2\text{O}_3$  coating. On the main ridge was formed again to the depth of the lower TiCN coating, which appeared only behind the main blade (out of  $a_p$ ). It is also possible to observe here area at the main ridge (like fig. 16 and 17

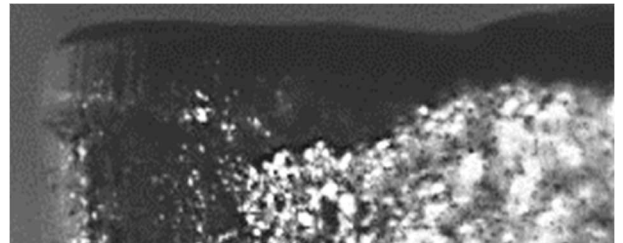
**Fig. 13** Final tool wear, WPP20S,  $120 m \cdot min^{-1}$

The cutting insert WPP20S, which was used at a cutting speed of  $120 \text{ m} \cdot \text{min}^{-1}$ , achieved wear  $VB_{\text{max}} = 0.3 \text{ mm}$  after 8.2 minutes (Fig. 26, 27). This insert carries signs of relatively uniform wear, again likely to be abrasive. In some places the machined material to be adhered (traces of Fe) is visible. On the main back is again visible the formation, which could be caused by flying chips, traces of Fe are observed here (similar case like on the fig. 17 or 23).

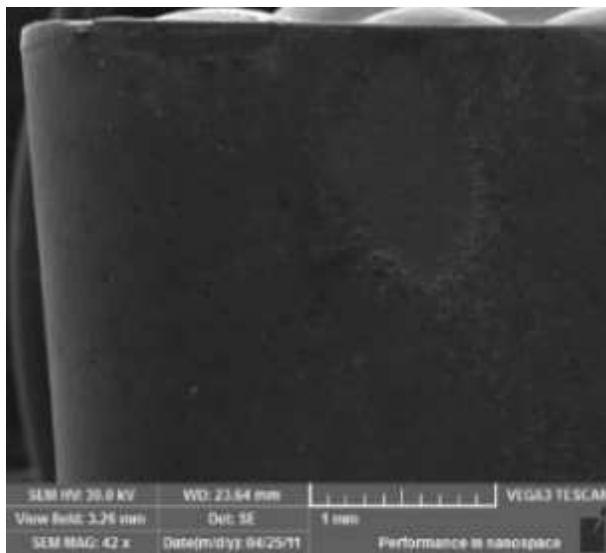
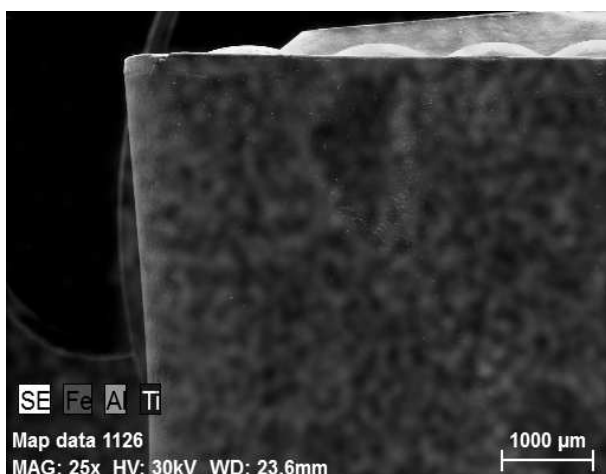
As shown by SEM and EDS analysis (Fig. 16, 17), this insert showed signs of wear most likely to be abrasive in origin. Furthermore, it was apparent that both coating layers were broken in the tip region and the insert substrate was exposed. The main blade showed signs of abrasive wear. When looking at the main ridge, there was a “pothole” behind the depth of cut area, which could be caused by the erosive effect of flying chips, as there were traces of iron (Fe) at this place. All these inserts exhibited this kind of damage for all machining speeds used. In this area, the lower TiC coating was exposed.

**Fig. 16** SEM main back WPP10S,  $120 \text{ m} \cdot \text{min}^{-1}$

**Fig. 17** EDS main back WPP10S,  $120 \text{ m} \cdot \text{min}^{-1}$

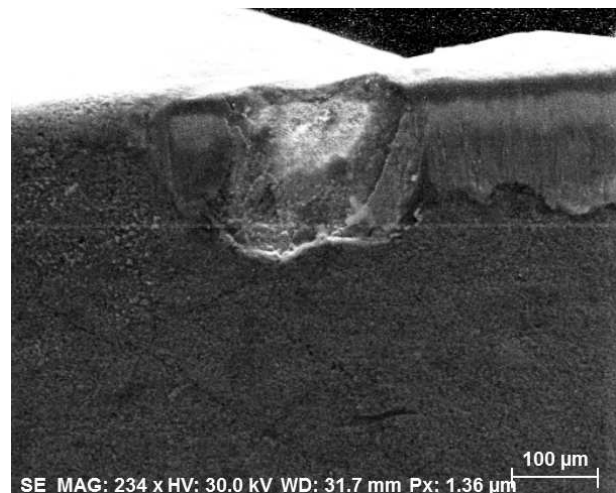
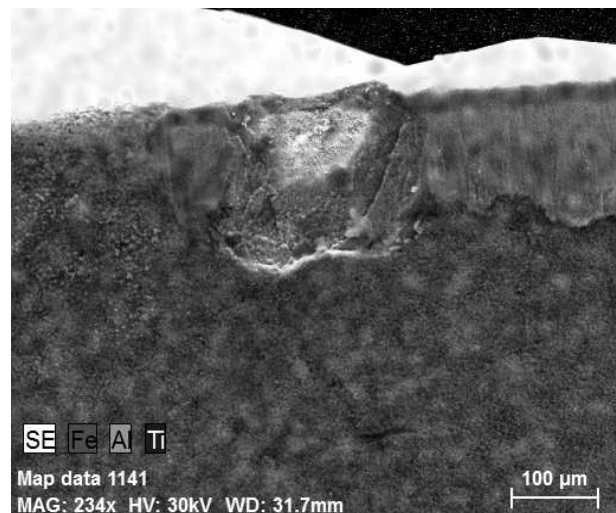
In the region of the minor blade, the most noticeable failure was apparent, in which not only the first coating layer but also the lower TiC coating layer

was removed and at this point a substrate was revealed (it having a light gray color, Fig. 18 and 19).

**Fig. 18** SEM minor blade WPP10S,  $120 \text{ m} \cdot \text{min}^{-1}$

**Fig. 19** EDS minor blade, WPP10S,  $120 \text{ m} \cdot \text{min}^{-1}$

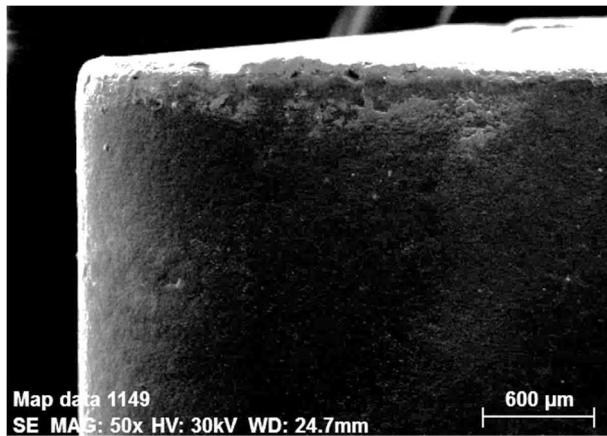
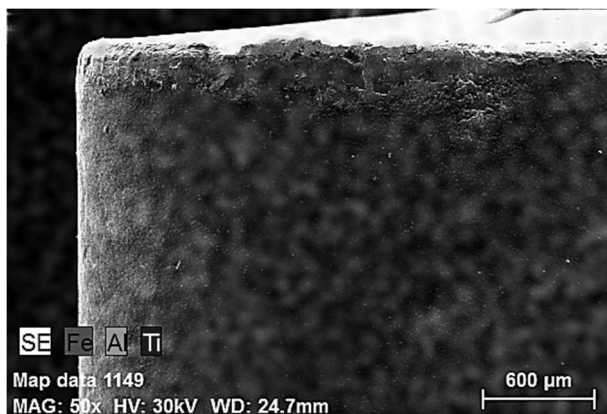
After this machining time, it was seen on the insert that the wear was moving at the interface between the upper and lower coating layers. The substrate was not detected. Furthermore, it was apparent that the material to be adhered to in the region of the cutting edge and the tool face, thus creating a build-up.

**Fig. 20** EDS minor blade, WPP10S,  $140 \text{ m} \cdot \text{min}^{-1}$

**Fig. 21** EDS minor blade, WPP10S,  $140 \text{ m} \cdot \text{min}^{-1}$

The obtained surface roughness  $R_z$  after machining ranged from  $12.2$  to  $20.5 \mu\text{m}$ . This variance in the obtained roughnesses can be considered as the largest in comparison with other measured surfaces for other  $v_c$  and inserts. But again there is no apparent dependence of  $R_z$  on the amount of wear. The highest roughness was measured after 2.5 minutes of machining, the lowest  $R_z$  size was measured after 5.5 minutes of machining. The considerable variation of  $R_z$  is likely to be attributed to the abovementioned build-up.

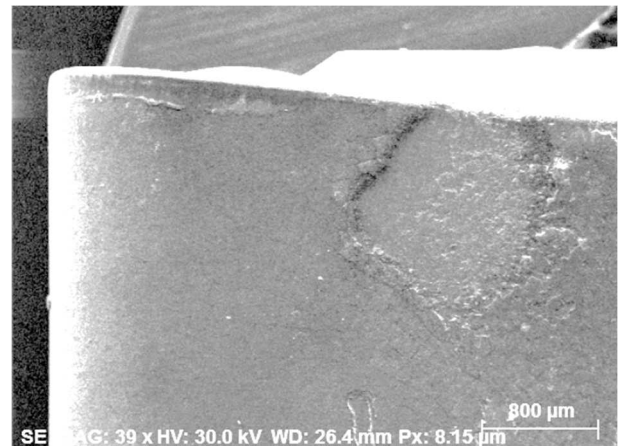
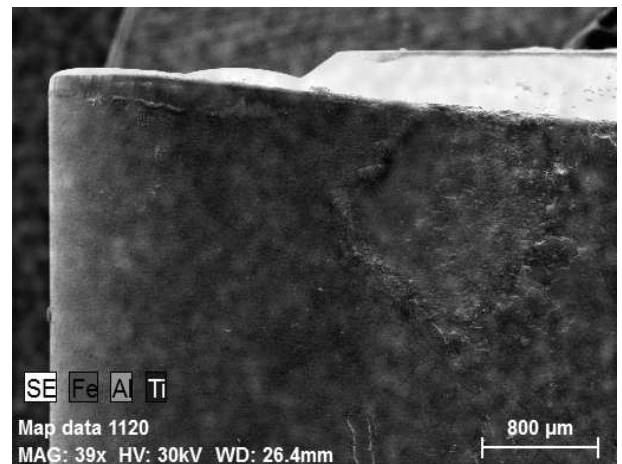
There was slight wear on the main edge of the insert, which was probably caused by abrasion (abrasive wear). This only extends into the topcoat layer, the bottom (second) layer of the coating being slightly exposed. Further, a formation that could be of erosive origin can be observed behind the cutting part of the head blade and in the wider area of the main back. In this area, however, only the lower (second) coating layer was exposed. This layer consists of TiCN. There are areas where the material (Fe) to be

adhered is noticeable, but in this case we cannot speak about built-up. When looking at the main ridge (like Fig. 16 and 17), there was a “pothole” behind the depth of cut area, which could be caused by the erosive effect of flying chips, as there were traces of iron (Fe) at this place.

**Fig. 22** SEM main back WPP20S,  $80 \text{ m} \cdot \text{min}^{-1}$

**Fig. 23** EDS main back WPP20S,  $80 \text{ m} \cdot \text{min}^{-1}$

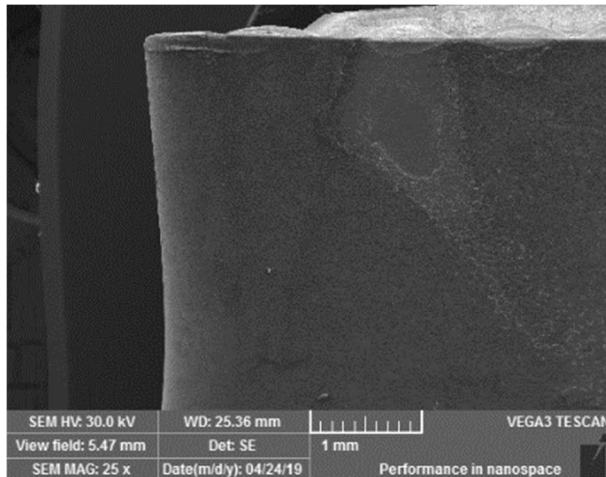
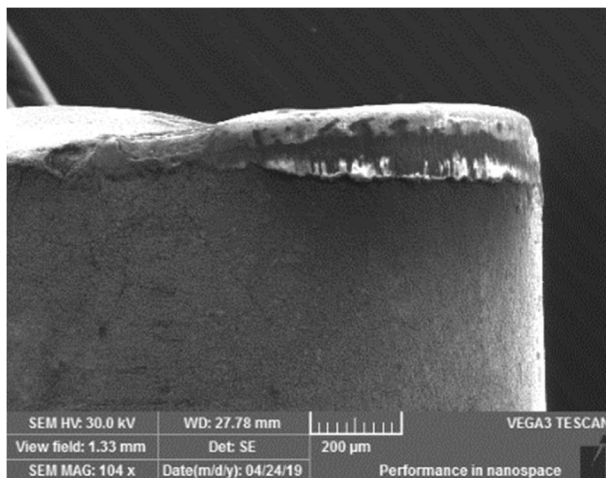
or 22 and 23), there was a “pothole” behind the depth of cut area, too, which could be caused by the erosive effect of flying chips, as in previous cases.

*Fig. 24 SEM main back WPPS20, 100  $\text{m} \cdot \text{min}^{-1}$*

*Fig. 25 SEM secondary blade WPP20S, 100  $\text{m} \cdot \text{min}^{-1}$*

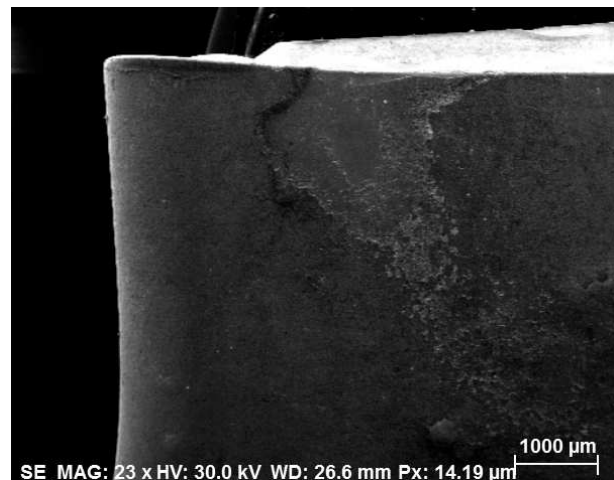
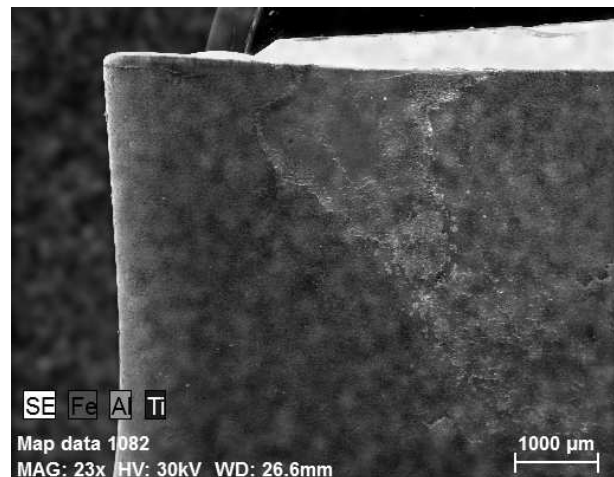
*Fig. 26 SEM main back WPP20, 120  $\text{m} \cdot \text{min}^{-1}$*

*Fig. 27 EDS main back WPP20, 120  $\text{m} \cdot \text{min}^{-1}$*
