Analysis of Fractured Weldment of Hadfield Steel

This contribution is divided into two sections. The first one deals with identifying the cause of fracture in a ring, which fractured after weld surfacing. Optical and scanning electron microscopy and hardness testing were employed. Chemical composition was determined using the GDOES and EDX methods. Although weld surfacing has led to fracture in the base material, the actual problem was in the inadequate microstructure of the base material. Microscopic analysis revealed that it was heterogeneous. It contained distinctive segregation bands with bands of complex carbides and pearlite colonies, which are undesirable. The microstructure of this steel should be fully austenitic. In order to remove the heterogeneities, solution annealing was proposed and carried out successfully. The second section of this paper explores the options for revealing the microstructure of Hadfield steel. Etching reagents from the literature and authors' experience were put to test.

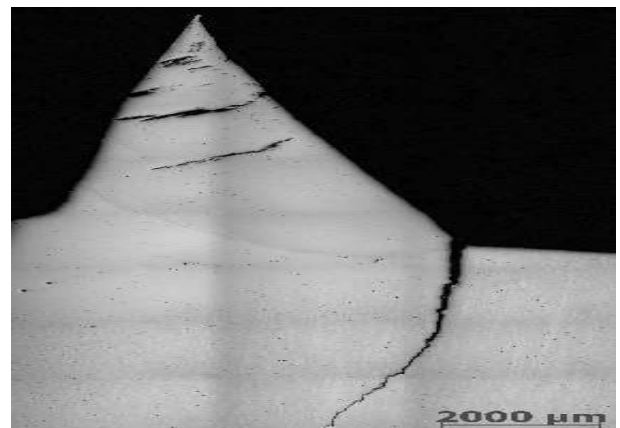
Fig. 2 Cracks in the base material, 50 ml HCl+25 ml $C_2H_6O+0.1$ ml H_2O_2 .

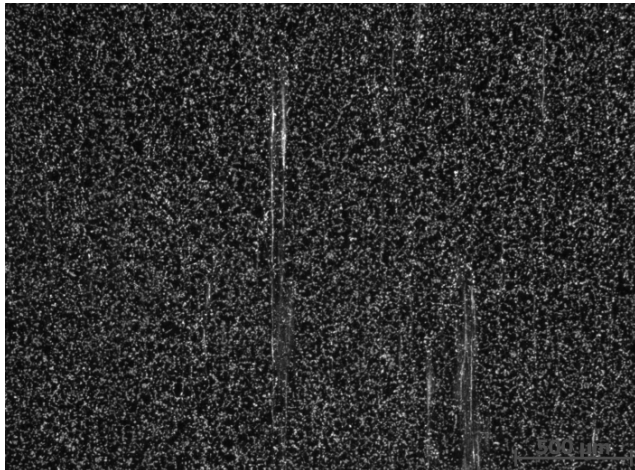
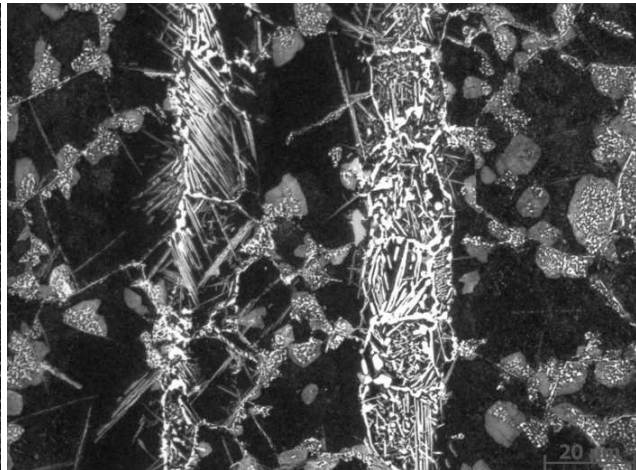
Segregation bands were found using an optical microscope, see Fig. 4. The micrograph on the left was taken at 25× magnification. The detail on the right was taken at 500×. This occurrence is definitely undesirable, as the steel should possess fully-austenitic microstructure, without

carbide precipitates if possible. Using EDX, increased levels of manganese and carbon were found in these bands. Manganese and carbon segregation has led to formation of complex carbides in these regions. The material fractured in one of these segregation bands, as evidenced by Fig. 5, which shows two fracture locations in the base material where the crack follows the carbide segregation bands. The micrographs were taken at 500 \times magnification. This segregation definitely could not have formed during welding. It formed after the steel had been poured. To remove it, the cast steel should have been solution annealed.

Fig. 4 Segregation bands in the base material, Klemm I.

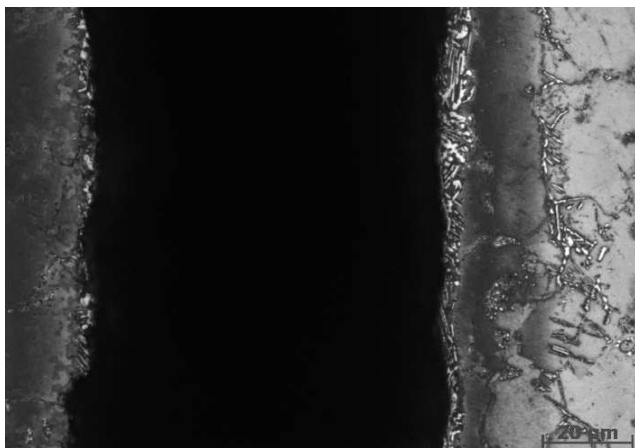
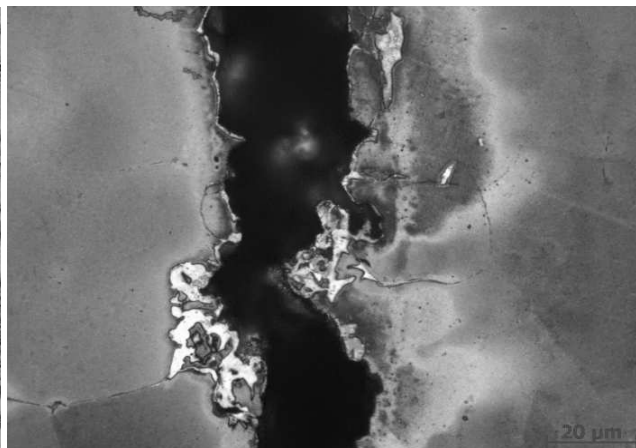
Fig. 5 Segregation bands around a fracture in the base material, Klemm I.

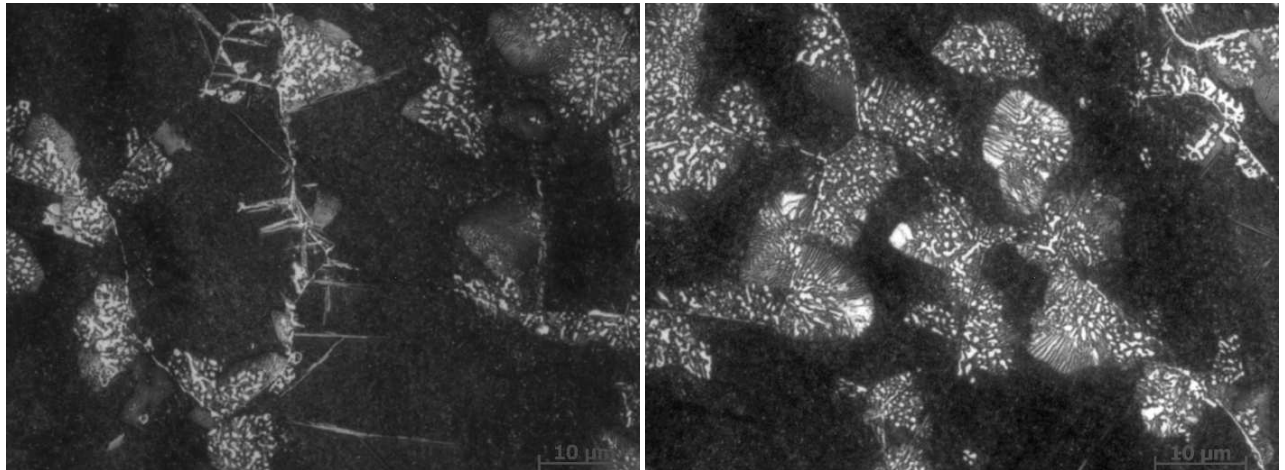
In addition to the segregation bands, many pearlite colonies were found, as illustrated in Fig. 6, left. The micrograph on the right in Fig. 6 shows another undesirable phase: carbides in the form of envelopes along austenite grain boundaries and needles emanating from the envelopes or existing within austenite grains. The micrograph was taken at 1000 \times magnification. Microhardness was measured to confirm the presence of pearlite colonies.

Their microhardness was 543 ± 96.5 HV 0.01. The microhardness of austenite grains was 311 ± 45.5 HV 0.01.

Fig. 6 Pearlite colonies and carbides within and along the boundaries of grains, Klemm I.

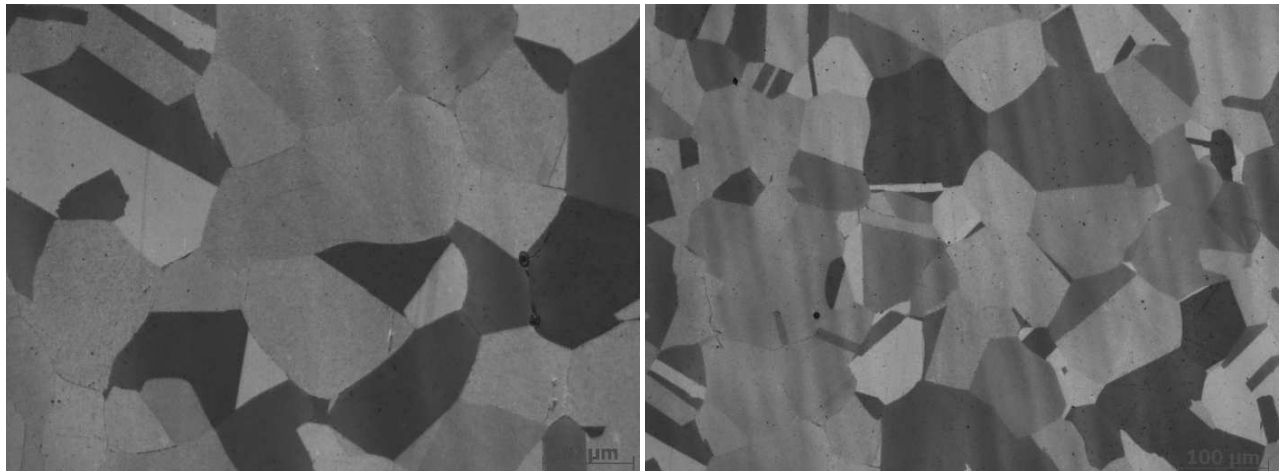
In an attempt to remove all the above-described microstructural heterogeneities, solution annealing was performed. The sequence comprised heating to 1050 $^{\circ}$ C, holding for 1 hour and subsequent water quenching [7]. The specimen was wrapped in a special protective foil to prevent decarburization. The solution-annealed microstructure is shown in Fig. 7. The micrographs were taken at 100 \times and 200 \times magnification. Microstructural

heterogeneities were successfully removed by this process. The result was an austenitic structure with a small amount of carbides along grain boundaries. However, the time at temperature proved longer than necessary, given the small size of the specimen, which was evidenced by the fact that the austenite grain had coarsened. The initial G6 size increased to G4. This negative effect could be avoided if the annealing time were shorter.

Fig. 7 Post-anneal microstructure, nital.
