The Crack Analysis of Fatigue Tested Steel Construction

Zbynek Bunda, Ludmila Kucerova, Miloslav Kepka

Regional Technological Institute, University of West Bohemia. Univerzitni 8, 306 14 Pilsen. Czech Republic. E-mail: bunda@rti.zcu.cz, skal@rti.zcu.cz, kepkami1@rti.zcu.cz

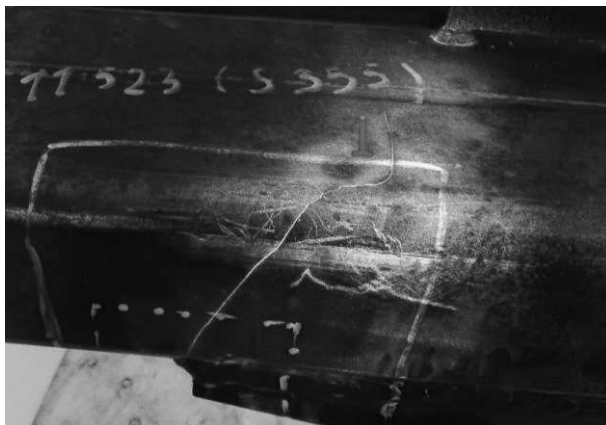
Fig. 3 The longest linear indication after 1 200 000 cycles

After 1 200 000 cycles were found 3 indications (Fig. 3, 4, 5). These indications were after MT repaired with weldings. The longest indication was about 40 cm (Fig 3.). This crack was cut out and fractographic analysis was done. The cutted sample was replaced with a new material. Next magnetic particle test was done after 1 500 000.

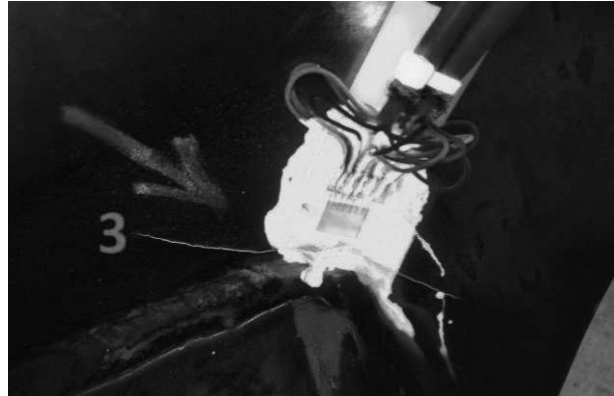
Fig. 4 Detail of the linear indication near the strain gauge after 1 200 000 cycles

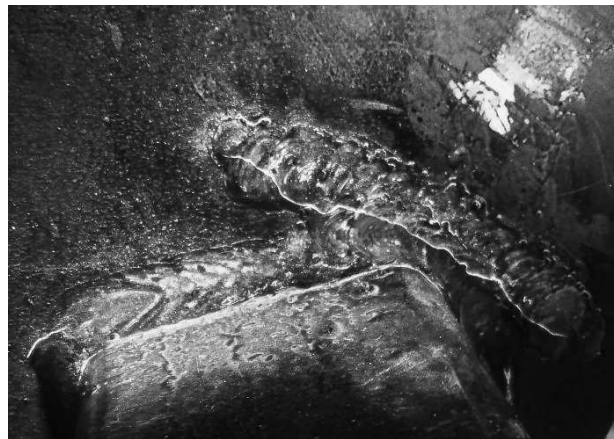
cycles. The last 300 000 cycles were performed with increased loading force about 20%. During this test were found 4 linear indications. 2 of them were old and repaired with weldings and 2 were new (Fig. 5, 6).

Fig. 5 Detail of the linear indication, repaired after 1 200 000 cycles, after 1 500 000 cycles occurrence again in weld

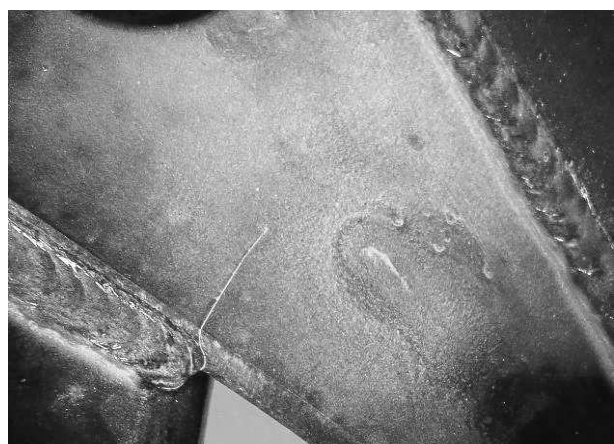
Fig. 6 Detail of the linear indication after 1 500 000 cycles

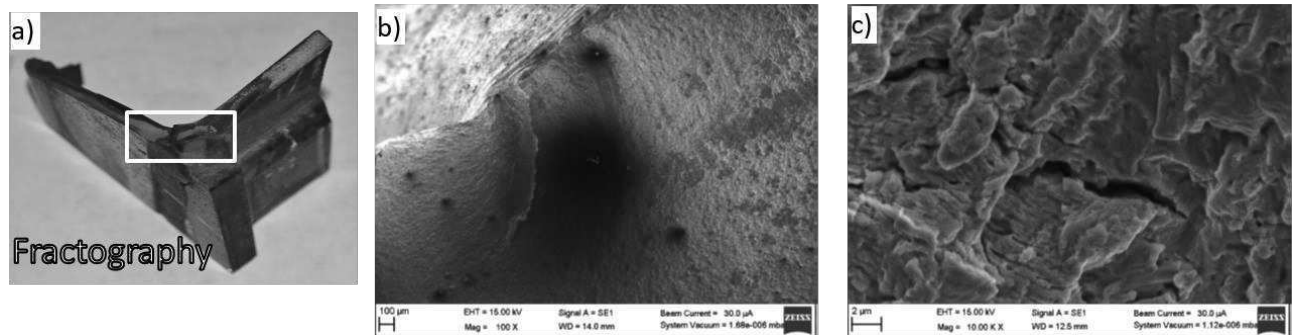
Fig. 7 Part of the crack with failure initiation area cut from the frame, (a) overview of fracture surface with initiation area marked by a white rectangular, (b) detail of the fracture initiation at the surface of the frame, (c) detail of fracture surface with striation created by gradual propagation of a fatigue crack and secondary cracks.

Fracture initiation site was detected at the surface of the welded part and the traces of propagation of fatigue failure were found at fracture surface (Fig. 7). The initiation was placed at the interface of weld metal and base material, at the outer surface of bended part of the frame. This is the area with the highest tensile loading during bending. Numerous sulphur inclusions were found in the base material, showing low metallurgical purity of used steel. Relatively large defects were observed also in weld metal (Fig. 8) in the proximity of fracture initiation site. Using EDS (Energy-dispersive X-ray spectroscopy) analysis, the presence of oxides was confirmed in the spherical defect (Fig. 8c, e) and also in the defect with a “crank”

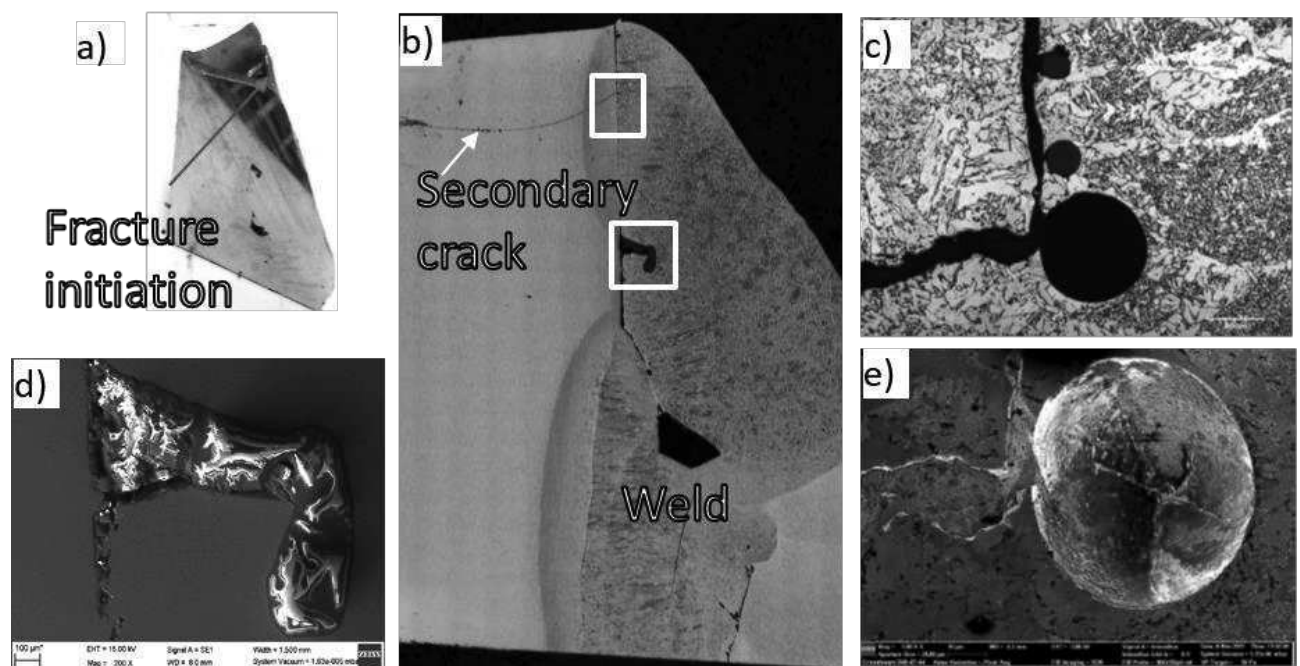
shape (Fig. 8d). It became also obvious that the joint was not welded completely thought (Fig. 8b). Large numbers of fine oxidic particles with increased amount of M and Si were also found in heat affected zone in the proximity of the weld-base metal interface. The microstructure of the base material was predominantly ferritic with very small pearlitic areas and it gradually changed to acicular ferrite in heat affected zone. The microstructure of the weld was mainly bainitic with either long columns of bainite or bainitic blocks with ferrite formed at the prior austenite grain boundaries.

Fig. 8 Metallography of the cross section perpendicular to fracture surface, provided in the area of crack initiation. (a) part of the frame for metallographic analysis, (b) macro of etched cross section, areas of defects found at the weld-base metal interface marked in white rectangles, (c) detail of the upper defect with initiation of secondary crack from the spherical defect, (d) detail of the “crank” shaped defect, (e) detail of spherical defect from Fig. 7(c).

Fatigue test supported by NDT and metallography led to the identification and removal of imperfections in design and also in a welding technology.
