## Using of the Electron Microscope to Evaluate the Tool Wear for a Selected Cutting Insert

Nataša Náprstková<sup>1</sup>, Karel Šramhauser<sup>1</sup>, Jaromír Cais<sup>1</sup>, Dana Stančeková<sup>2</sup>

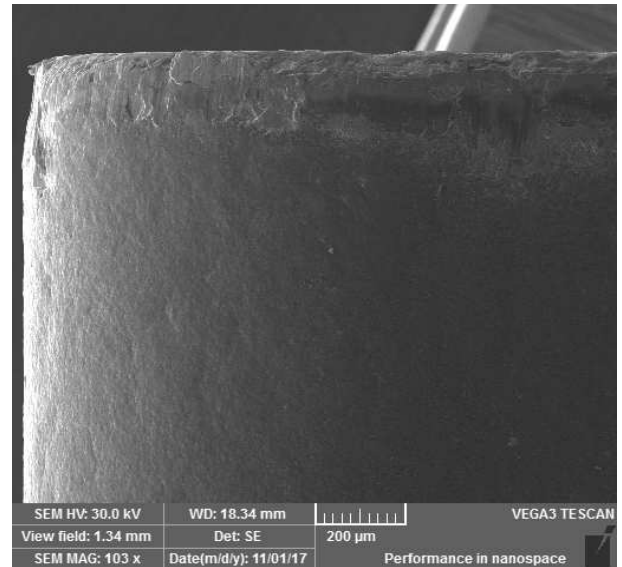
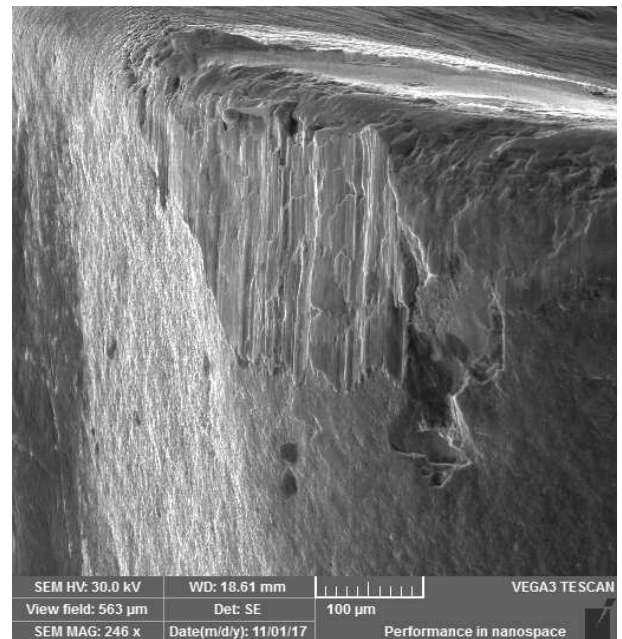
The first insert was analyzed after machining at  $v_c = 230 \text{ m min}^{-1}$ . In Fig. 6 and 7, the SEM images of the resulting tool wear of the plate are for this rate. This wear

**Fig. 6** SEM for insert after machining by  $v_c = 230 \text{ m min}^{-1}$

**Fig. 7** SEM for insert after machining by  $v_c = 230 \text{ m min}^{-1}$ , greater magnification

SEM analysis showed that the resultant tool wear for cutting speed  $v_c = 230 \text{ m min}^{-1}$  showed the usual traits, and there were no anomalies visible on the plate after this machining. Additionally, EDS analysis was carried out. It can be seen from these figures that, after the machining, the substrate of the plate was not detected (revealed), which is made of tungsten carbide and niobium and cobalt binder. The tool wear revealed the lower coating, which is made of titanium carbide. The top coat of  $\text{Al}_2\text{O}_3$  has been damaged in the machining area, essentially in the entire area of machining (contacting the insert with the material). There is also a visible presence of iron that comes from the machined material.

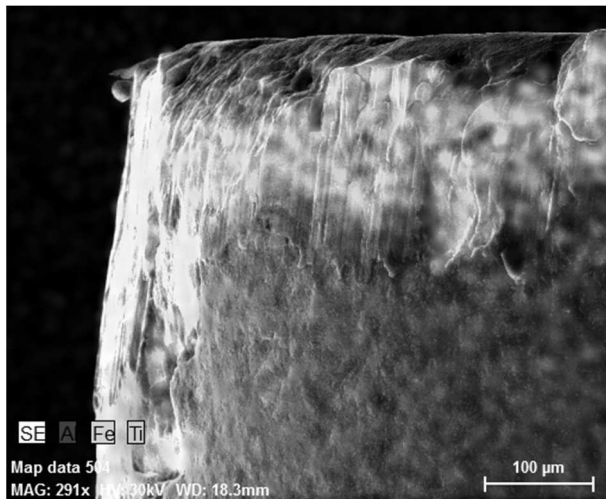
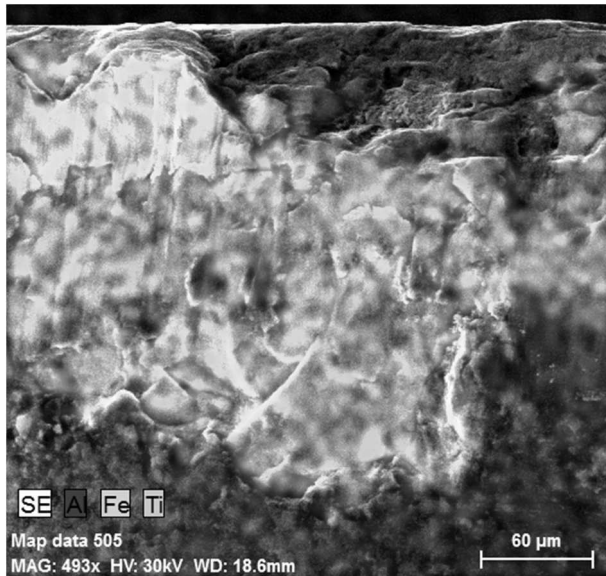
**Fig. 8** EDS for insert after machining by  $v_c=230 \text{ m} \cdot \text{min}^{-1}$

**Fig. 9** EDS for insert after machining by  $v_c=230 \text{ m} \cdot \text{min}^{-1}$ , greater magnification

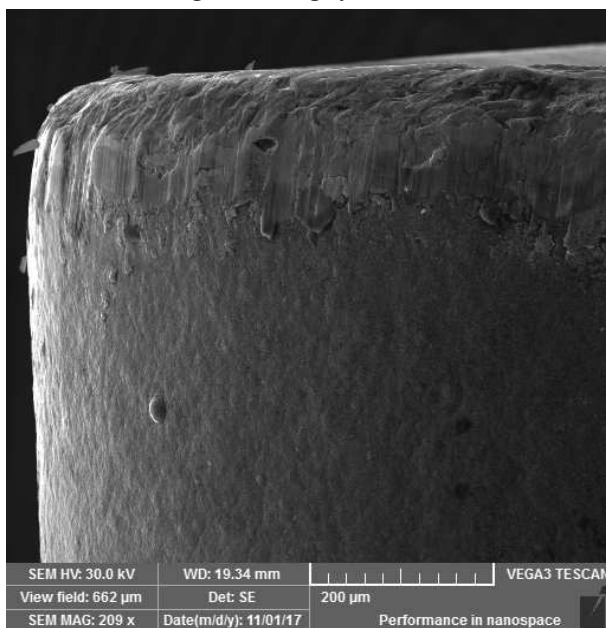
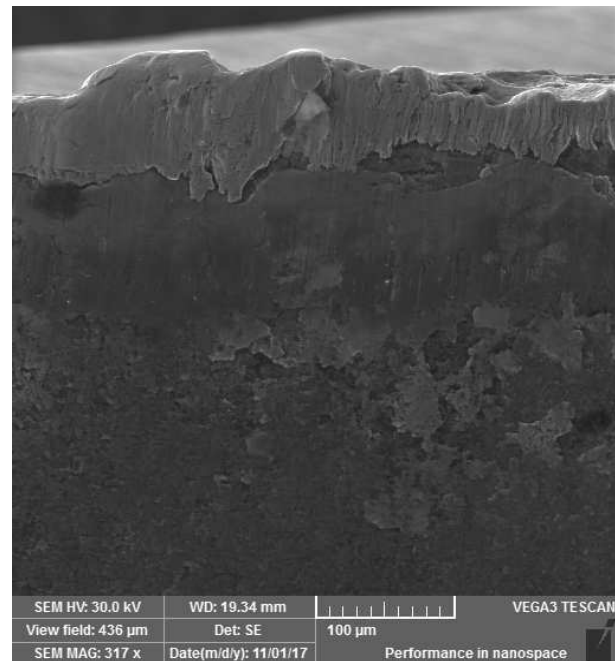
**Fig. 10** SEM for insert after machining by  $v_c=250 \text{ m} \cdot \text{min}^{-1}$

**Fig. 11** SEM for insert after machining by  $v_c=250 \text{ m} \cdot \text{min}^{-1}$ , greater magnification

Next, the plate was analyzed after machining at a rate of  $v_c = 250 \text{ m} \cdot \text{min}^{-1}$ . This tool wear was achieved after 32 minutes of machining. In Fig. 10 and 11, the SEM images of the resulting tool wear of the plate are for this rate. Fig. 12 and 13 are images taken with an EDS analysis showing the occurrence of individual elements within a replaceable cutting insert after machining.

SEM analysis showed that the resultant tool wear for cutting speed  $v_c = 250 \text{ m} \cdot \text{min}^{-1}$  showed the usual traits, and there were no anomalies visible on the plate after this machining. There is no significant difference between wear for  $v_c = 230 \text{ m} \cdot \text{min}^{-1}$  and for  $v_c = 250 \text{ m} \cdot \text{min}^{-1}$ . Additionally, EDS analysis was carried out. It can be seen from these figures that even with this machining speed after machining, the substrate of the plate was not detected. Here, the wear revealed the lower coating, which is made of titanium carbide, too. The topcoat formed by  $\text{Al}_2\text{O}_3$  has been damaged in the machining area, again in substantially the whole machining area (contacting the insert with the material). There is again the presence of iron that comes from the machined material.

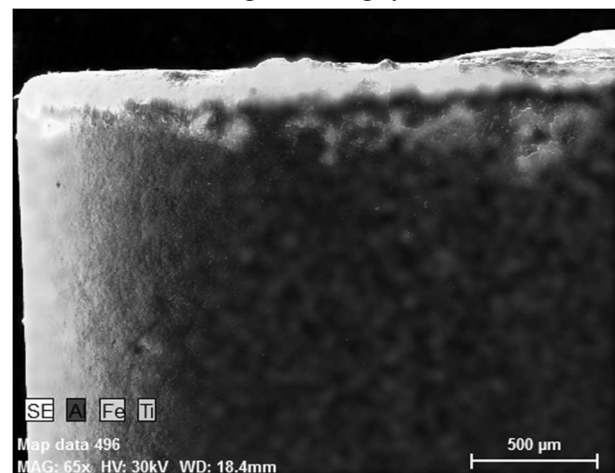
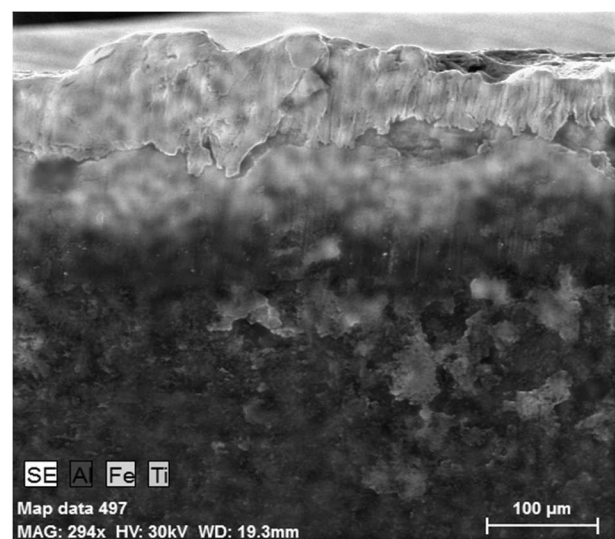
**Fig. 12** EDS for insert after machining by  $v_c=250 \text{ m} \cdot \text{min}^{-1}$

**Fig. 13** EDS for insert after machining by  $v_c=250 \text{ m} \cdot \text{min}^{-1}$ , greater magnification

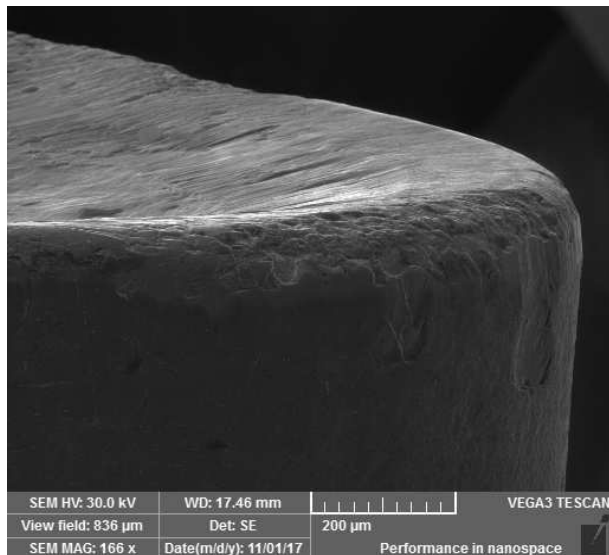
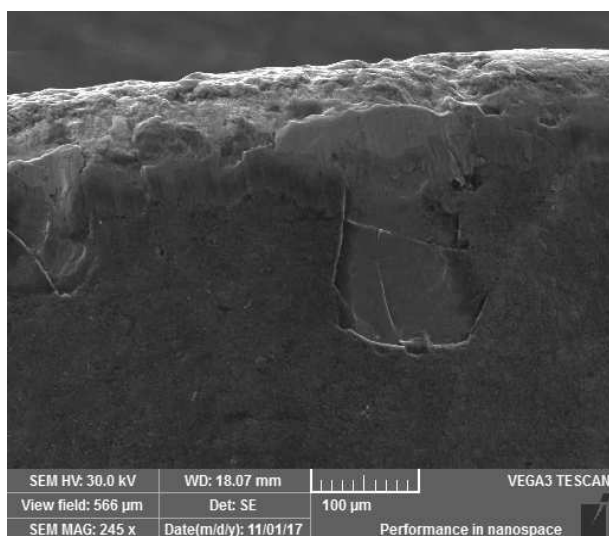
**Fig. 14** SEM for insert after machining by  $v_c = 270 \text{ m} \cdot \text{min}^{-1}$

**Fig. 15** SEM for insert after machining by  $v_c = 270 \text{ m} \cdot \text{min}^{-1}$ , greater magnification

Next, the plate was analyzed after machining at a rate of  $v_c = 270 \text{ m} \cdot \text{min}^{-1}$ . In Fig. 14 and 15, the SEM images of the resulting tool wear of the plate are for this rate. This tool wear was achieved after 27 minutes of machining. Fig. 16 and 17 are images taken with an EDS analysis showing the occurrence of individual elements within a replaceable cutting insert after machining.

SEM analysis showed that the resultant tool wear for cutting speed  $v_c = 270 \text{ m} \cdot \text{min}^{-1}$  showed the usual traits, and there were no anomalies visible on the plate after this machining. Against the previous  $v_c$ , there are two small grooves visible on the edge. Here, EDS analysis was also carried out. It can be seen from these figures that even with this machining speed after machining, the plate substrate was not detected. Here, the tool wear revealed the lower coating, which is made of titanium carbide, too. The top coat of  $\text{Al}_2\text{O}_3$  has been damaged in the machining area, again substantially throughout the machining area. There is again the presence of iron that comes from the machined material. For this rate, the presence of iron from the machined material was the smallest.

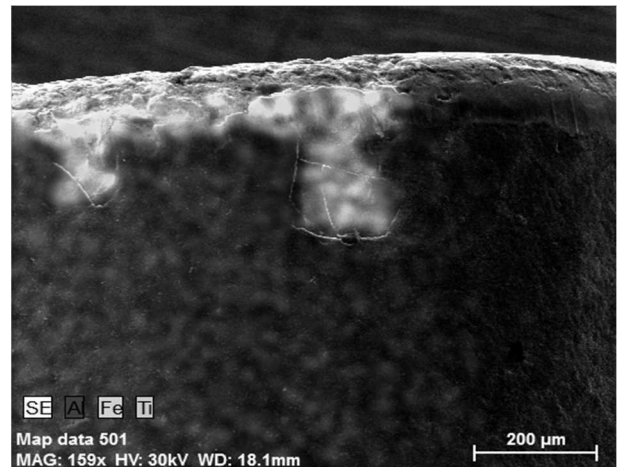
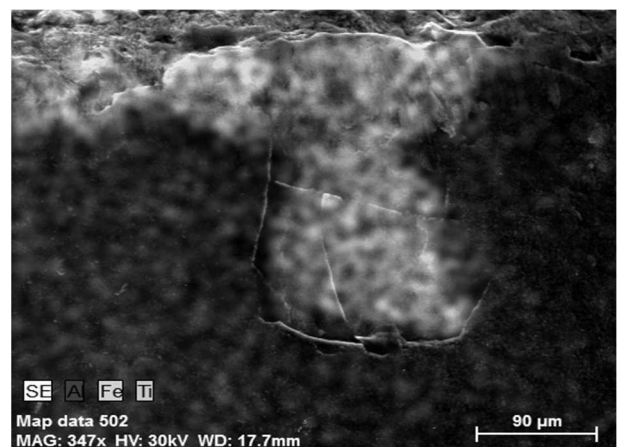
**Fig. 16** EDS for insert after machining by  $v_c = 270 \text{ m} \cdot \text{min}^{-1}$

**Fig. 17** EDS for insert after machining by  $v_c = 270 \text{ m} \cdot \text{min}^{-1}$ , greater magnification
