Analysis of Al-Si Layer on Steel Sheet during Thermo Mechanical Processing Using Microscopic Methods

Sylvia Kusmierczak, Michal Slavik

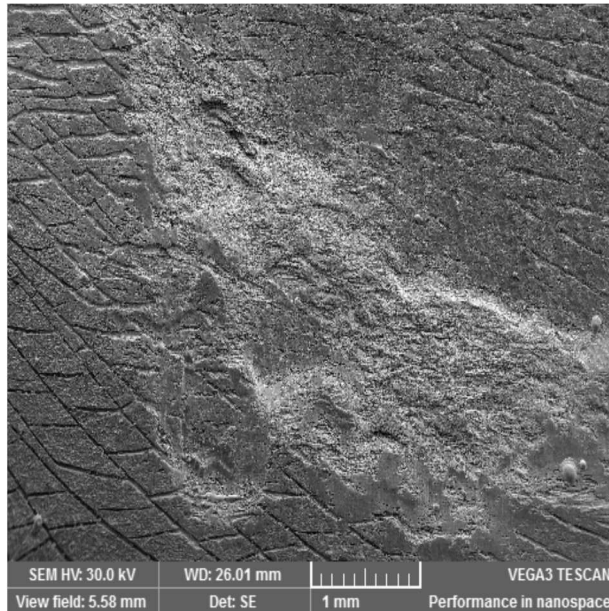
At first were samples analyzed which showed degradation of the protective layer. Impaired surface layer is always located on the oblique surface of the molding. In practice, this kind of degradation is called "galling". On samples 1 and 2 (Figures 3 and 4) it is visible that the surface layer is traced to the corners of the damaged area. Regular macro cracks can also be seen on the images, especially in areas where the surface layer is not damaged. The macro cracks are in a regular spacing ($150 \div 180$) μm with a width of $30 \mu\text{m}$, Fig. 3. Their formation is due to insufficient compression in the mold, due to poor or no contact with the sheet, it cools down at a lower velocity and in the base material there are tensile stresses cooler surface layer, cause macro cracks. To the forma-

tion of macro cracks contributes Kirkendall effect that assesses the chemical potentials of the various elements, in this case is most likely a Fe - base material and Fe_2Al_5 dominant phase, which is represented by the most resources. The principle of this phenomenon is the formation of a vacancy mechanism, in which atoms from a certain thickness of the surface Al-Si layer are transferred to a lower thickness of the surface layer.

Fig. 3 Sample 1, damaged surface

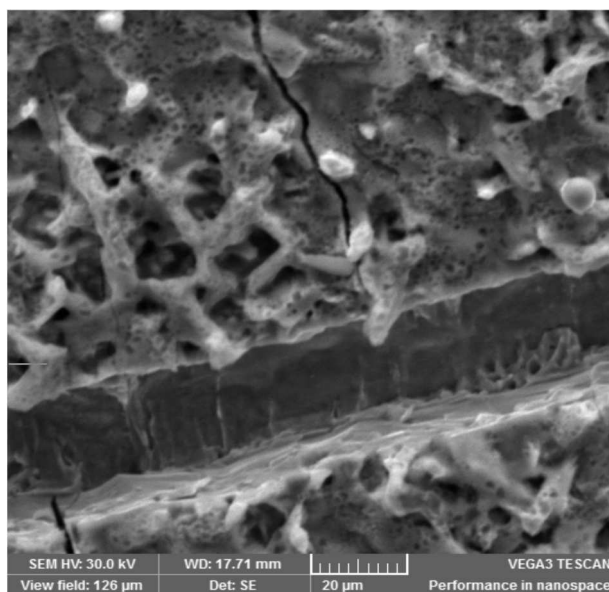
Fig. 5 Sample 1, cracks from the surface to the base material

In the surface layer there is often a uniform and regular repetition cracks of the surface layer to the base material. In this part of the surface there are also spherical inclusions, Fig. 5.

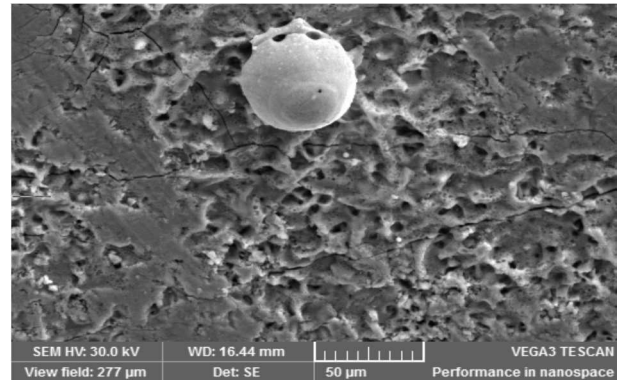
Fig. 4 Sample 1, spherical inclusion 1, detail

For more detailed analyzes of the state of the surface layer was observed in the presence of spherical inclusions (Fig. 3, 4). The results of EDX analysis of spherical inclusion 1 (Table 3) indicate that this is the inclusion on the base of iron oxides

The Nb and V elements are not defined in the chemical composition of the base material (22MnB5 steel) or the surface Al-Si layer. For this reason, it can be assumed that these are elements that include the forming tool. The Nb content, together with Ti and V, provides steel precipitation, grain refinement, and these elements can also influence the temperature of the polymorphic transformation ferrite ↔ austenite.

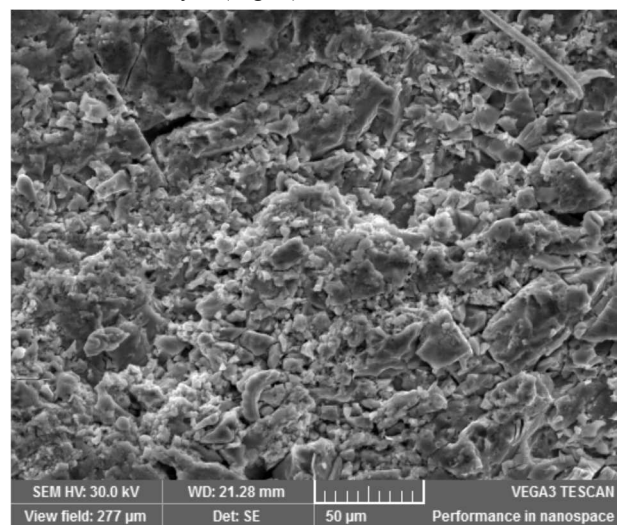
Sample 2 shows the state of the surface of the sheet material, where there is no significant plastic deformation of the surface layer (Fig. 6).

Fig. 6 Sample 2, condition of the surface layer

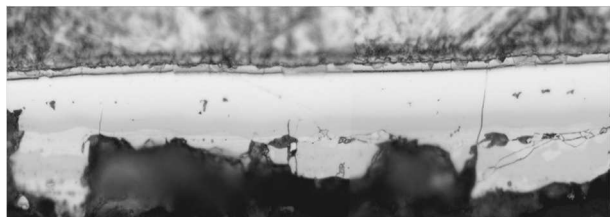
Fig. 7 Sample 3, bottom surface layer, mag. 500x

According to the standards, the stable surface layer should have a thickness $(30 \div 50) \mu\text{m}$ and the thickness of the diffusion layer should be less than $16 \mu\text{m}$. The section of the surface layer are shown in Fig. 7 shows different bands resulting from heat treatment and diffusion processes Fe to Al Si layer. In the surface layer there are cavities which endanger the stability of the surface layer. The surface layer also contains micro cracks that are a natural phenomenon in this surface treatment. From the observation of the state of the surface layer, it can be seen that none of the values correspond to the requirements for the prescribed thickness to what extent the thickness of the layer is uneven, unstable, non-constant, Fig. 8 a 9.

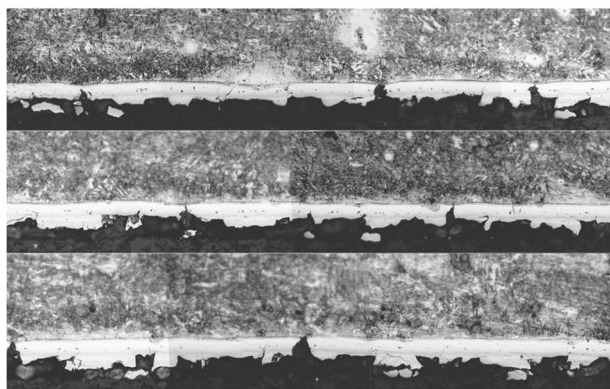
Fig. 8 Sample 4, underside of the surface layer, mag. 200x

The macro cracks are seen but are not of the same type as for sample 1. These macro cracks are wedge shaped. In the previous case, it was a flat, periodically repeating

and equally deep damage to the surface layer. In some places, the surface layer was completely removed and consequently the corrosion resistance of the sheet was deteriorated. In those places where there is no surface layer, a corrosion microcell may occur which causes pitting corrosion attack between the base material and the protective layer.

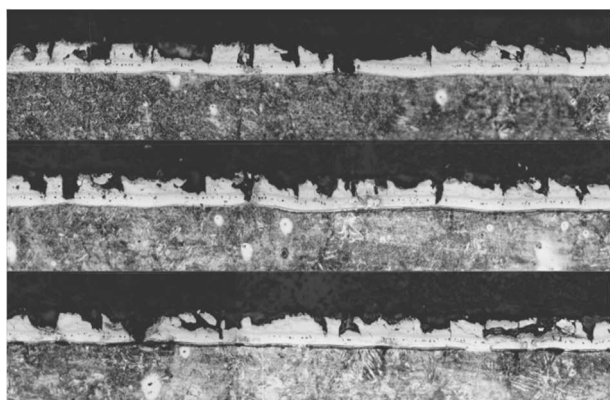
Fig. 9 Sample 4, top side of the surface layer, mag. 200x

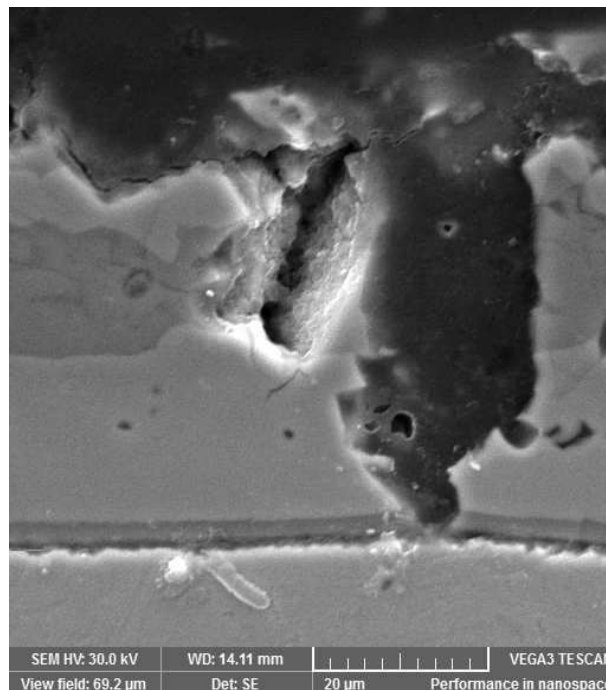
Fig. 10 Sample 3, interruption of the surface layer

In sample 3 (Figure 10), which was also investigated after forming of the blank, the observed areas were observed in the electron microscopy analysis, where the surface layer was interrupted locally, Fig. 10. Fig. 11 illustrates the interruption of the interface of the surface layer

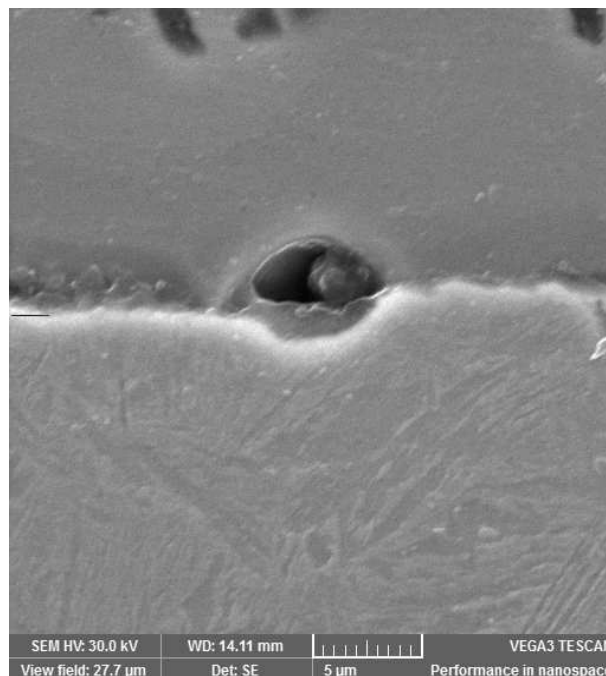
Fig. 11 Sample 3, inclusion in interlayer

with the base material and also documents the occurrence of particles in the interfacial interface. It can be presumed that this particle has not been removed during pre-treatment during application of the surface layer, it is already the above-described spherical inclusion.

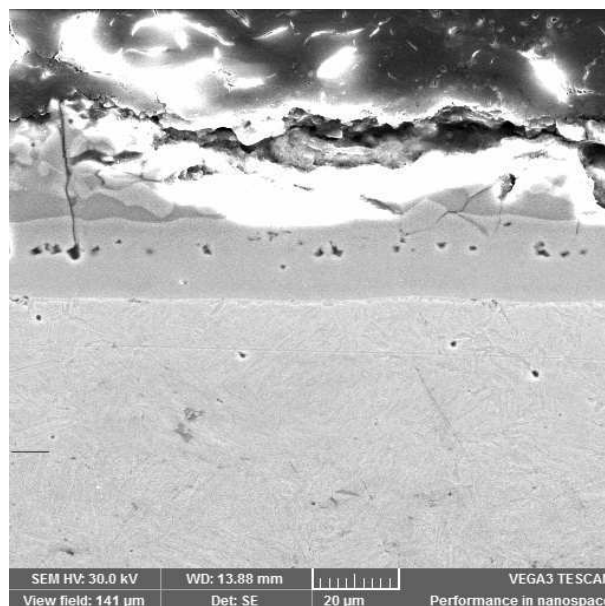
Further investigation of the specimen was focused on the area of the base material (area 1) and the area around the particle in the interlayer (region 2) where EDX analyzes were performed, Fig. 12. Analytical values are shown in Tab. 4. The high Fe content is understandable, but also in all cases there is a high Mn content, which should according to the standards be only in an amount up to 1.4 wt.%. A high O content was recorded only for the particle in the interlayer and the area adjacent to it. In this area also increased Si content. It can be assumed that diffusion from the surface layer into the base material took place here.

Fig. 12 Sample 3, cavities in the surface layer
