## Firefighter Ladders Made of AA6063 Alloy Exposed to Elevated Temperatures and its Influence onto Mechanical Properties

Filip Průša, Denisa Kubičková, Vít Jonák, Zbyněk Veselka, Dalibor Vojtěch

Faculty of Chemistry and Technology, University of Chemistry and Technology Prague, Technická 5, 166 28 Prague 6. Czech Republic. E-mail: prusaf@vscht.cz.

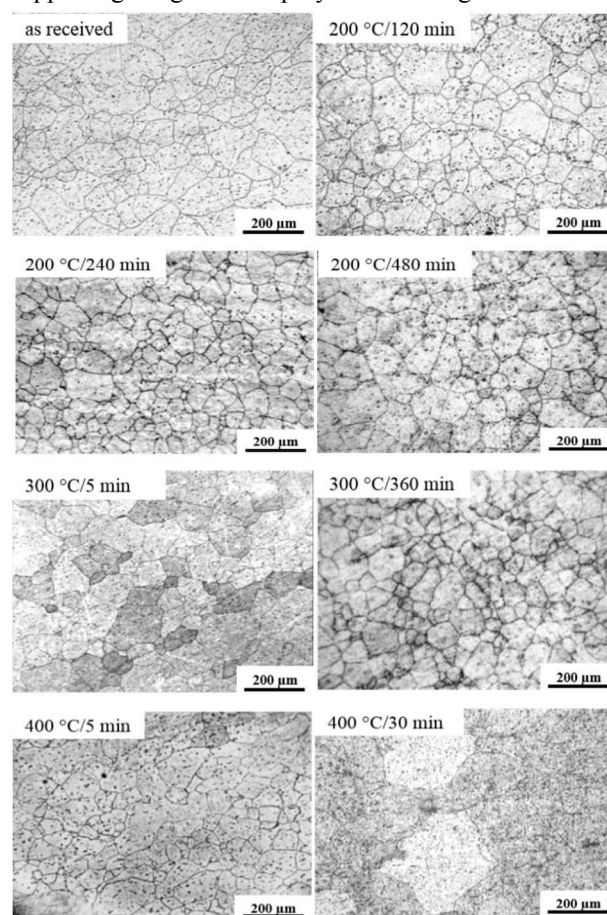
**Fig. 2** LM micrographs of the ladder no.1 after heat treatment.

Both the ladders showed microstructural coarsening as the temperature and duration of annealing increases. When exposed to temperatures of 200 °C, the microstructural coarsening was the slowest and both the ladders remained almost the same  $\alpha$ -Al grain size even

when exposed up to 240 min. However, the microstructure coarsened when the time of annealing at 200 °C was prolonged up to 480 min showing a presence of larger  $\alpha$ -Al grains approximately 70  $\mu\text{m}$  in diameter. Exposure to a higher temperature of 300 °C resulted in a size increase of  $\alpha$ -Al grains growing up to 80  $\mu\text{m}$  in diameter already after 5 min exposure and then retained the same size even when exposed for the total duration of 360 min. The annealing at the highest temperature of 400 °C resulted in the highest increase in  $\alpha$ -Al grain sizes that were newly approximately 170  $\mu\text{m}$  in size after 30 min of exposure. Simultaneously,  $\text{Mg}_2\text{Si}$  precipitates, as well as the  $\text{Al}(\text{FeMn})\text{Si}$  phases coarsened as the time or temperature of annealing increased up to higher values. Both the ladders showed the same behaviour and thus, the results for the ladder no.2 are not shown.

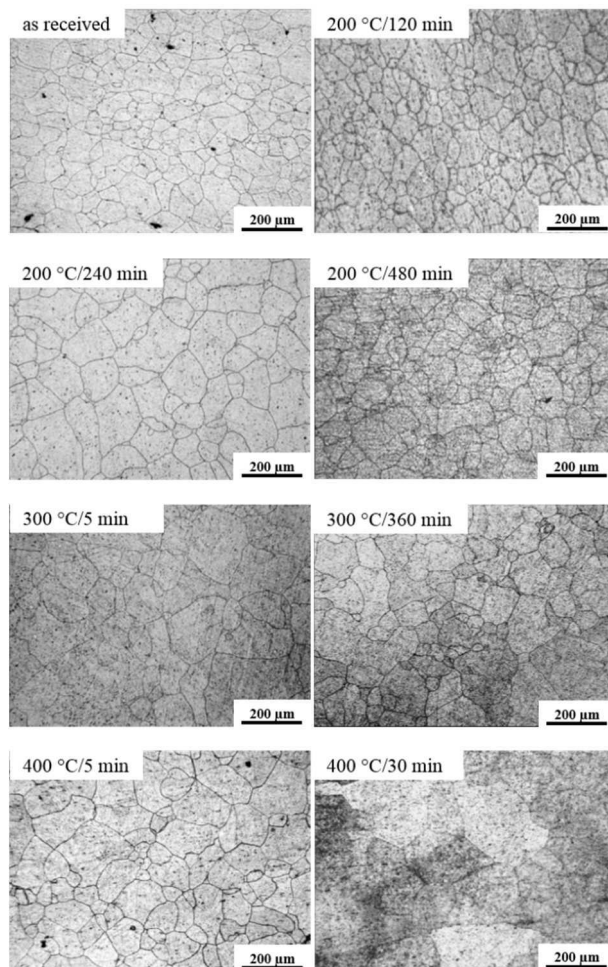
**Fig. 3** LM micrographs of the ladder no.2 after heat treatment.

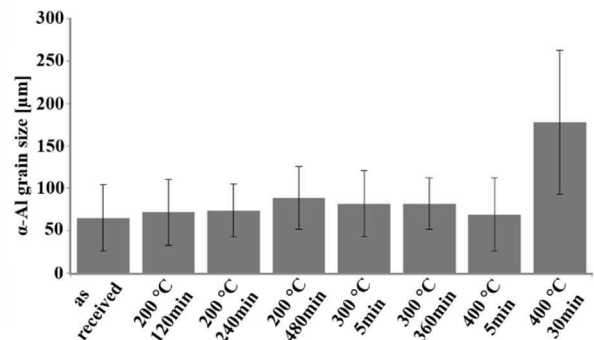
One can see, that the  $\alpha$ -Al grain growth, considering the standard deviation displayed as error bar, was lower in the case of samples annealed up to 300 °C. However, both the ladders significantly changed  $\alpha$ -Al grain sizes when exposed to 400 °C at least for 30 minutes. From this point of view, temperatures above 400 °C are significantly dangerous since the exposure to such temperatures quickly changes the microstructure-related properties like tensile yield strength (TYS) and ultimate tensile strength (UTS) of both the ladders.

**Fig. 4** Grain size development (in  $\mu\text{m}$ ) in the ladder no.1 during annealing at temperatures ranging from 200 °C to 400 °C and a different time.

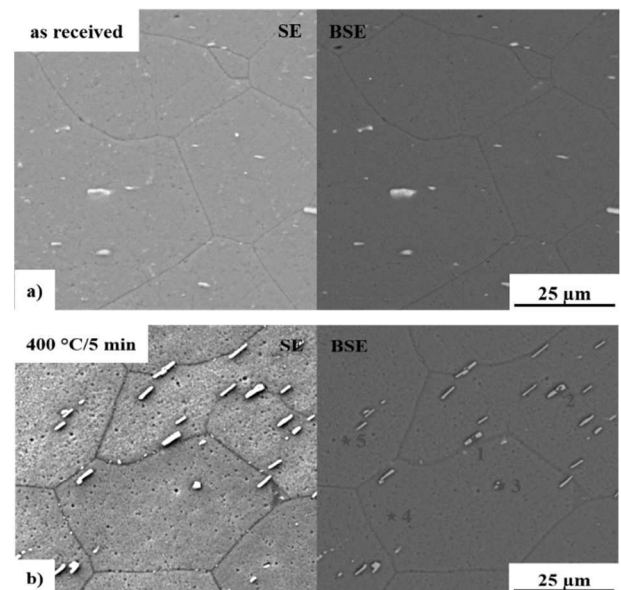
More detailed SEM micrographs (Fig. 5) revealed the presence of both the phases, namely of the  $\text{Al}(\text{FeMn})\text{Si}$  phase, which actual chemical composition vary due to the background effect. On the other hand, the presence of  $\text{Mg}_2\text{Si}$  phases was highly controversial since it tends to dissolve during etching leaving small dimples in the  $\alpha$ -Al grain interior.

**Fig. 5** The SEM micrographs of the ladder no.1: a) in as received state; b) after 5 min annealing at 400 °C with marked points of SEM+EDS analysis which results are shown in Tab. 2

The results of SEM+EDS point analysis of present phases (see Fig. 5b) in the ladder no.1 which has been annealed at 400 °C for 5 min are shown in Tab. 2. The analysis of bright rod-shaped particles confirmed the increased concentration of Fe (up to 5.3 at.%) and Si (up to 3.9 at.%) although the influence of surrounding area highly affected the results. Regarding the common data available in the literature, these phases were identified as  $\text{Al}(\text{FeMn})\text{Si}$ . Presence of  $\text{Mg}_2\text{Si}$  precipitates has not been observed since they dissolved during two-step etching.

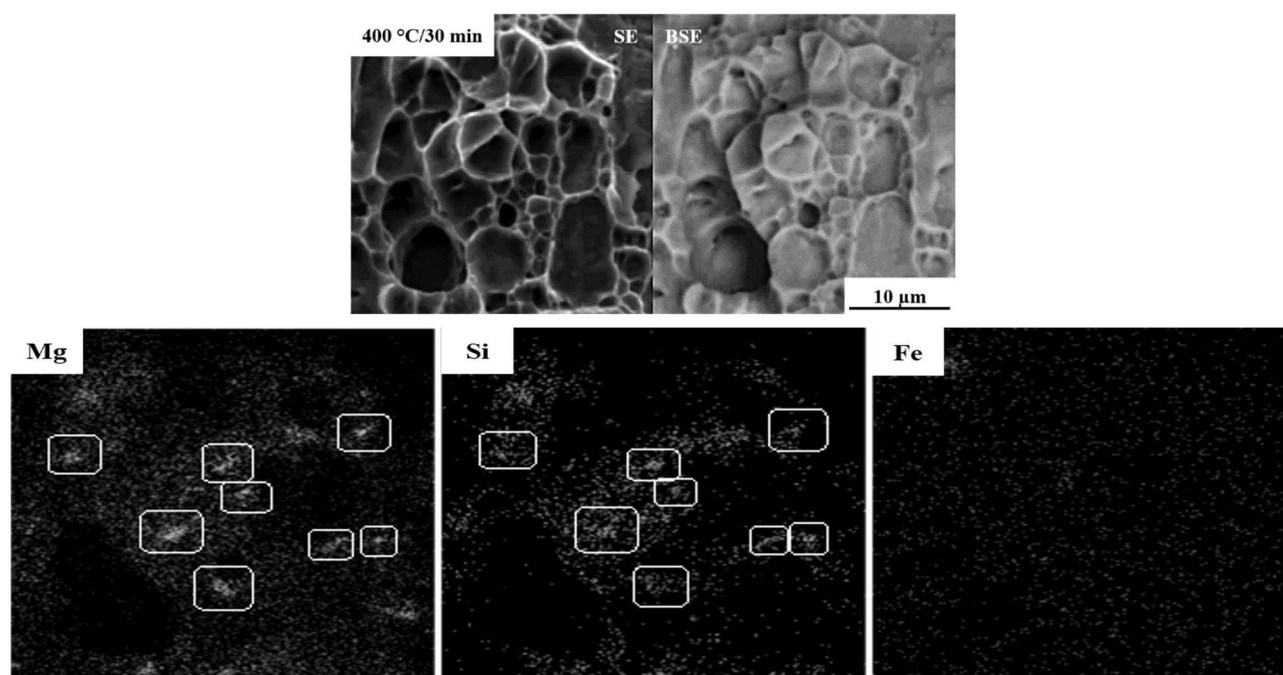
The  $Mg_2Si$  precipitates were observed on the fracture surface of the ladder no.1 sample that was annealed at 400 °C for 30 min. These precipitates with an average dimension of approximately 5  $\mu m$  were located at the tip of the present micro-dimples as is shown in Fig. 6. Since

**Fig. 6** The SEM micrographs and SEM+EDS element distribution maps of the ladder no.1 fracture surface that has been annealed at 400 °C for 30 min. (white rectangles point at places with possible occurrence of  $Mg_2Si$  phases)

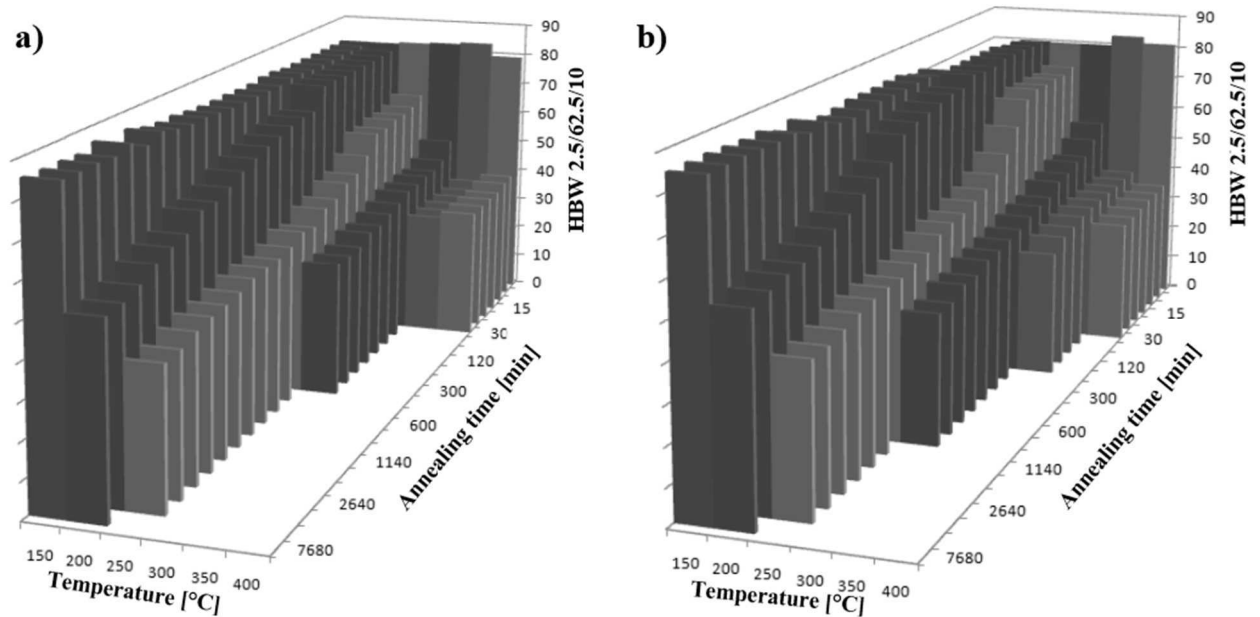
Both the ladders were investigated for mechanical properties change during annealing. For this purpose, the Brinell hardness change was the first indication of the microstructural changes during annealing. Based on the results of hardness measurements (see Fig. 7), the samples were consequentially investigated for microstructure and tensile tested. The hardness measurements were done until the sample did not change their hardness during at least 3 consequential time periods. From this point of view, it is clearly visible, that the ladders annealed at a temperature of 150 °C were tested for the longest period reaching up to 7680 min while the samples annealed at 400 °C were tested only up to 30 min already reducing their hardness by more than 50%.

One can also see, that the ladder no.2 hardened during annealing at 150 °C suggesting further precipitation hardening. This behaviour corresponds to the state of the ladder, which was supplied completely new. In comparison,

the ladder no.1 already experienced 8 years of heavy workload which could either thermally influence the ladder itself while such long period might lead to spontaneous ageing. Therefore, the effect of hardening was in case of ladder no.2 almost negligible.

**Fig. 7** The HBW change during annealing at temperatures ranging from 150 °C to 400 °C of the: a) ladder no.1; b) ladder no.2
