Degradation Structures of the Steels Applied in Energetics

Keywords: Degradation, Steels, Energetics, Microstructure, Carbides

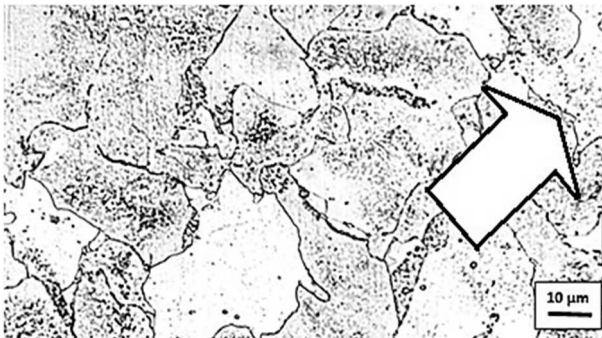
The character of the degraded structure with globular carbide particles of the initially lamellar perlite and the excluded carbides at the grain boundaries after 198.217 hours is documented in Figure 5, the detail of the globular carbides is shown in Figure 6. It occurred simultaneously to the following degradation structural changes during the exploitation of the pipeline:

- the change of the initial lamellar pearlite to globulitic,
- the redistribution of carbide alloying elements (Cr, Mo, V) to the grain boundaries and thereby to its attenuation.

Fig. 5 Degradation structure character of the 15 128 steel after 198.217 hours

The analysis results of the structure degradation processes and thus of the mechanical properties showed that the objective steam pipeline is necessary to replace during the course of one year [5-7].

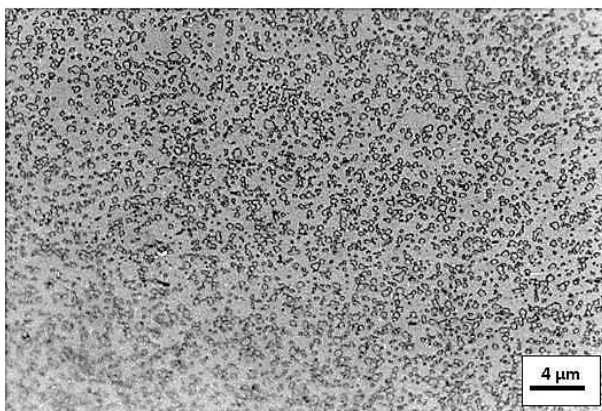
Fig. 6 Detail of globular carbides

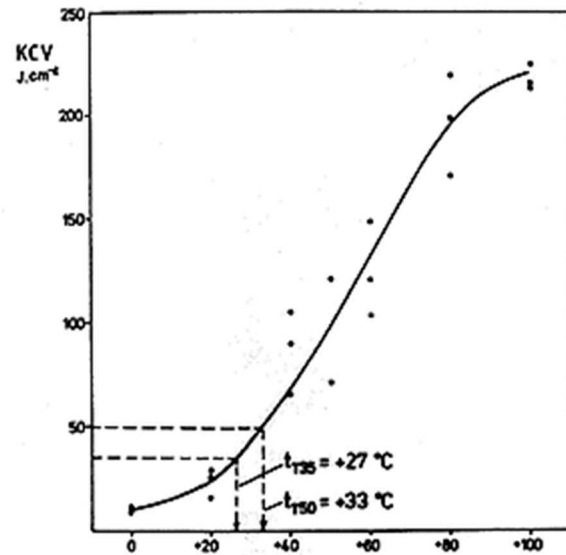
transit curve of the steel 15 128 after 198.217 hours of exposure. For the $KCV = 35 \text{ J.cm}^{-1}$ criterion, the displacement of the transit temperature was determined from the original temperature 18°C to 27°C .

Low KCV values in the temperature interval from 0 to 25°C are unacceptable from the view of the unavailability time and restarting to the operating value of the temperatures and pressures. If these values are low, it may occur to the rupture of the pipeline at the restart. Steel has become "brittle" due to degradation structural processes.

Fig. 7 Steel 15 128 transit curve after 198.217 hour exploitation

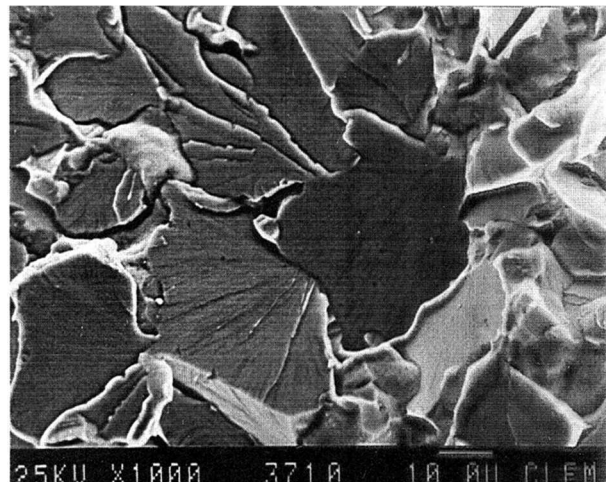
The cleavable character of the sample transcrystalline brittle fracture after the impact resistance test at the temperature 0°C is documented at Figure 8.

Fig. 8 Transcrystalline brittle failure of the sample at the temperature 0°C

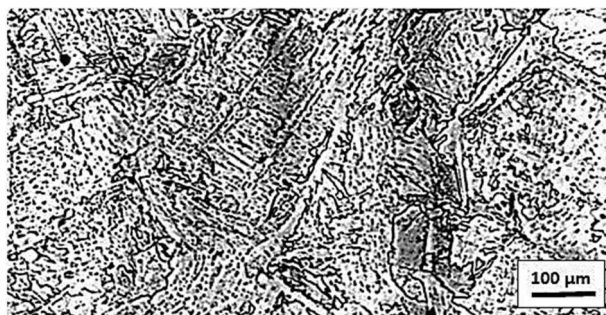
Fig. 10 15 111 steel degraded structure character, upper bainite

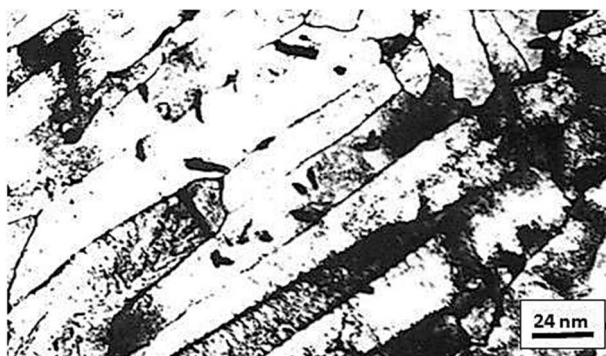
Fig. 11 Detail of the needle-shaped upper bainite character

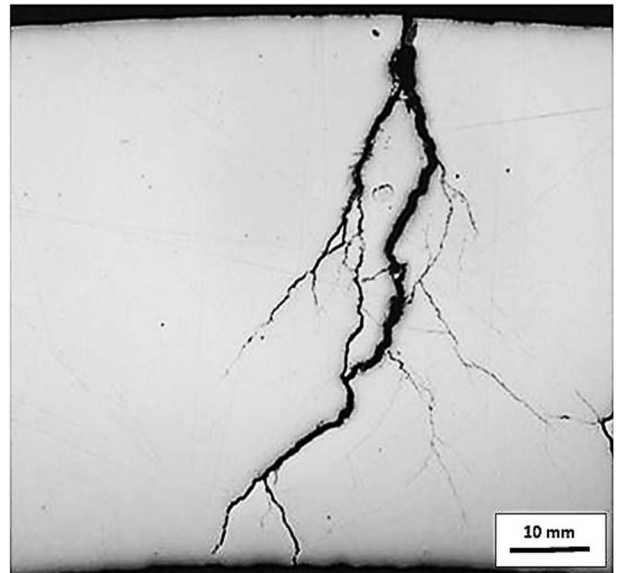
Fig. 12 Surface cracks on the 15 111 steel pipe

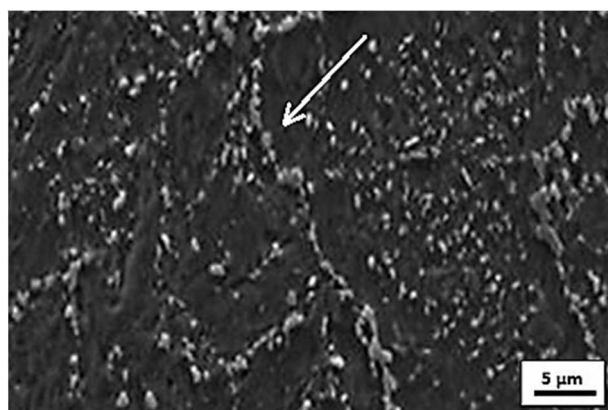
Fig. 15 Excluded carbides $Cr_{23}C_6$ along the initial austenitic grain boundaries of the steel 17 119
