Analysis of the Cause of Titanium Endoprosthesis Failure

Patricia Hanusová, Peter Palček, Milan Uhrčík

Faculty of Mechanical Engineering, Žilinská univerzita. Univerzitná 8215/1, 010 26 Žilina. Slovakia. E-mail: patricia.hanusova@fstroj.uniza.sk, peter.palcek@fstroj.uniza.sk, milan.uhrick@fstroj.uniza.sk

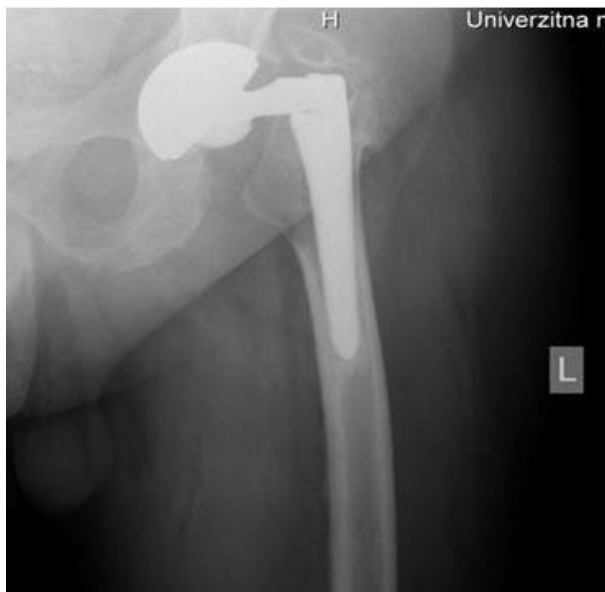
Fig. 1 Failure of hip endoprosthesis on X-ray

Hip replacement is a surgical procedure in which parts of a hip joint are removed and replaced with a prosthesis, most commonly made of titanium-based alloys, especially Ti-6Al-4V. Although great advances have been made in this field, the fracture (Fig. 1) is still one of the main problems associated with hip implant failure. [1] Double-modular hip implants consist of a neck that is separate from both the stem and the head – the three parts fit together via tapered joints. Several necks and heads of different geometries are available, allowing the surgeon to optimize the hip angle, hip offset, and leg length during surgery. However, concerns exist about the stability of the tapered joints used to connect the neck to the head and stem. Specifically, tapered joints are susceptible to corrosion, which may lead to the release of toxic metal ions and mechanical failure. [2]

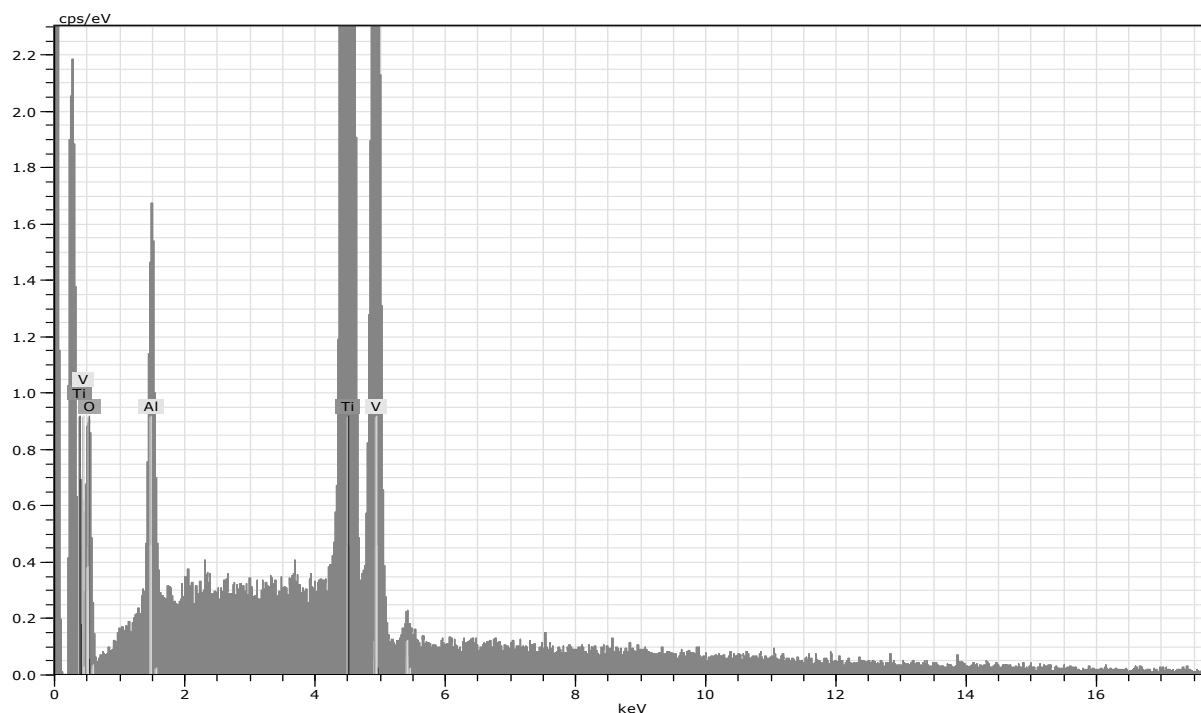
Fig. 2 Spectral analysis of endoprosthesis

The fractured endoprosthesis was surgically extracted from the patient's left leg. Experiments were implemented to clarify the causes of the fracture. Microstructures of both parts and neck were examined by endoprosthesis using a NEOPHOT 32 light microscope. The samples were metallographically prepared with TEGRAPOL 15 and etched with 10 % HF. Furthermore, Surface of fracture was observed on TESCAN VEGA LMU2-emission scanning electron microscope (SEM). The examined samples were made from titanium alloy Ti6Al4V, which was confirmed by spectral analysis (Fig. 2). Microhardness was measured using a ZWICK ROELL with a load of 0.5 HV.

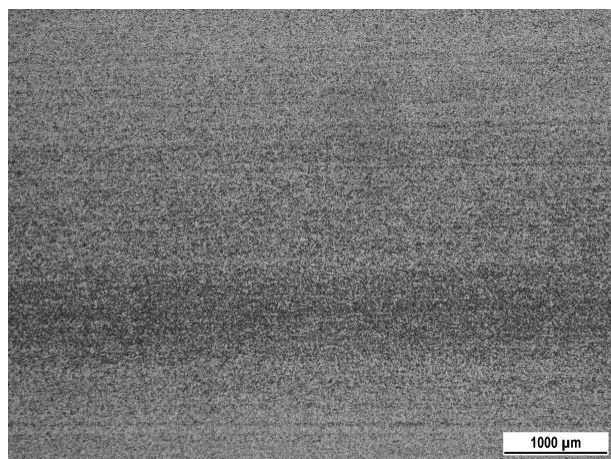
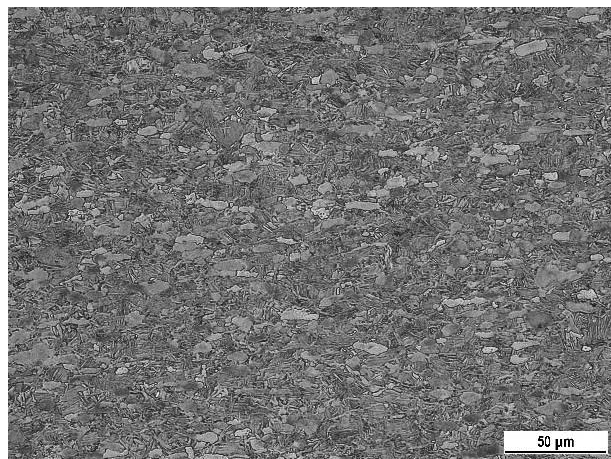
Fig. 3 Microstructure of stem

a) 25x magnification, etched 10%HF

b) 500x magnification, etched 10%HF

The study of microstructure confirmed the divergence changes in the items of implant. The neck part of the prosthesis (*Fig. 3*) was made by casting. The microstructure of the sample is very fine-grained. The stem part (*Fig. 4*) was forged to the desired shape. The different microstructures are caused by different methods of manufacturing.

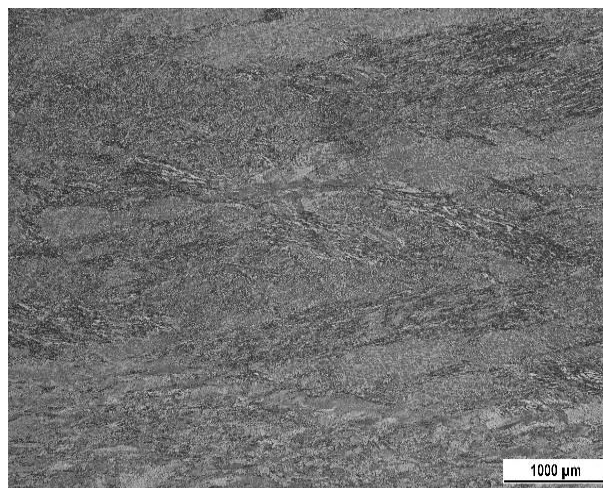
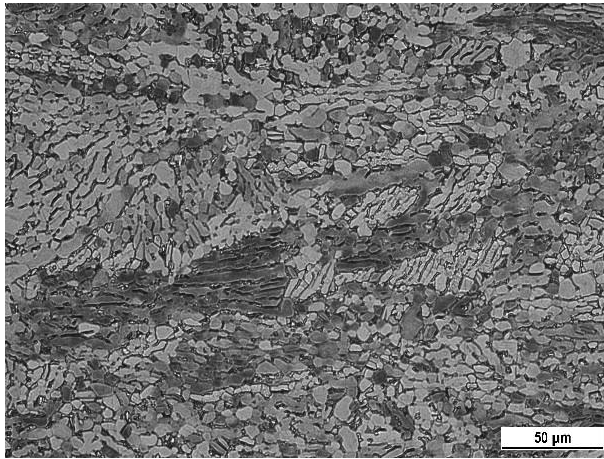
Fig. 4 Microstructure of neck

a) 25x magnification, etched 10%HF

b) 500x magnification, etched 10%HF

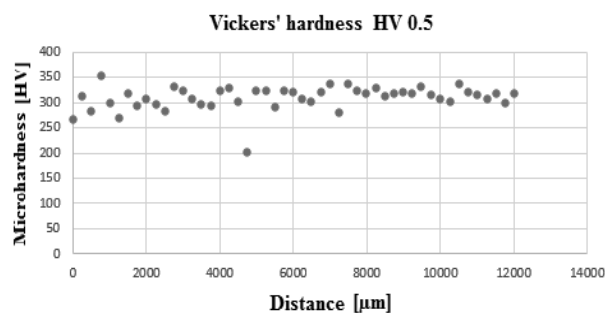
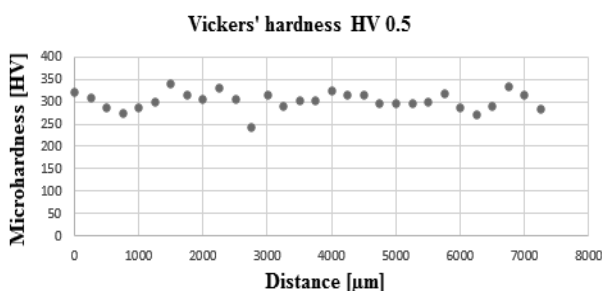
Fig. 8 Vickers' microhardness HV 0.5

By measuring the hardness of the neck of endoprosthesis specimen, 49 points were determined in a horizontal direction with a 250 μm spacing of the individual indentations. The hardness values of this specimen ranged from 201 HV to 353 HV. The average microhardness value was 309.47 HV 0.5. The measurement was linear along with the whole sample.

To measure the hardness of the stem of endoprosthesis determination of 30 points in the horizontal direction. The interval at which the hardness values were varied was 243 HV to 341 HV. The calculated average hardness of the endoprosthesis stem sample was 301.9 HV.

Comparison the average hardness values of the individual specimens proved that the neck sample of the endoprosthesis has slightly higher hardness values than that of the endoprosthesis stem.

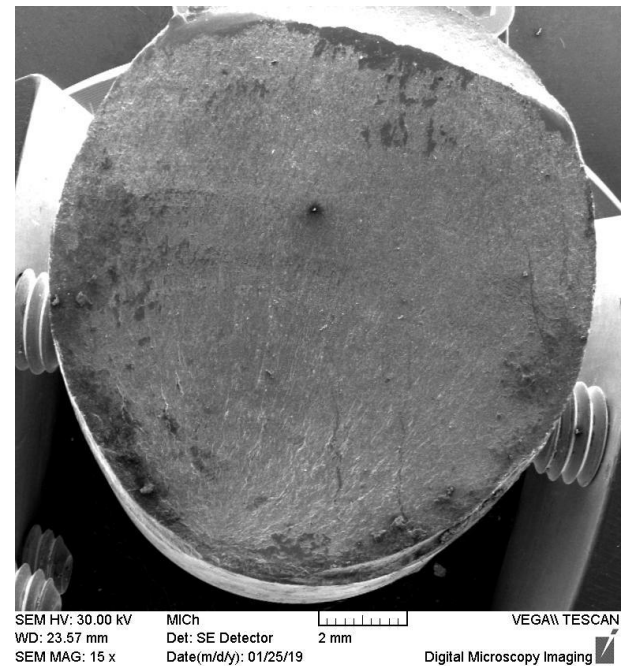
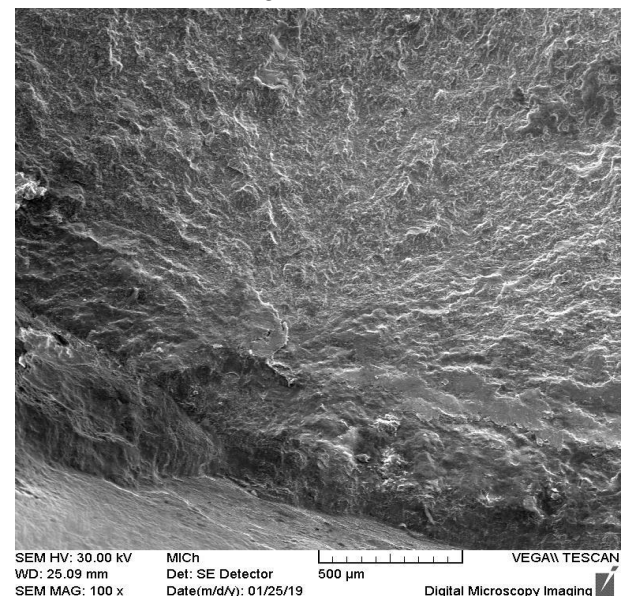
The overall view of the neck of the endoprosthesis is considered to be fatigue (Fig. 5a). The area is divided into fatigue portion and a part to failed statically. The border has a width and it is not possible to precisely determine the boundary line. Fatigue started at the place with the highest stress concentration - initiation of fatigue crack (Fig. 5b).

a) general view

b) the place of initialization of fatigue
Fig. 5 Surface of the fracture

Secondary cracks were confirmed on the fracture surface. Their orientation is influenced by the linearity of the structure. Existing oxide layer fragments demonstrated the presence of corrosion. At the bottom, chlorides and oxides of titanium were proved by the BSE method.

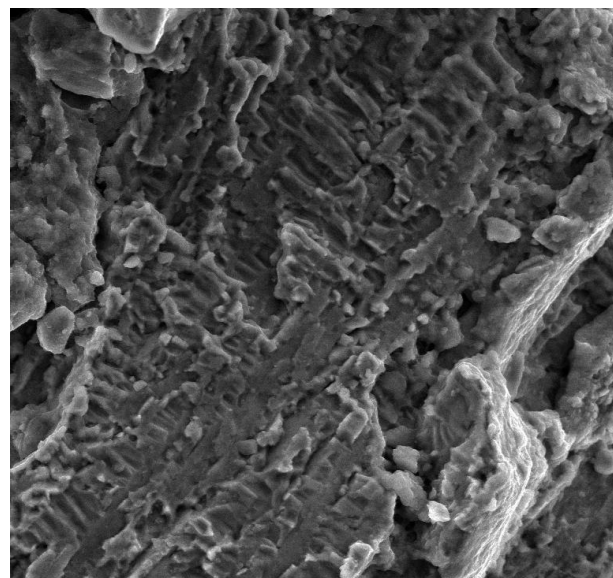
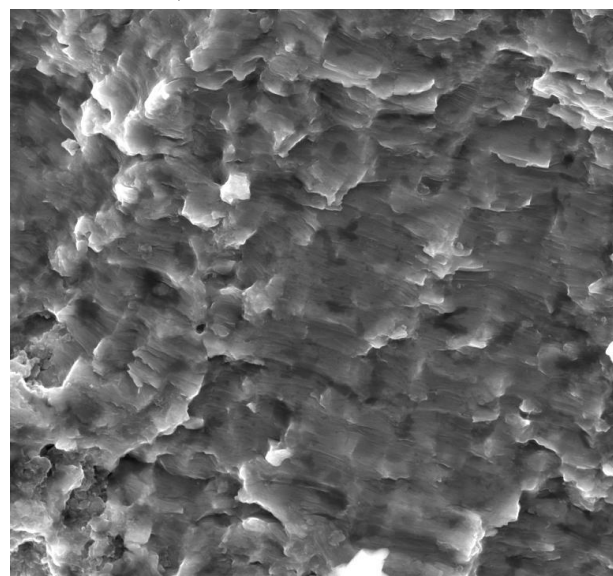
Fig. 6 Fractography of fracture surface

Study of material properties by SEM confirmed dendritic structure (Fig. 6a) detectable also on the optical microscope. When analyzing the fatigue area of the neck of the endoprosthesis, transcrystalline ductile failure with fatigue lines-striations (Fig. 6b) were investigated. It is confirming the occurrence of fatigue material during stress.

a) dendrit structure od neck

b) striations
