Corrosion of Inconel 800HT Alloy in Molten Fluoride Salts

Zdeněk Fulín (0009-0000-3115-1387), Josef Strejcius, Zbyněk Špirit (0000-0002-5676-1840)

Centrum výzkumu Rez s.r.o., Morseova 1245/6, 301 00, Pilsen, Czech Republic; zdenek.fulin@cvrez.cz, zbynek.spirit@cvrez.cz, josef.strejcius@cvrez.cz

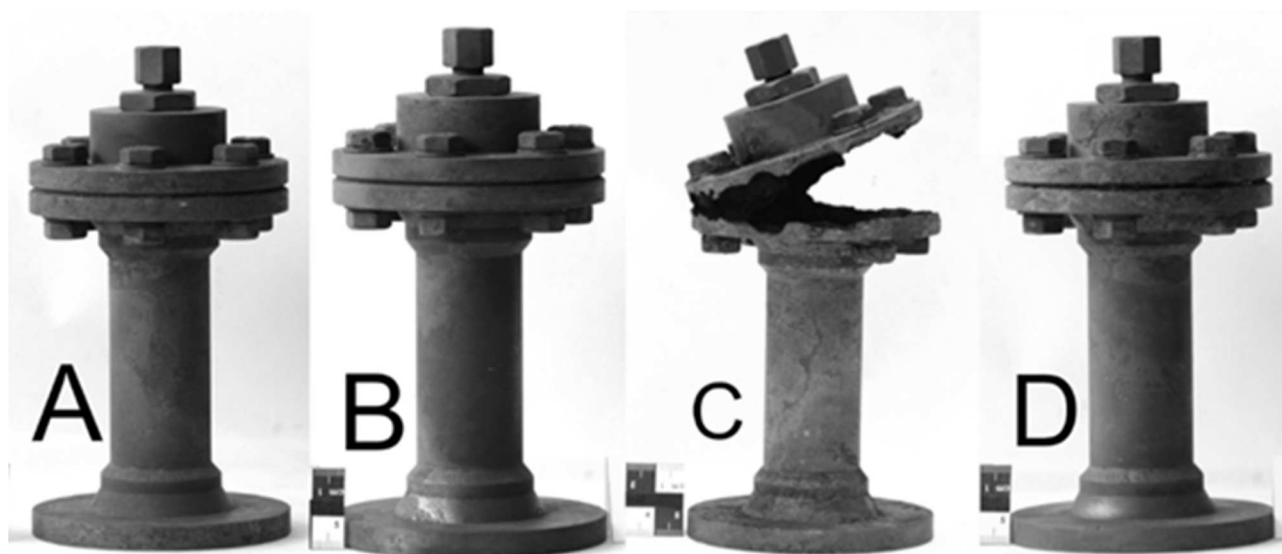
After the experiment, the outer surface of test vessels was covered with a layer of oxides. The layer was compact and did not peel off the surface. The two vessels containing the $\text{NaBF}_4\text{-NaF}$ mixture appeared undamaged, see Fig. 2 A, B.

Fig. 2 Test vessels after the experiment with $\text{NaBF}_4\text{-NaF}$ (A, B) and FLiNaK (C, D)

In the case of test vessels filled with FLiNaK, damage was obvious. In one case, the lid was torn off (Fig. 2 C) and the interior was filled with corrosion products mixed with the remaining fluoride salt (Fig. 3).

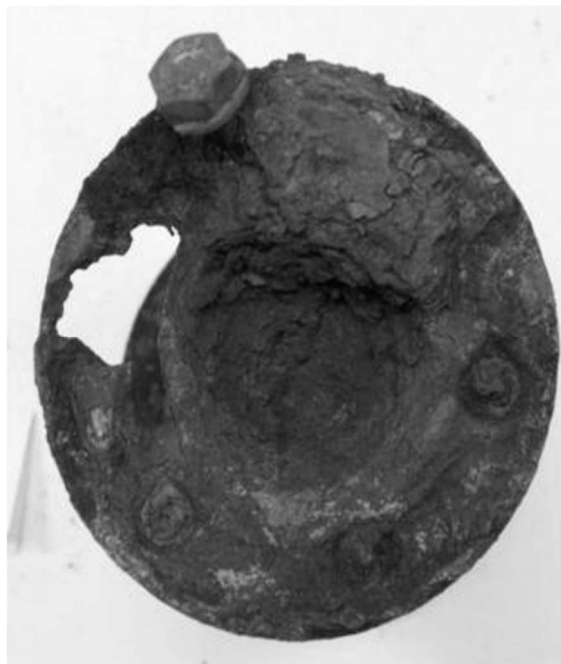
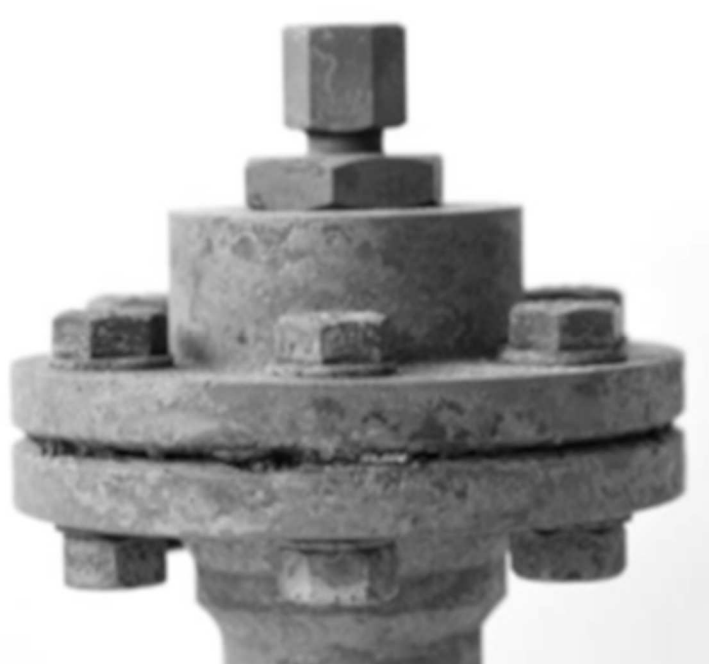
Fig. 3 Detail of corrosion damage of Test vessels exposed to FLiNaK salt (specimen C on the left, specimen D on the right)

ket. On the cross-section, corrosion around the graphite ring is visible and the gap between the lid and the flange is widened on the outside. Similar gasket failure probably caused the extensive damage of the test vessel C. The increase in the volume of corrosion products then led to lifting the lid. This has completely broken the seal of the vial. Since the seal and caused the leak. Since the damaged gasket was located above the melt level, corrosion was probably initiated by the release of hydrogen fluoride from the molten salt. This indicates a presence of moisture in the salt mixture.

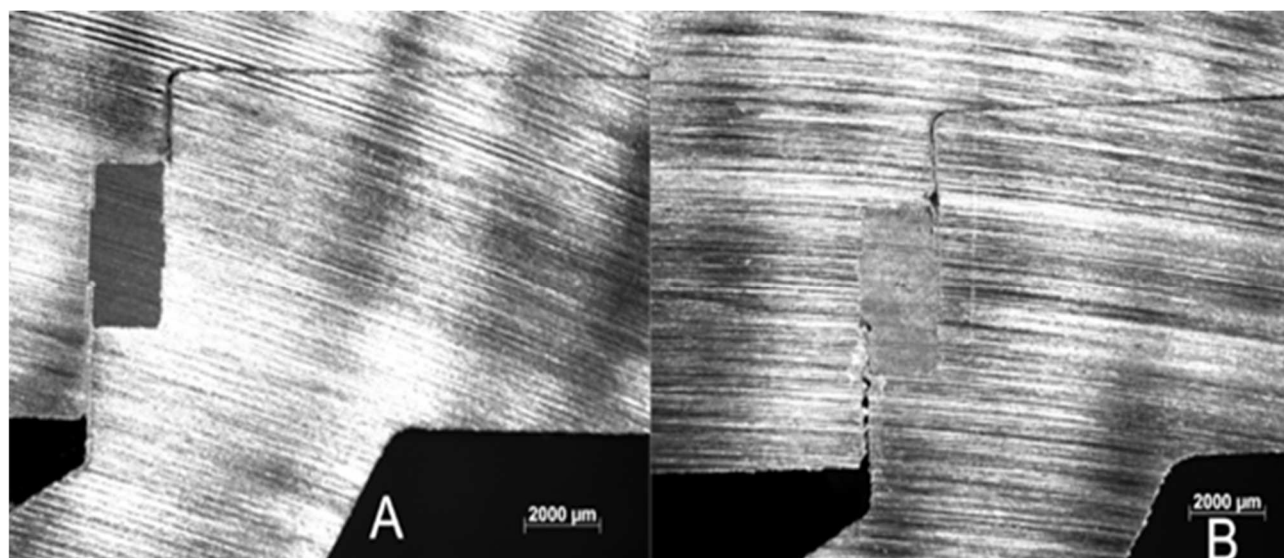
The lid assembly of test vessels A, B and D were cut off and a cross-section of each was prepared. As shown in Fig. 4, exposure in $\text{NaBF}_4\text{-NaF}$ did not cause damage to the gasket. It would seem that some minor corrosion may have occurred in the seam on specimen B, but it may also be damage caused by cutting the specimen.

Fig. 4 The lid assembly cross-section after exposure in $\text{NaBF}_4\text{-NaF}$

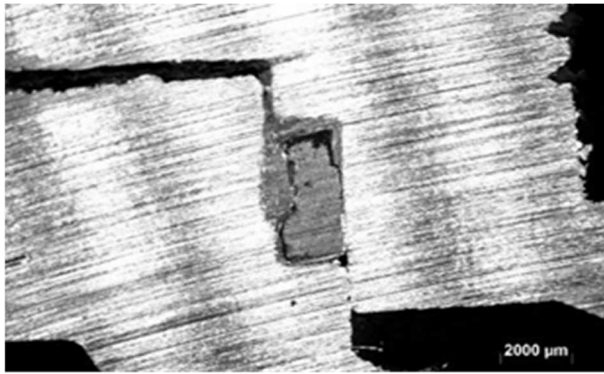
In contrast, exposure in FLiNaK salt, see Fig. 5, caused corrosion in the lid assembly, around the gas-

Fig. 5 The lid assembly cross-section after exposure in FLiNaK

FLiNaK salt caused a considerable damage to the lid assembly. In this case it was HF produced by insufficiently removed moisture causing the issue. This observation supports the above conclusions on the presence of impurities in the FLiNaK salt.

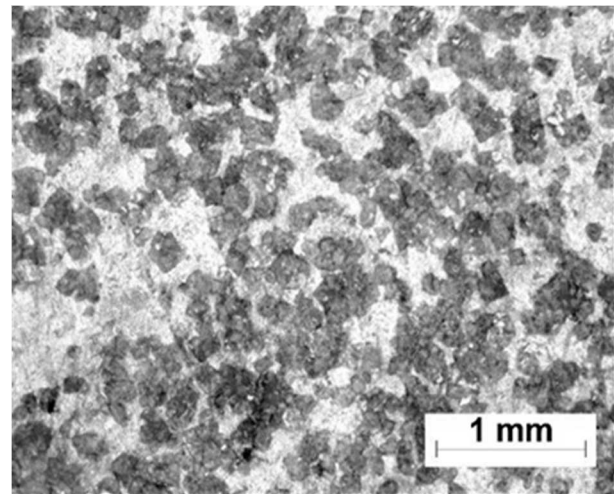
The inner surface of the samples exposed to the NaBF₄-NaF salt was covered with green crystals (see Fig. 6). The solidified salt was also green coloured. The surface does not appear damaged in visual inspection (except for the aforementioned crystals), but the green colour of the salt indicates a presence of chromium dissolved from the material. EDS analysis of the particles confirmed high Cr content (13 % wt.) together with Na and F. Fe and Ni weren't detected in the particles.

Fig. 6 The inner wall of test vessel exposed to NaBF₄-NaF

The behaviour of the studied material in $\text{NaBF}_4 + \text{NaF}$ mixture differed from the other two salts through the precipitation of large particles on the surface. According to a technical report from ORNL [18], the presence of such particles was observed on Hastelloy N alloy after exposure in CrF_3 -contaminated fluoroborate salt. According to that report, the precipitates are Na_3CrF_6 , which is consistent with the estimated composition of these particles based on our EDS analysis. Since the salt volume in the experiment was quite small compared to the material surface area, a Cr-related contamination was possible. The significantly higher Cr content in Inconel 800 HT compared to Hastelloy H is certainly a contributing factor to the contamination.

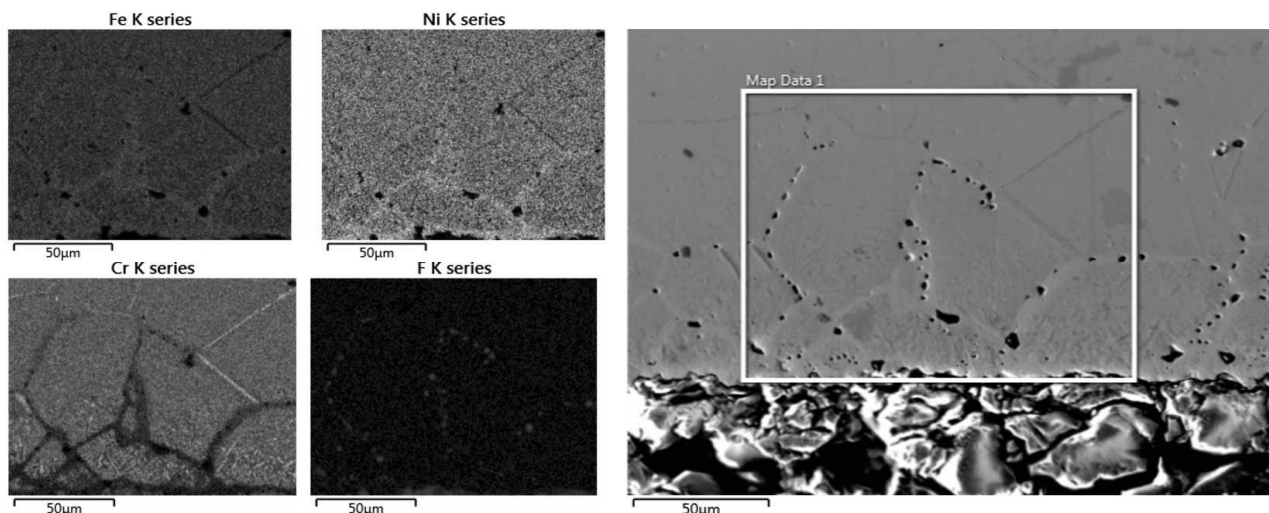
Microscopic examination of the wall cross-section revealed dissolution of the material along grain boundaries (see Fig. 7). The depth of the observed intergranular corrosion varies a bit depending on the location but didn't exceed 150 μm. The appearance of corrosion damage coincides with selective dissolution of chromium along grain boundaries revealed in exposure tests on similar materials [11]. The EDS analysis of the damaged area confirmed the selective corrosion. It has also been observed by EDS that fluorine penetrates along grain boundaries into the material. In parts closer to the surface there are cavities where the material has been completely dissolved. It is in these areas that the presence of fluorine was detected.

Fig. 7 Cross-section of material exposed to NaBF₄-NaF: EDS analysis (left) and cross-section (right)

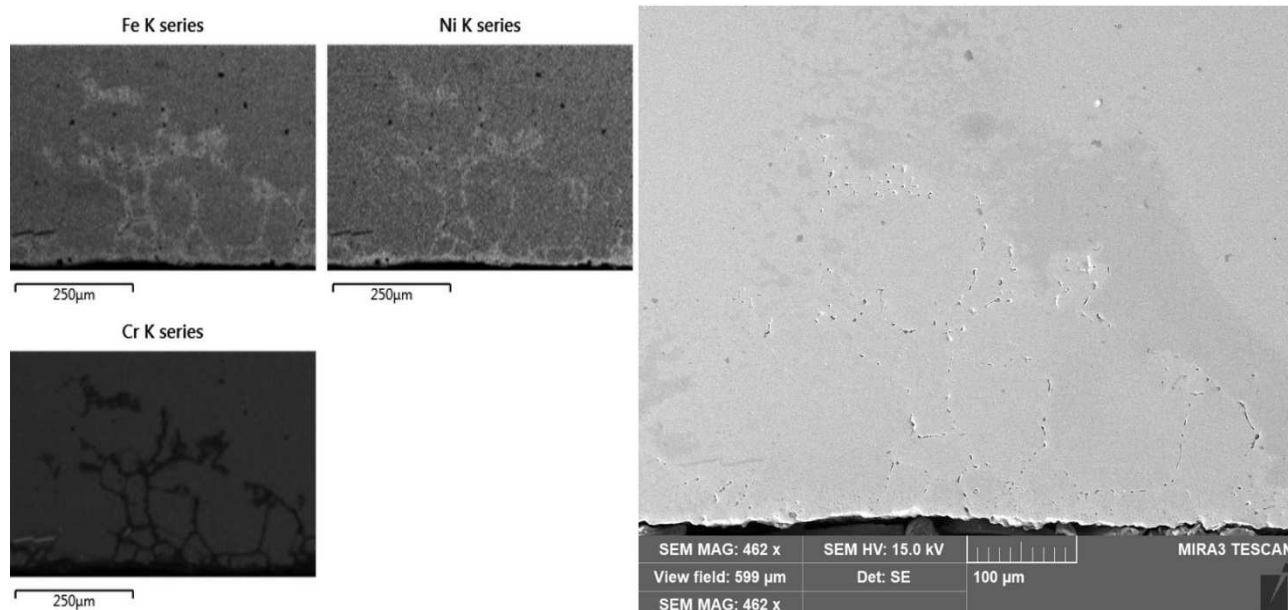
The material exposed in FLiNaK was not, unlike the previous case, covered by the green chromium fluoride crystals. The solidified salt inside the vessel was coloured green, so dissolution of chromium was also taking place. Again, corrosion along the grain boundaries is visible on the cross-section of the inner wall (see Fig. 8), and as in the previous cases, the depth of

damage varies in different places. The intergranular corrosion was detected to greater distance from the surface, up to 500 μm. The affected areas along grain boundaries are also much more connected and the cavities of dissolved material are more prominent. Unlike the case of NaBF₄-NaF salt, there was no fluorine detected in the material.

Fig. 8 Cross-section of material exposed to FLiNaK: EDS analysis (left) and cross-section (right)

- Exposure to a molten FLiNaK mixture caused more severe damage to the material. There is a significant dissolution of Cr around the grain boundaries as well as intergranular corrosion present. The corrosion reached about 3 times greater distance from the surface than in case of $\text{NaBF}_4 + \text{NaF}$ mixture and the cavities are much more connected.

The use of Inconel 800HT in FLiNaK is not suitable without active environment control.

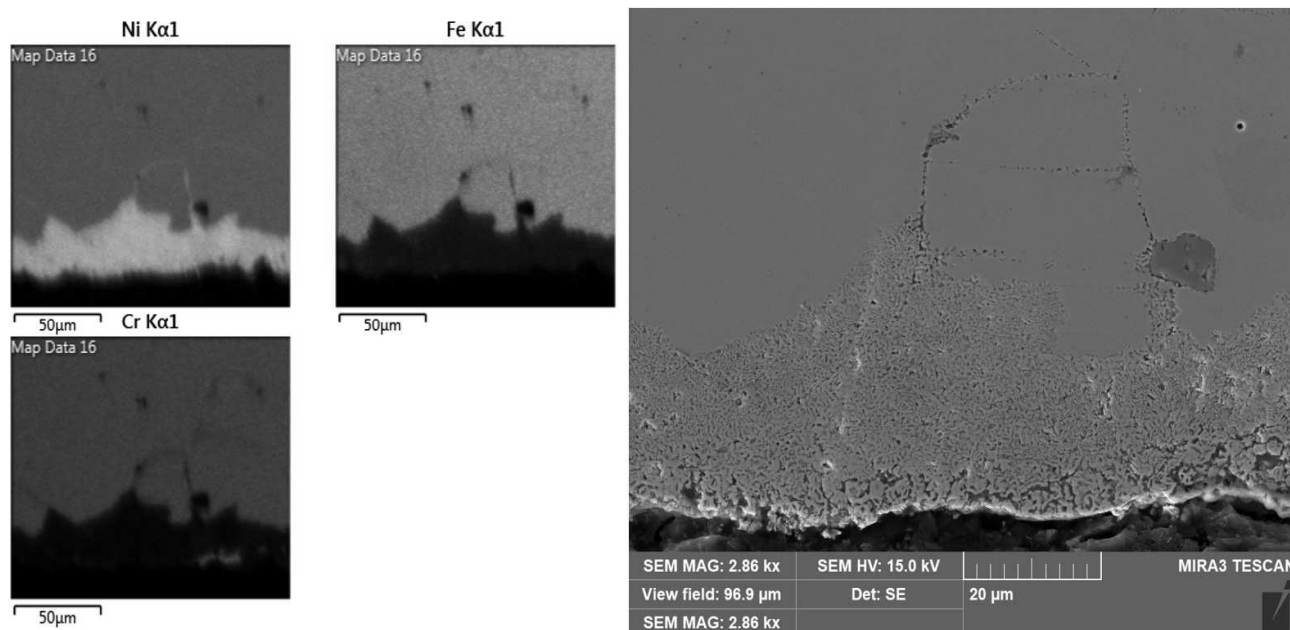
Unlike the other salt mixtures, the exposure to FLiBe salt caused a different form of corrosion damage. The dissolution of Cr on grain boundaries is still visible, but there is also a layer on the surface where both Cr and Fe are completely missing. This part is porous and contains only Ni (see Fig. 9). Thickness of

this layer is 20 to 50 μm. The intergranular corrosion of Cr reaches depth up to 150 μm. From this pattern, it can be concluded that intergranular corrosion with selective chromium dissolution occurred first, followed by formation of the porous Ni layer.

Fig. 9 Cross-section of material exposed to FLiBe: EDS analysis (left) and cross-section (right)

The corrosion found on specimen immersed in FLiBe mixture is different to other two tested salts. There is still selective corrosion on grain boundaries present, but near the surface, there is a layer where both Cr and Fe are dissolved completely in bulk material, not only around grain boundaries. This layer is about 50 µm thick and composed only of porous Ni. The reason for this layer formation isn't clear. While the intergranular corrosion reached about the same

The surface condition of the specimen exposed to the FLiBe salt in this experiment was different to the other. The surface layer was depleted of Fe in addition to Cr. According to Quilong et al. [11], Fe can be affected by dealloying like Cr. While their study did not observe such significant dealloying, there were cavities present in comparable manner, located away from grain boundaries. There are other studies both on 316 steel and Inconel 800 HT where the Fe dealloying was observed. It is reported [19], that less stable metal fluorides like FeF₂, FeF₃ and NiF₂ are causing significant

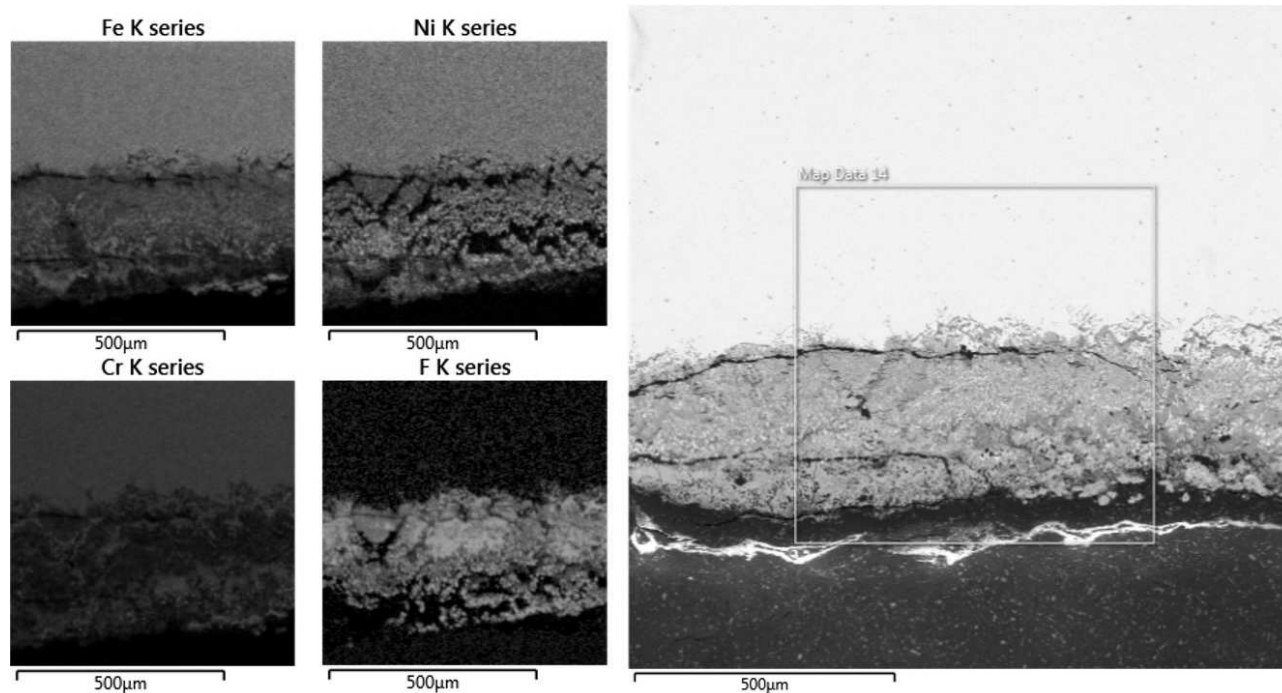
As mentioned above in the “Visual inspection” section, one FLiNaK salt test vessel experienced a seal failure. Although this case can be considered a failed experiment, the material was still examined to see what effect does have exposure to molten salt without the protective atmosphere. As can be expected in such conditions, the corrosion rate was high, about half of the vessel wall thickness was corroded. The surface

was covered with a non-compact layer of corrosion products, composed of a mixture of fluorides and oxides. There was no selective corrosion found, even in greater distance from the surface. It is obvious that in the event of loss of the protective atmosphere, the material is rapidly degraded and even for limited time, it can't be expected any resistance to corrosion.

Fig. 10 Cross-section of material exposed to FLiNaK after the loss of protective atmosphere (specimen C): EDS analysis (left) and surface layer (right)
