## Experimental Measurement of Defects Propagation for a Passenger Car Tire Casing under Dynamic Loading

The given paper deals with the defects propagation in car tires for passenger vehicles under dynamic loading. The occurrence of defects has the significant influence on the lifetime and quality of the tire, especially during its operation as a part of the vehicle. The given defects are closely connected with a safety in road traffic. The aim of the study was to carry out a non-destructive analysis of the car tire for the purpose to analyze the defects propagation as well as to introduce the defects classification and their location along with the whole course of rupture as a result of increasing speed, loading and the number of hours or kilometers driven. During the analysis, we used a non-destructive method for detecting defects using a non-destructive analyzer that works on the principle of shearography. The experimental measurement was carried out for 12 car tires. The measurement results are displayed from the non-destructive analyzer in the form of protocols from measurement and video display. The evaluation of the results of the measurement for the propagation of defects

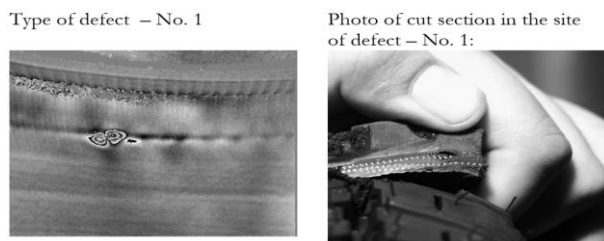
**Fig. 13** The local defect in the site where the second buffer lining end

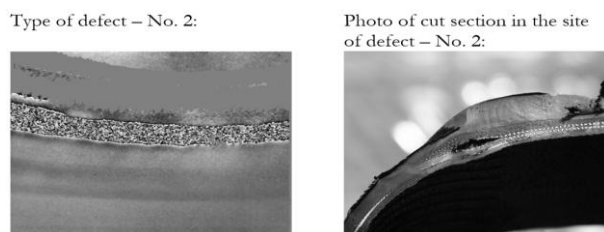
**Fig. 14** The longitudinal continuous defect in the shoulder between the first and second buffer lining

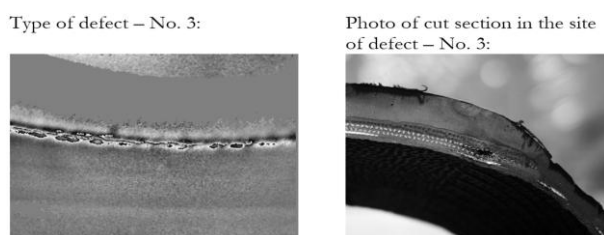
**Fig. 15** The longitudinal chain defect in the shoulder between the first and the second buffer lining

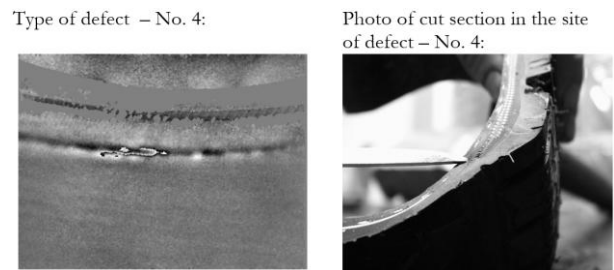
**Fig. 16** The local defect in the shoulder where the first buffer lining ends

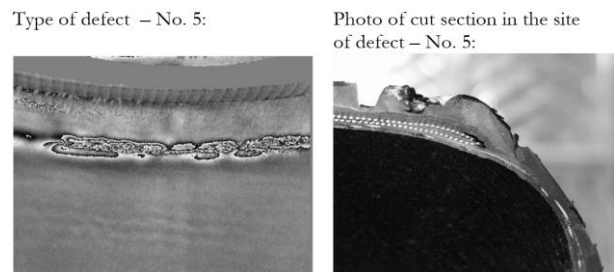
**Fig. 17** The longitudinal defect in the shoulder where the first and the second buffer linings end and its propagation to the crown

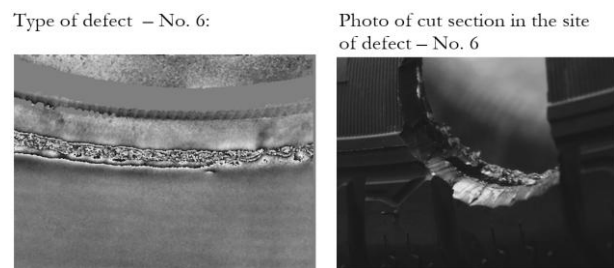
**Fig. 18** The longitudinal defect in the shoulder and its propagation to the sidewall directions

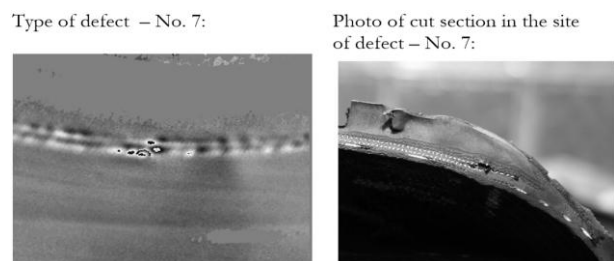
**Fig. 19** The local defect in the shoulder in the site where the second buffer lining ends

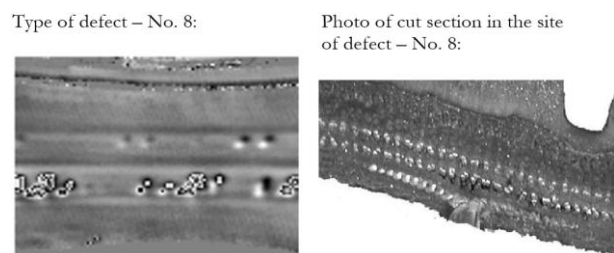
**Fig. 20** The local defect in the crown between the first buffer lining and the cord carcass

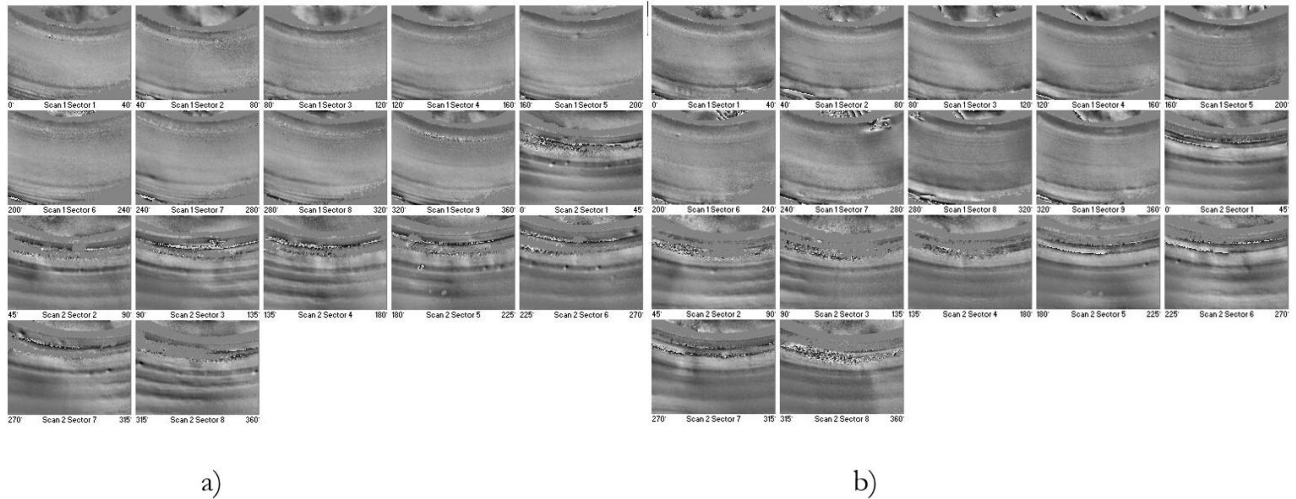
During the first testing, when the casing had not been subjected to any test yet, the defects were not detected in the casing with the non-destructive analyzer (Fig. 27). Subsequently, the given casing was further tested, using a 75 kN drum fatigue testing machine. After 20 hours, the first small local defects in the shoulders started to occur in the casing (Fig. 28).

**Fig. 28** The second measurement of V001 tire after the in-service for 20 hours (cca 800 km), using the serial interferometric diagnostics; (a) Serial side (with DOT designation), (b) Non-serial side (without DOT designation)

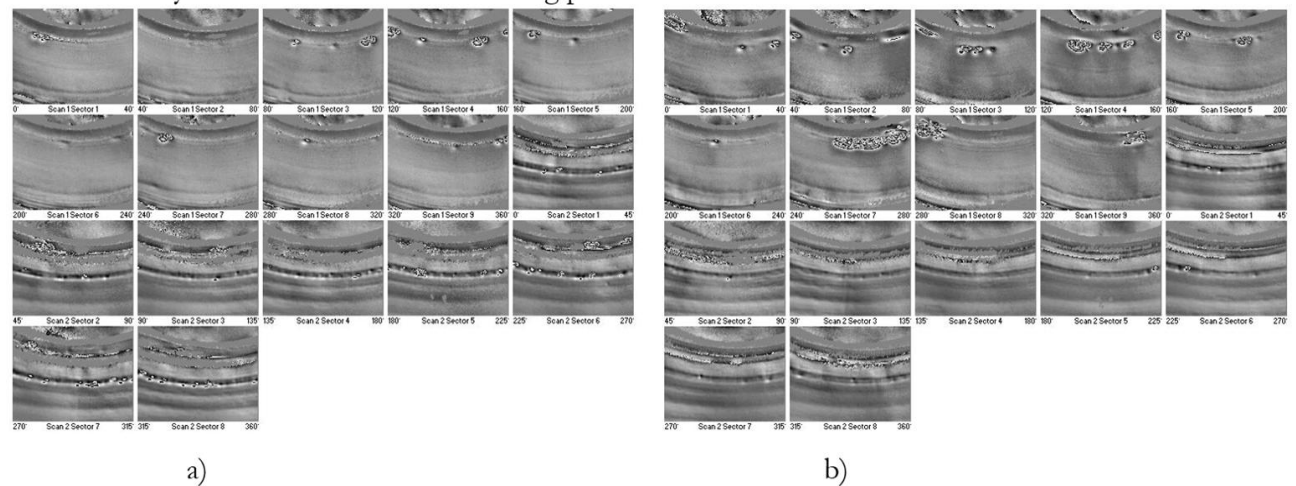
After in-service of tire for further 20 hours (40 hours) or after 1,600 km, there was the occurrence of defects above the bead as well as small local defects in the shoulders and as it can be seen in the scans from the non-destructive analyzer, they even started to be joined gradually around the circumference (Fig. 29).

**Fig. 29** The third measurement of V001 tire after the in-service for 40 hours (cca 1,600 km), using the serial interferometric diagnostics; (a) Serial side (with DOT designation), (b) Non-serial side (without DOT designation)

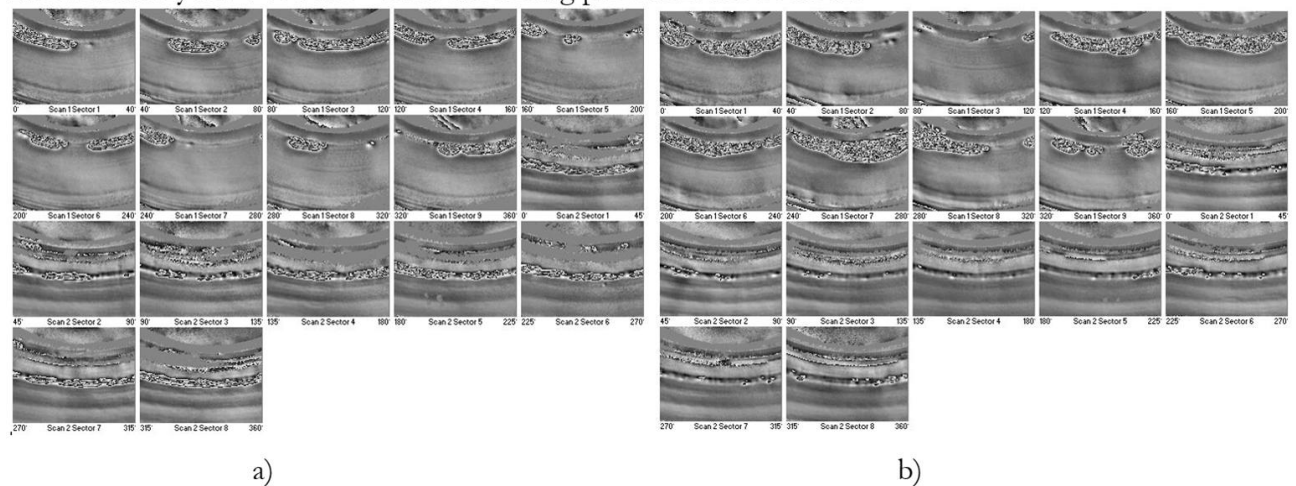
After 60 hours of tire in-service (cca 2,400 km), the defects started to be propagated noticeably in the casing. In the area above the bead, the individual local defects were joined together into the larger ones and moreover, at the same time, they were propagated towards the shoulders. In the shoulder, the defects were joined almost all the way around the whole circumference and they continued in their propagation to the crown (Fig. 30).

**Fig. 30** The fourth measurement of V001 tire after the in-service for 60 hours (cca 2,400 km), using the serial interferometric diagnostics; (a) Serial side (with DOT designation), (b) Non-serial side (without DOT designation)

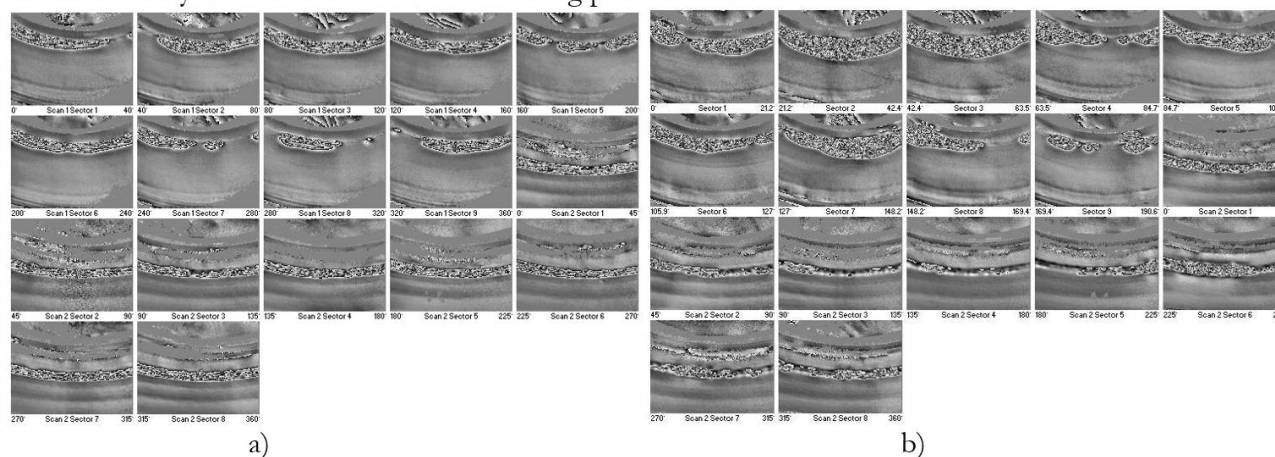
After the in-service of tire for 80 hours (cca 3,200 km), the test was stopped with the tire touch sensor shutting down due to a large defect above the bead. The defects above the bead had the increasing propagation character and they started to join around the circumference. In the shoulder, they were propagated increasingly into the crown as well as into the sidewall of the casing (Fig. 31).

**Fig. 31** The fifth measurement of V001 tire after the in-service for 80 hours (cca 3,200 km), using the serial interferometric diagnostics – the end of the testing procedure; (a) Serial side (with DOT designation), (b) Non-serial side (without DOT designation)

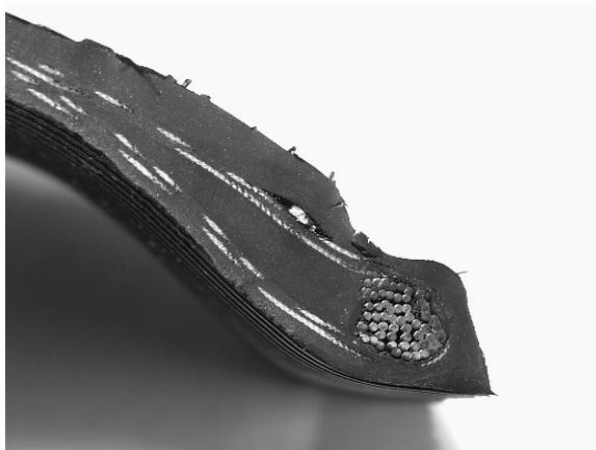
After completion of the test, cut sections were made for the defect areas where the given defects were detected with the non-destructive analyzer. From the individual cut sections can be determined that there are the defects in the shoulder and above the bead. The defects in the shoulder were initiated and propagated between the first and the second buffer lining in the site of their ending point. In the bead area, the defect was initiated above the bead bundle, between the carcass and the bead buffer linings (Fig. 34 and Fig. 37).

**Fig. 34** The cut section of No. 1 casing – Scan 1, Sector 1 – serial side – the defect above the bead

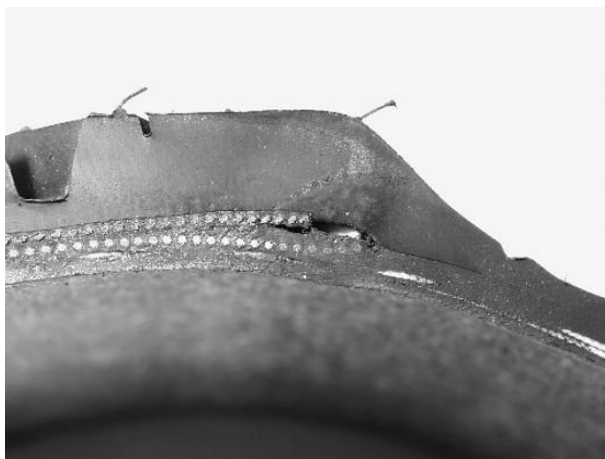
**Fig. 35** The cut section of No. 1 casing – Scan 2, Sector 2 – non-serial side – the defect in the shoulder between the buffer linings

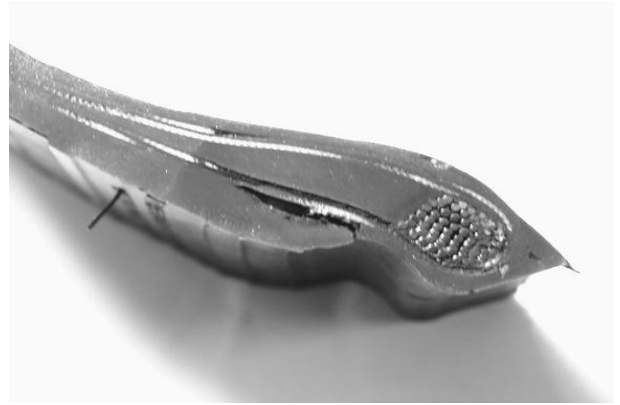
**Fig. 36** Cut section of No. 1 casing– Scan 1, Sector 6 – serial side – the defect above the bead

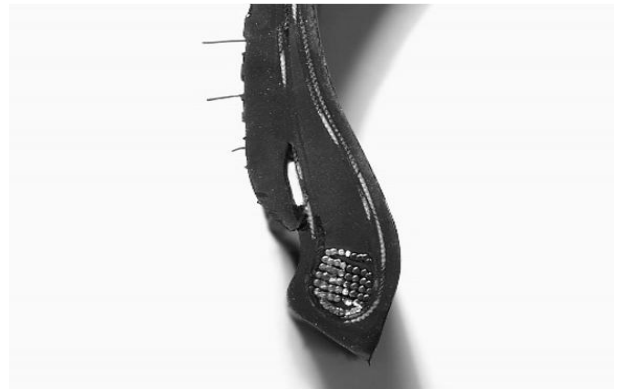
**Fig. 37** Cut section of No. 1 casing – Scan 1, Sector 1 – non-serial side – the defect above the bead; The same testing procedure was used for all of the other variants of casings with the same dimensional proportions.
