The Heat Treatment Impact on Material Properties of 34CrNiMo6 Steel

An article deals with the assessment of the heat treatment of the material for a particular machine component. This material is 34CrNiMo6, made of two melts. This steel belongs to a group of materials with special properties for working at higher temperatures and for the production of demanding components, turbine wheels, cardan shafts, toothed wheels. The material was evaluated for microstructure quality before and after heat treatment. Based on metallographic microstructures, it is possible to review the heat treatment mode, which subsequently affects the mechanical properties of the components. For a particular design element, better cast material was recommended based on a comprehensive evaluation.

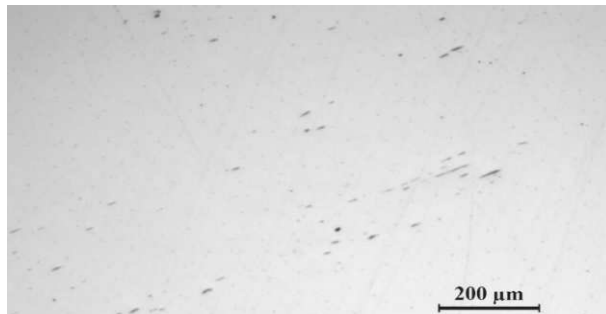
a) Melt No. 1

Fig. 1 Micro-purity of Melt No.1 and No.2

- dot oxides, grade: 2,
- sulphides, grade: 2,

- non-formable silicates, grade: 2,

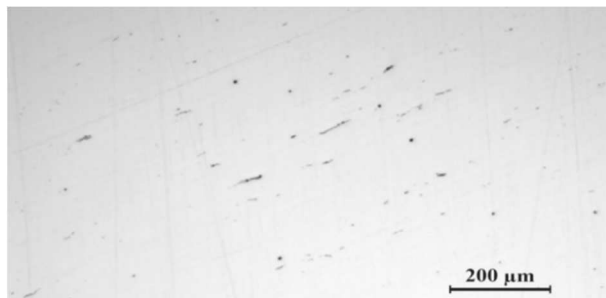
b) Melt No.2

- dot oxides, grade: 2,
- sulphides, grade: 3,
- non-formable silicates, grade: 3, (in compliance with STN EN 10 247).

In melt No.2, the alignment of carbide phases occurred more clearly **Fig. 1**.

The accumulation of sulphides with silicates causes stresses, which results in brittleness of the material [5].

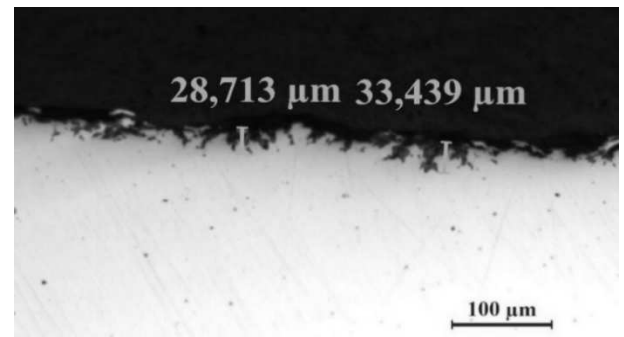
Fig.2 Presence of oxide phases and change of roughness in the surface layer – melt No.1

In relation to melt No.1, the measured depth of oxide phases in the basic material was within the range app. 35 μm **Fig.2**. For melt No.2, depth in some places was up to

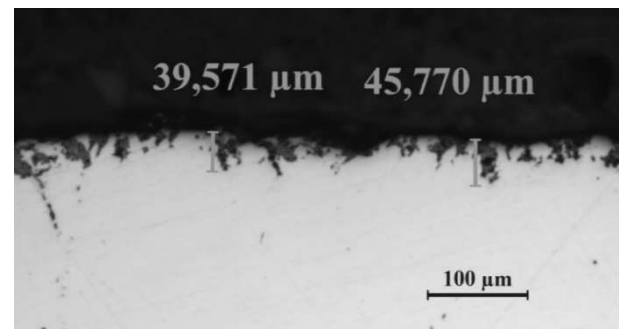
Fig. 3 Oxide phases and change of roughness from the selected area – melt No.2

The oxide thicknesses were not arranged uniformly and even oxide phase could be observed at high depth in primary structure. Such cases result in initiation of the rupture as well as occurrence of intercrystalline corrosion.

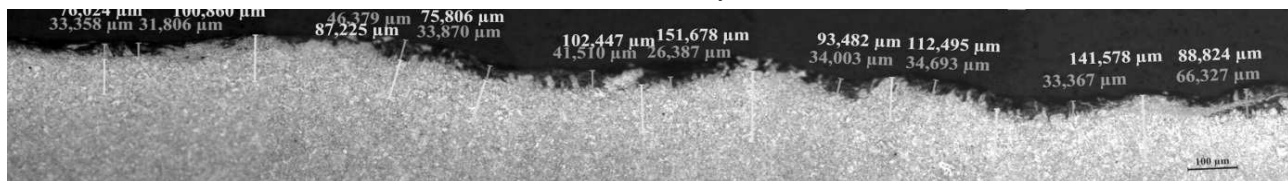
Fig. 4 Measured surface changes – Melt No.2

In the subsurface regions of both components there was even partial decarburization, which was continuously monitored. In the case of the melt No.1, the thickness of decarburization was relatively smaller than that of the No.2. For melt No.1, average decarburization was about 50 μm , but in melt No.2 it was up to 150 μm **Fig. 4** – (green colour represents oxidation, yellow one represents decarburization).

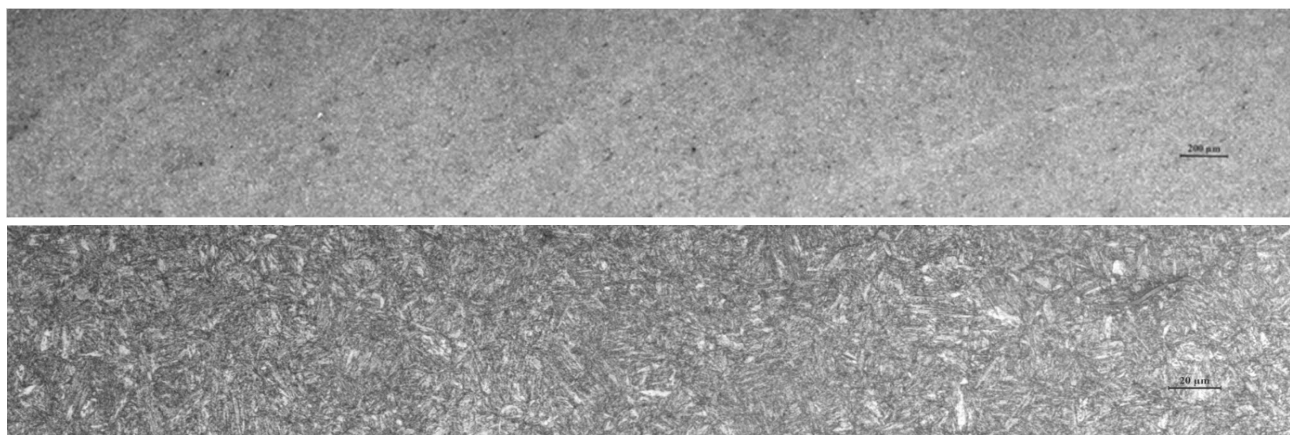
At the joined areas, shown **Fig. 5**, the microstructure appeared to be relatively evenly arranged, with slight alignment of the structure.

Fig. 5 Microstructure of 34CrNiMo6 steel – Melt No. 1

This microstructure can be classified as martensitic-bainite, high tempered – sorbitic, without any free ferrite occurrence. This sorbitic microstructure is fine and evenly arranged. Based on cementite evaluation, with compliance SEP 1520, after stronger etching the structure of melt No.1, was:

- carbon size corresponds to grade: 2,
- carbodic mesh corresponds to grade: 5,

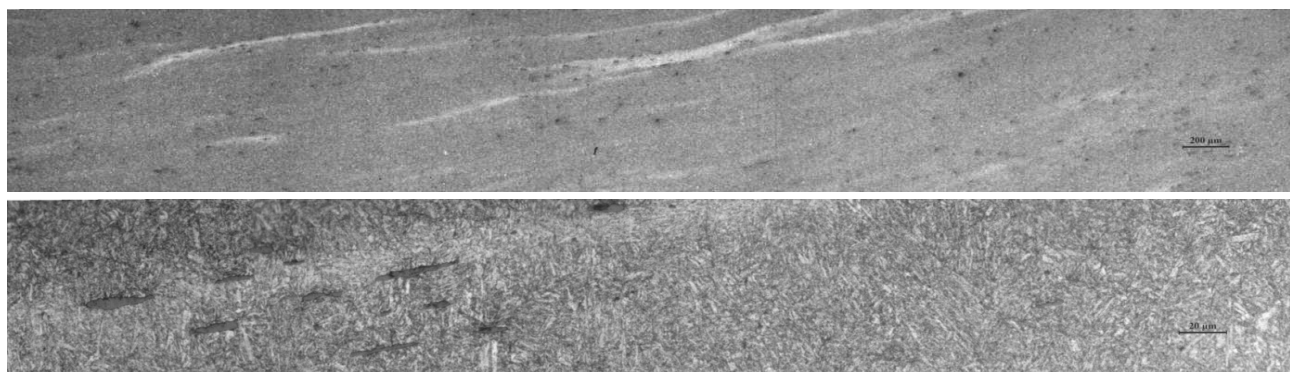
The microstructure from the melt No.2 was typical by the occurrence of inclusions and more continues alignment of carbodic phases **Fig.6 and 6a**.

Fig. 6 Microstructure of material – melt No.2

- carbon size corresponds to grade: 2.2
- carbidic mesh corresponds to grade: 5.2

The heterogeneous microstructure of the melt No.2 can also be defined as martensitic – bainite (high tempered – sorbitic), without occurrence of free ferrite, displayed in **Fig.6**.

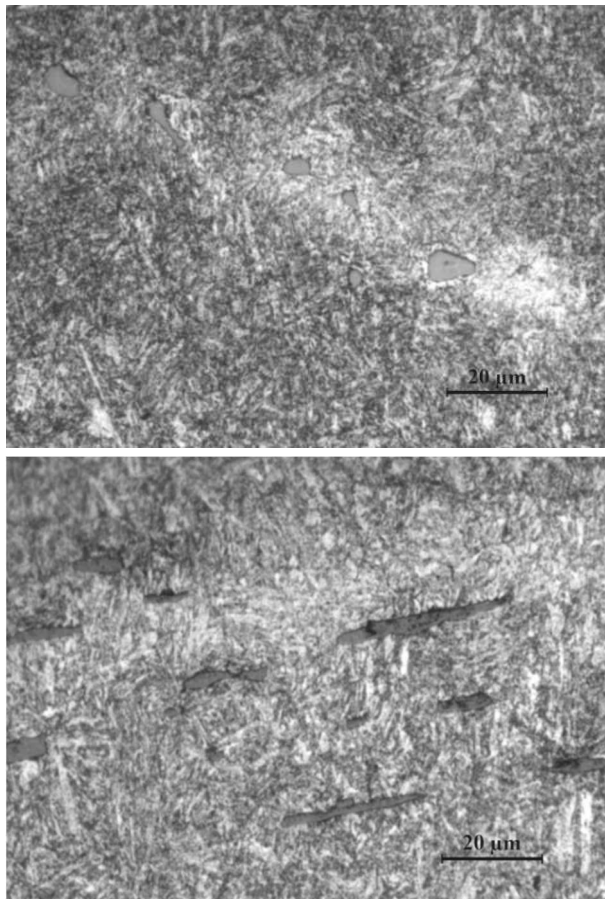
Fig. 6a Details of material microstructure – melt No. 2

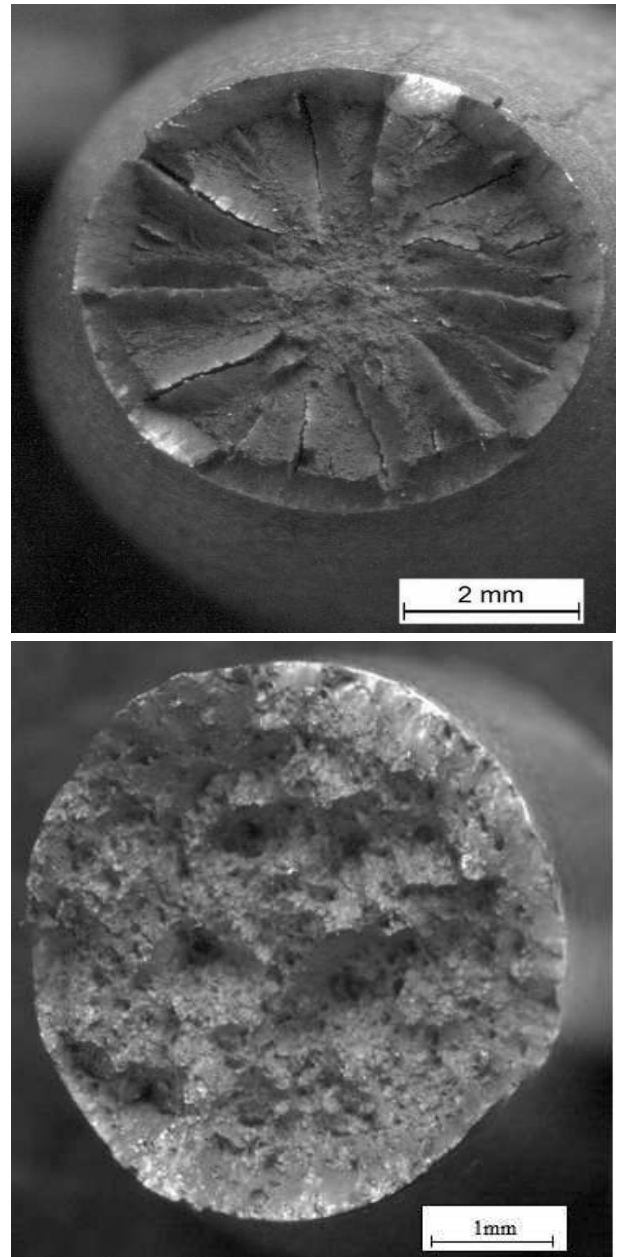
complete information on microstructure imperfection[9,10]. The fracture of the melt No.1 was in the form of rosette **Fig.7**, corresponding to deformation of the standard material.

Fig. 7 Fracture areas of material – melt No.1 and melt No.2

The morphology of the fracture area of melt No.2 was in the form of stone fracture **Fig.7**, and it is connected with the evidence of material brittleness and moreover, it was also confirmed by low values of ductility and contraction **Tab. 2**. A detailed analysis of the fracture surface gave proof to the presence of eutectic interdendritic formations of sulphide inclusions. The researched facts indicated an undesirable distribution of sulphides in particular area of the material. In the case of occurrence of sulphides in the form of a line in a rosette arrangement, the stress arises in this micro-location, which is superposed by occurrence of silicates and the material becomes very brittle in this location.

It can be concluded that the chemical and structural heterogeneity in components, even after heat treatment, superposes stress – strain states. We recommend continuous testing of the chemical composition for each material, before its utilisation. For heavily loaded components, it will be necessary not only to perform microscopic investigation of the material purity, but also evaluate the microstructure quality before and after the heat treatment.
