## Possibilities of Modification of Ploughshares Used for Winter Maintenance of Forest Roads

The article presents partial results of research to increase the service life of snow ploughshares, which are used for winter maintenance of forest transport roads. The main working tool of vehicles - snow plough is the arrow ploughshare. It is made as a weldment. The contact tool, when in contact with the road, is the rake blade, which is subject to abrasive wear. The experiment consisted of analysing the current state of materials, designing and exploring such options that would ensure a longer service life of the blades. Welding material was designed to be applied to the base material of the blade. Furthermore, the HARDOX 450 was designed for the production of the whole ploughshare. The last design was welding HARDOX 450 with an electrode OK 48.00 with the base material steel 11 484. This proposal is presented in more detail in the article. The hardness of HBW, HV and HRC was measured on the samples and microscopic analysis was performed using light and electron microscopy. The aim was to determine the quality of the connection of materials, mixing in the connection zone and comparison

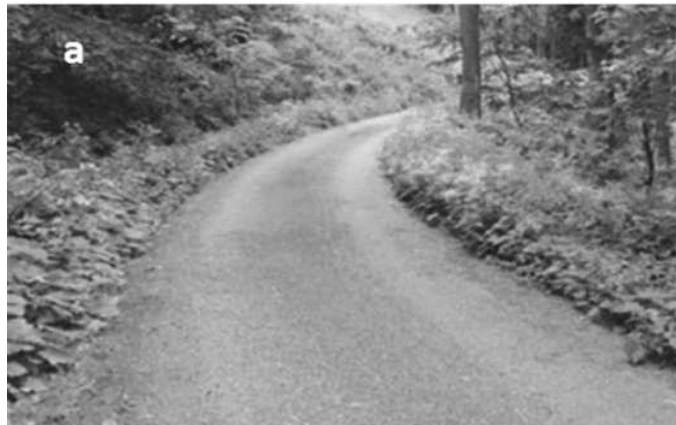
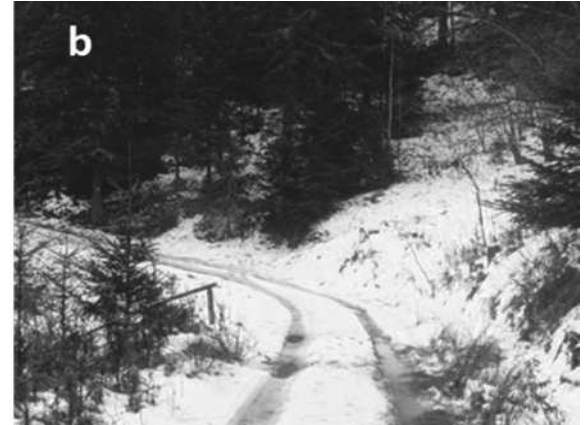
**Fig. 1** The 1st class forest roads - 1L [2], a - forest road in summer; b - forest road without winter maintenance

A forest road is a purpose-built road that is part of a forest transport network. It is intended for the transport of wood, people, materials, for the passage the special vehicles (fire, medical service), but it can also be used for other purposes. It has a built-in earth body and at least a simple drainage [2]. The transport forest roads of 1st class (1L) are usually single-lane, enabling their spatial arrangement and technical equipment to operate all year round (assuming winter maintenance) with a relevant vehicle, by the considered design intensity of traffic. These roads have a roadway, complete drainage of the crown and the body of the forest road and must be equipped with shunt. The recommended lane width is 3.5 m (at least 3.0 m), the free width of the road is recommended 4.5 m (at least 4.0 m). The maximum permissible longitudinal slope is 10% (max. 12%) (Fig. 1a) [2,3].

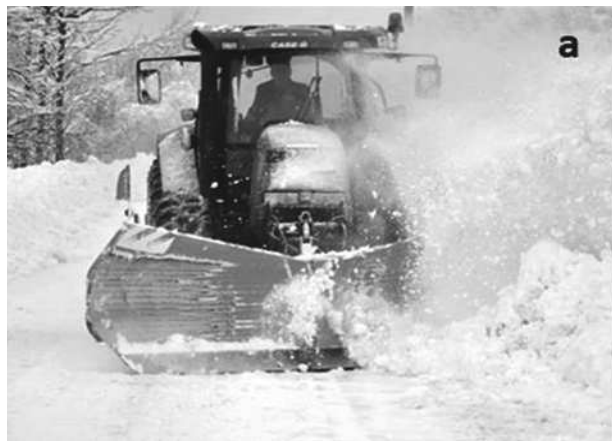
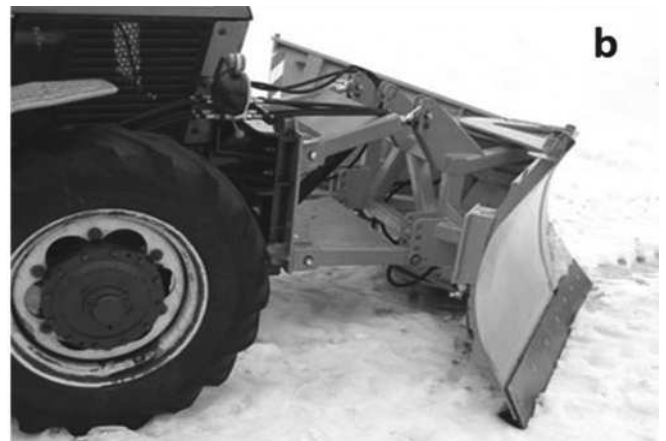
**Fig. 2** Examples of the use of snow arrow blades for road maintenance [4]

from external surfaces. The shape and inclination of the snow ploughshare is adapted so that the snow is deflected onto the relevant part of the road (Fig. 2a and 2b).

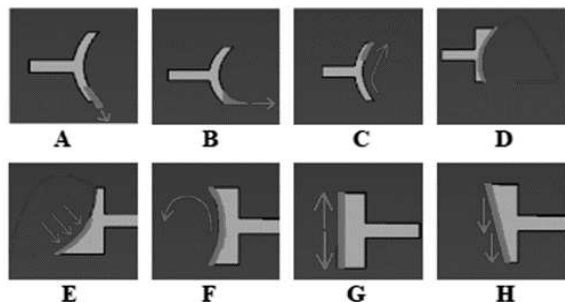
**Fig. 3** The forces impacted to ploughshare [5], A-penetrating, B-cutting, C-digging, D-trapping, E-carrying, F-rolling, G-planning, H-lining

The ploughshare itself (not only the raked blade) is stressed by abrasive wear due to forces (Fig. 3) from the removed material.

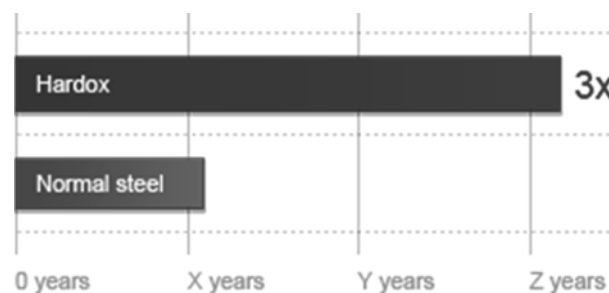
**Fig. 4** Comparison of resistance of HARDOX and normal steel [14]

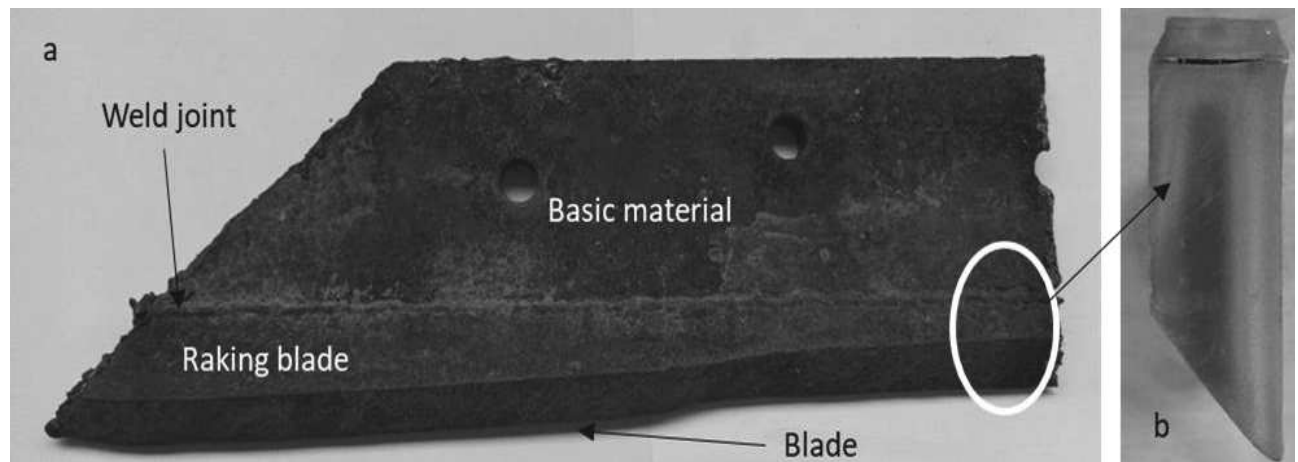
**Fig. 5** Part of the decommissioned ploughshare used in the experiment (a); detail of part of ploughshare (b)

The ploughshare that was the subject of the experiment is a commonly used tool for road modification in winter. It is attached to the working machine with a front clamping plate or, in the case of more difficult terrain, with a three-point hitch. In Fig. 5 is a part of an arrow ploughshare from which samples were taken for the experiment.

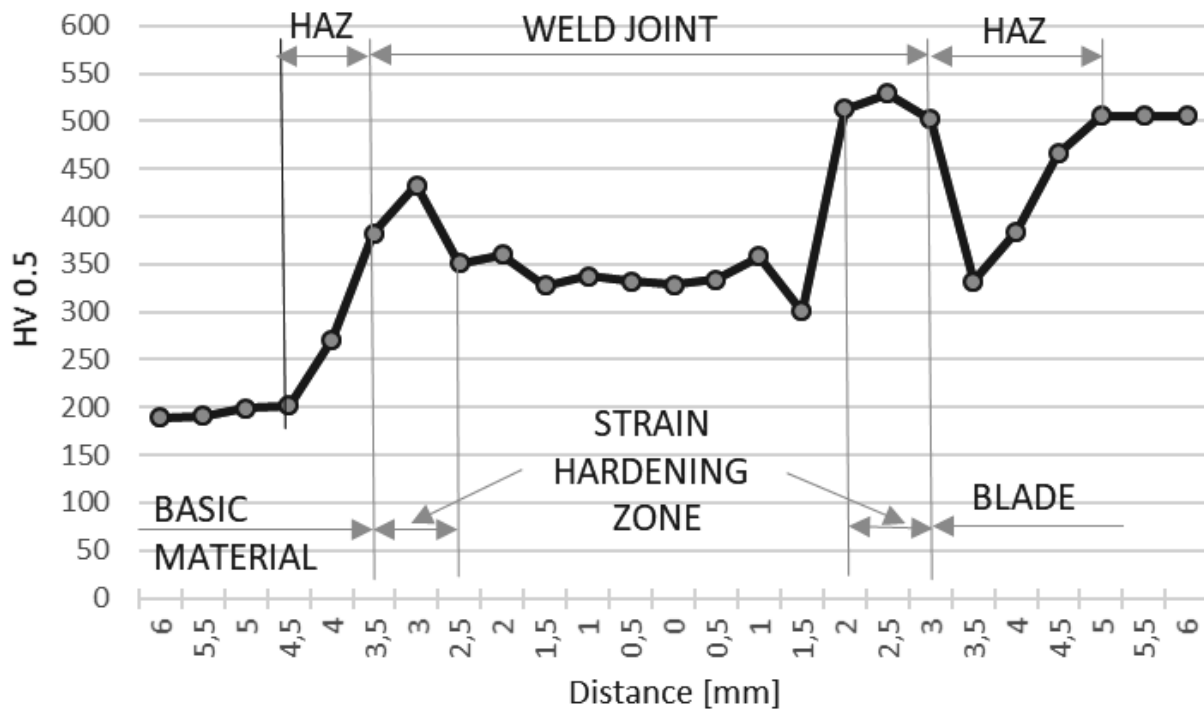
**Fig. 6** Hardness curve of the decommissioned ploughshare – weldment

Vickers HV 0.5, Rockwell and Brinell hardness measurements were performed on samples taken from the decommissioned blade. Vickers hardness was measured according to the ISO 6507-1:2018 methodology [18] with a Vickers 432SVD hardness tester. Load duration  $t = 15\text{ s}$ , load force  $F = 98.07\text{ N}$ . In Fig. 6 is a graph of HV0.5 measurements. The curve indicates how the hardness changes from the base material through the weld to the ranking blade material. We can observe zones at the boundary between the weld and the welded materials, where the hardness increased. We can state that during long-term use of the blade, a lot of pressure is created, which caused local strengthening in these zones.

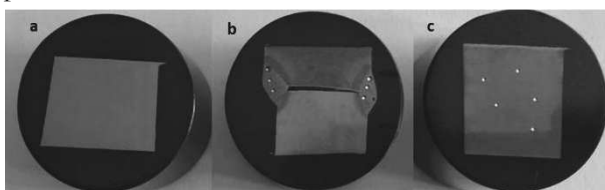
**Fig. 7** Samples for input microscopic analysis, a – basic material; b – weld joint; c – raking blade

Using light microscopy, microscopic analysis was performed on samples (Fig. 7) prepared in a standard process.

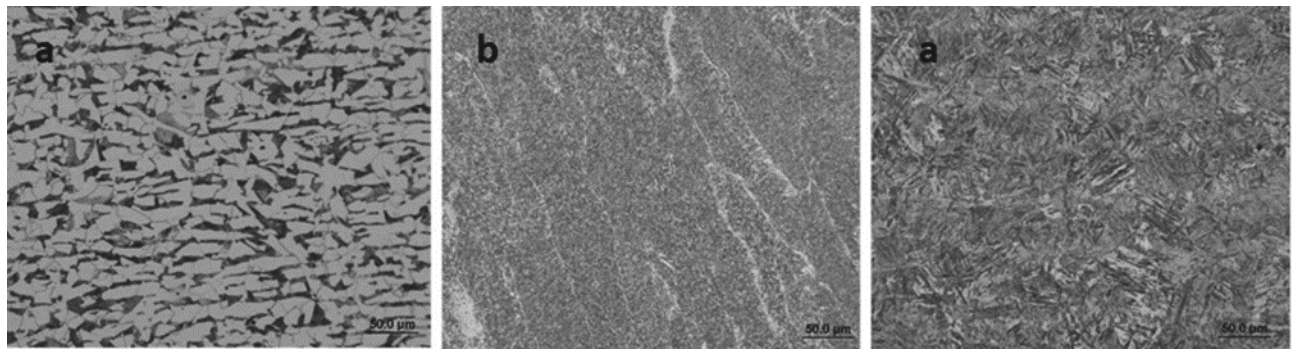
After etching the samples (2% Nital) of the base material, the weld joint and the material of the raking blade, we can in Fig. 9a shows the microstructure of basic material, which is characterized by a slight linearity. It is a ferritic-pearlitic steel with a higher proportion of ferrite. An indicate of linearity indicates that it is rolled steel. We can admit that the steel was also normalized annealed. In Fig. 9b we can see the microstructure of the weld with a characteristic growth of structural elements, which were welded

parts of the ploughshare – basic material and the raking blade. In Fig. 9c is the microstructure of the rake

blade material. It is a sorbitic structure that was formed after tempering.

**Fig. 9** Microstructure – light microscopy - input analysis of weldment, a – basic material; b – weld joint; c - raking blade

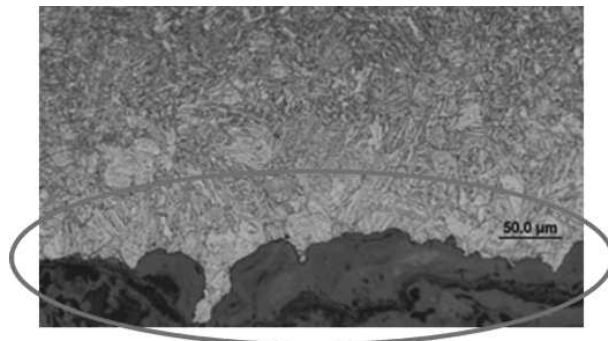
**Fig. 10** Microstructure - wear condition of the raking blade

In Fig. 10 is a state of wear of the raking blade. In the lower part we can see uneven wear on the blade.

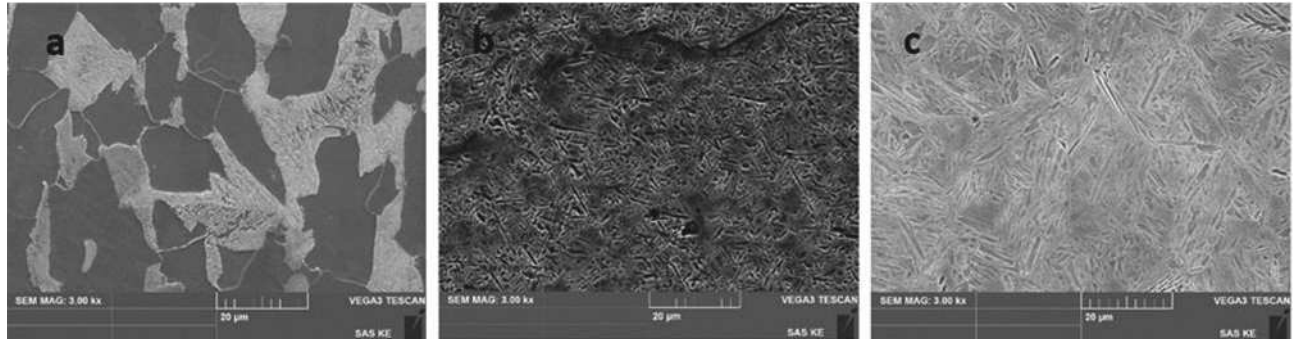
In Fig. 11a is the microstructure of basic material. Fig. 11b shows the microstructure of the weld joint to which the blade parts – basic material and the rake blade were connected, and in Fig. 11c we can see the microstructure of the rake blade material, which was performed by electron microscopy. As declared by the authors using SEM, it is possible to analyse in detail the disturbances, errors or deformations on the worn surface with greater magnification as possible by light microscopy. It was confirmed the type of structures obtained from light microscopy.

**Fig. 11** Microstructure - SEM - input analysis of weldment, a – basic material; b – weld joint; c - raking blade

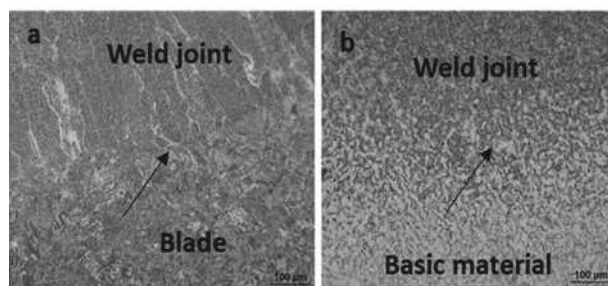
**Fig. 12** Joining and mixing materials in zones: a - weld joint – blade; b – weld joint - basic material

In Fig. 12a we can see the mixed zone of the weld – the blade. The weld has a typical dendritic structure.

in Fig. 12b is weld joint - basic material. We can state that in both cases there was sufficient mixing of both materials with the weld, without the occurrence of defects.

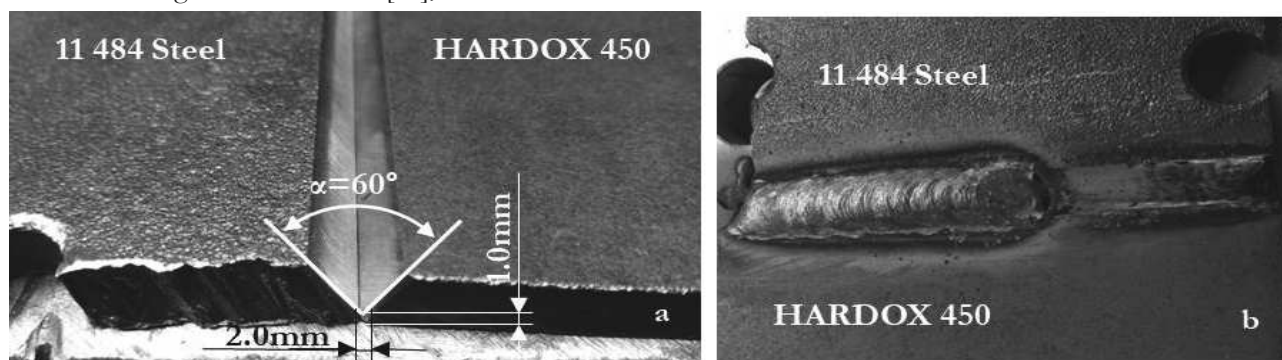
of the welded parts  $s = 10.0$  mm, the bevel angle of the welded edges  $\alpha = 60^\circ$ , the width of the root weld  $b = 2.0$  mm and the height of the root weld  $c = 1.0$  mm. selected. In Fig. 13a are dimensional parameters of the welded joint before welding, Fig. 13b shows the appearance of the weld during welding.

**Fig. 13** Dimensional parameters of the welded joint (a); welding process (b)

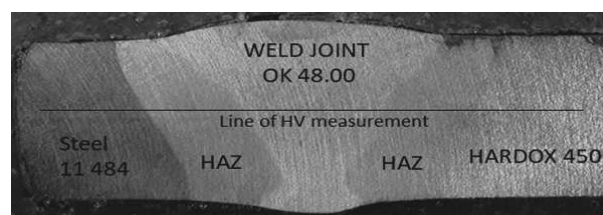
**Fig. 14** Macroscopic image of the welded joint

A macroscopic image of the welded joint was taken with a STEMI 2000 stereomicroscope at 63x magnification (Fig. 14).

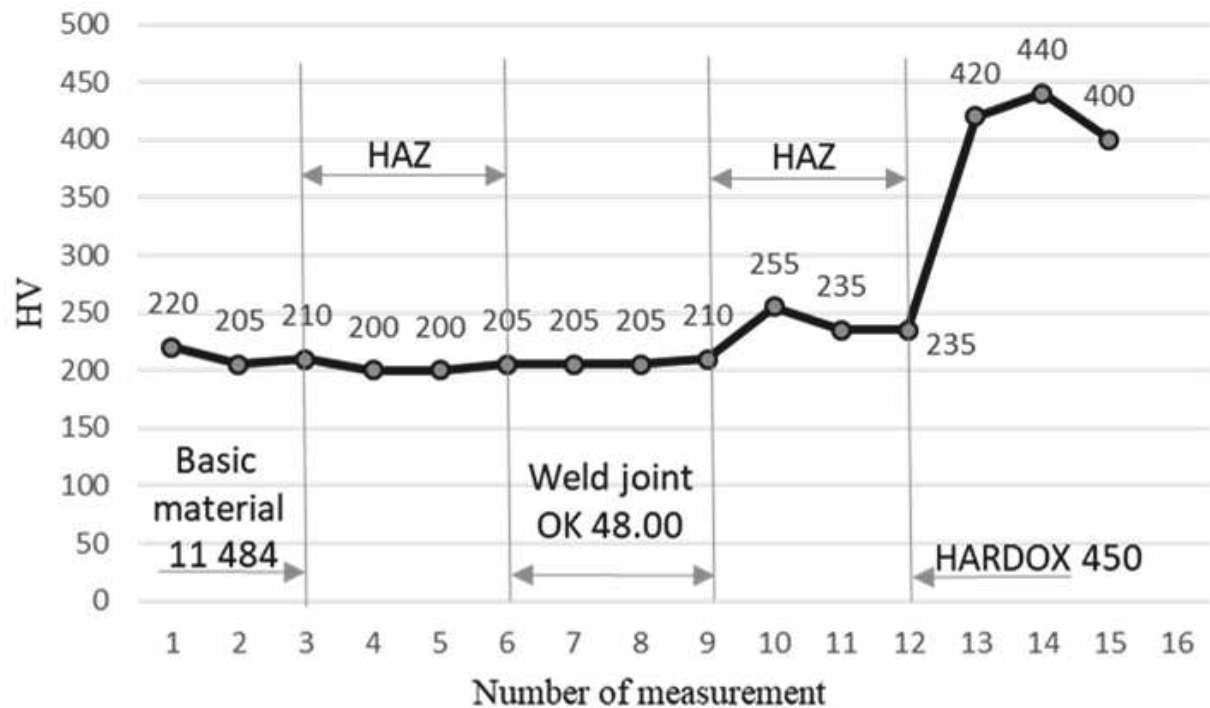
In Fig. 15 is a graph of course of measurements according Vickers. The curve indicates how the hardness changes from the base material through the weld to the HARDOX.

*Fig. 15 Hardness curve on experimental weld joint*

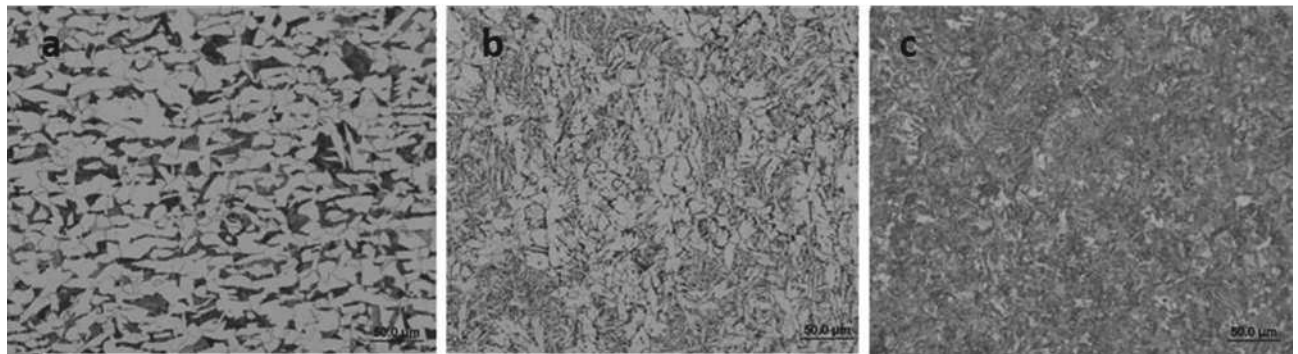
In Fig. 16b we can observe the microstructure of the weld OK 48.00, which was welded steel 11 484 (16a) with HARDOX 450. Compared to the microstructure of the weld from the input analysis of the decommissioned raking blade, this is a different weld structure. The structure in FIG. 16b is finer-grained than the structure on the original weldment (Fig. 9b). We assume that a different electrode was used on

the original weldment. In Fig. 16c we can observe the microstructure of HARDOX 450. It is a sorbitic structure. This is confirmed by information from the Technical Data Sheet [14], which states that in this type of steel, the mechanical properties are achieved by heat treatment - hardening and subsequent tempering.

*Fig. 16 Microstructure of individual parts of a welded joint - light microscopy, a - steel 11 484; b - weld joint OK 48.00; c - HARDOX 450*

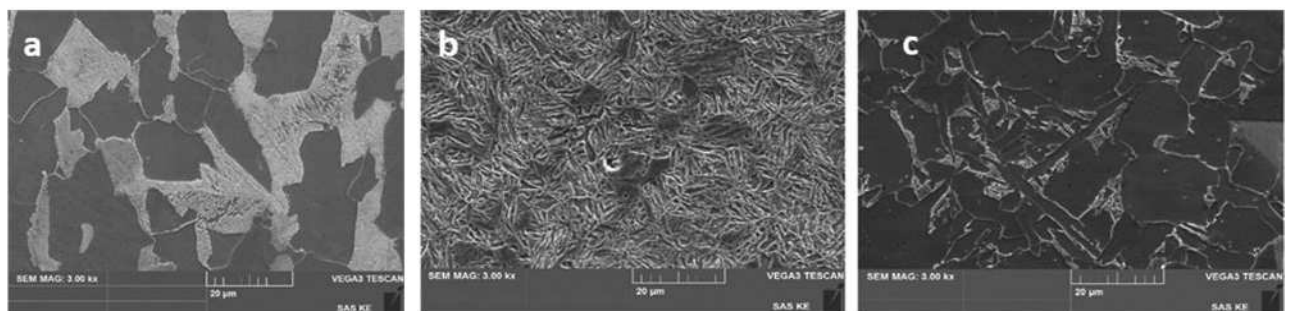
*Fig. 16 Microstructure of individual parts of a welded joint - electron microscopy, a - steel 11 484; b - weld joint OK 48.00; c - HARDOX 450*

In Fig. 17 we see the structures of materials from electron microscopy, which confirms the results obtained from light microscopy.

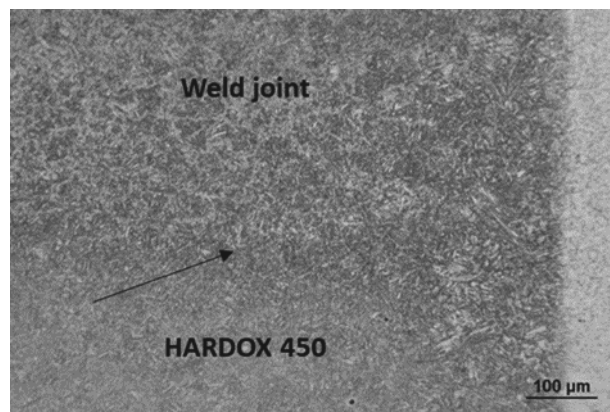
In Fig. 18 shows the microstructure of the connection of the HARDOX 450 to the OK 48.00 electrode. We can state that there is a sufficiently satisfactory connection of materials. No defects are visible. The welding parameters were therefore set correctly.

**Fig. 18** Connection of HARDOX and electrode OK 48.00

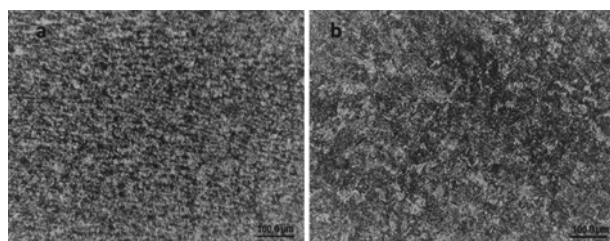
In Fig. 19a we can observe the heat-affected zone (HAZ) of the steel 11 484, which has a fine-grained structure characteristic of the state achieved during welding when the material is heat-affected. In Fig. 19b we can observe the HAZ of HARDOX 450. Not so significant change from the structure of HARDOX 450 (see Fig. 17c.).

**Fig. 19** Microstructure of heat-affected zone, a - steel 11 484; b - HARDOX 450
