## Stress Corrosion Cracking and Copper Alloy Products

Vladivoj Očenášek (0000-0002-7817-8701), Jan Luštinec (0000-0001-8764-6514)

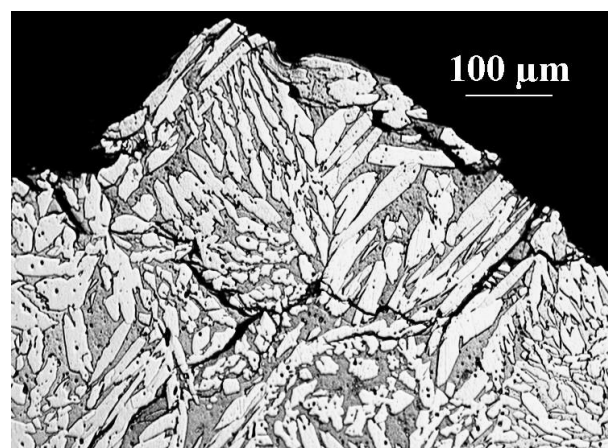
**Fig. 1** Partly intergranular and transgranular SCC crack of two-phase ( $\alpha/\beta$ ) brass CuZn40Pb2 [10]

Stress corrosion cracking (SCC) is one of the forms of breaking materials. This type of failure often leads to unexpected and sudden fractures. Cracks form and propagate always occur in a corrosive environment in the presence of tensile stresses. SCC violation is thus due to the interaction of these two factors. Another characteristic feature of SCC failure is imperceptible manifestations on the surface at the crack site. There are no corrosion products on the surface and no traces of plastic deformation are visible around the crack. The absence of plastic deformation is due to the fact that cracks occur at stresses lower than the yield strength. SCC failure occurs at various combinations of chemical composition of the material, the state of the structure of the material, the state of the surface, the composition of the ambient atmosphere, temperature, and mechanical stress. Due to the emergence of SCC violations, different combinations of these factors lead to a relatively large variance of results and to their difficult predictability. For a particular metal or alloy, there are then typical environments that cause SCC failure. Therefore, in the case of long-term exposure to stress and the environment, a change in the chemical composition of the environment over time may also play a role. Because failure of a structure or part due to SCC occurs at low stress levels, cracks can occur over a wide period, depending on the interaction of the individual factors. It can be tens of hours or many years. SCC fractures have a brittle fracture morphology and can be intercrystalline or transcrystalline. In many cases, these are mixed quarries, which have both transcrystalline and intercrystalline character (Fig. 1). Often the crack branches away from the main crack. The formation and propagation of SCC

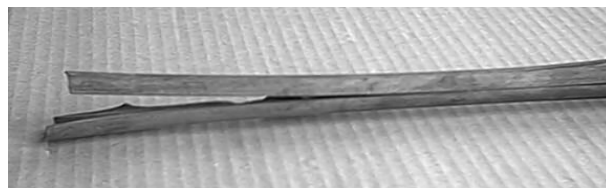
**Fig. 3** SCC cracks of cold drawn CuZn20Ni18 bar due to improper storage [10]

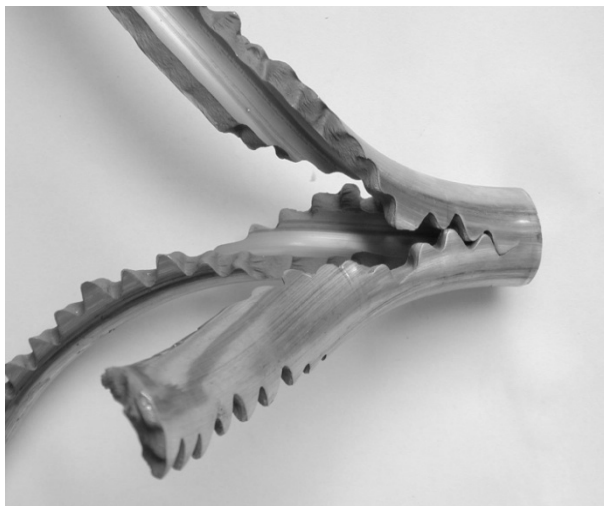
**Fig. 4** Fatal cracks after pushing the brass tube before drawing initiated by small SCC cracks [10]

bar into the die is used. When pushing, the beginning of the rod at the exit of the die is stressed by tensile stress. If a sufficiently long time elapses between the division of the bars and the pushing into the die, a SCC crack will form at the face of the bar and the bar will rupture at the exit of the die (Fig. 4). The course of the deformation of the surface layer caused by the division of the rod and the SCC crack adapted to the shape and orientation are very clearly visible in Fig. 5. These cracks, when pushed into the die, are the site of extensive and fatal failure of the rod by longitudinal cracks (Fig. 4). On the fracture surface (Figs. 6 to 9), the initiating part of the SCC crack and the crack, which is formed only when pushed into the die, is then very clearly visible. This example shows that a completely marginal technological operation can lead to production interruptions, but the detection of the cause is not easy and instant? [10].

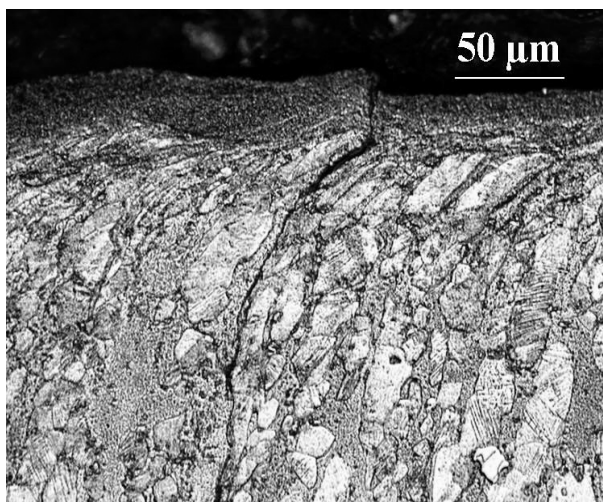
**Fig. 5** SCC crack in the deformed surface layer after cutting the rod [10]

The occurrence of SCC cracks due to residual stresses after cold deformation may also be related to ancillary technological operations, such as the division of bars or thick-walled pipes. If they are separated after hot extrusion until the material has cooled, local surface plastic deformation may occur at the cut surface, which may be a source of problems by following cold drawing. When calibrating the dimensions of bars by cold drawing, for larger cross-sections, pushing the

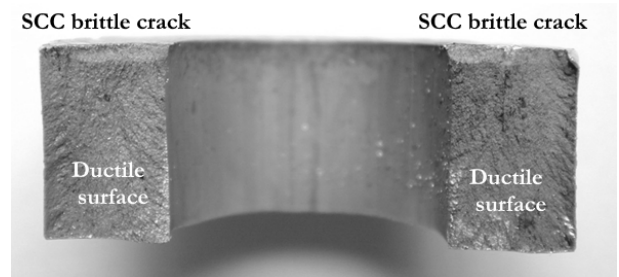
**Fig. 6** SCC initial cracks at the surface of the cut cross section [10]

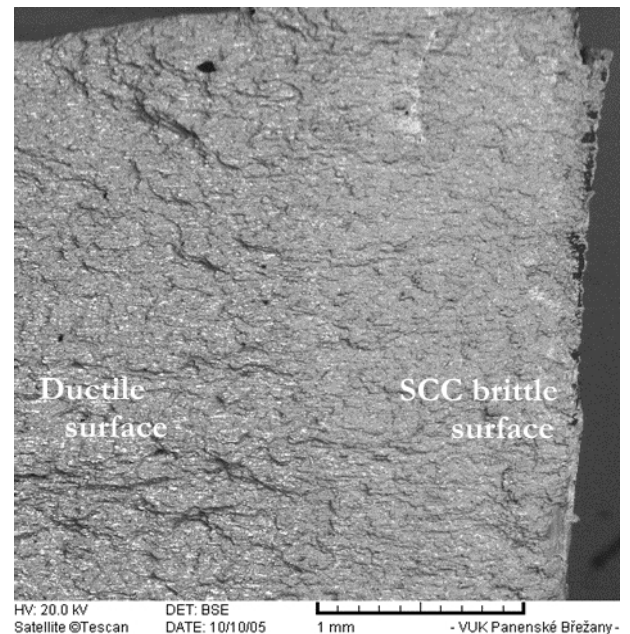
**Fig. 7** Overall view of the crack, which consists of the brittle part of the SCC fracture at the surface and the continuing ductile fracture [10]

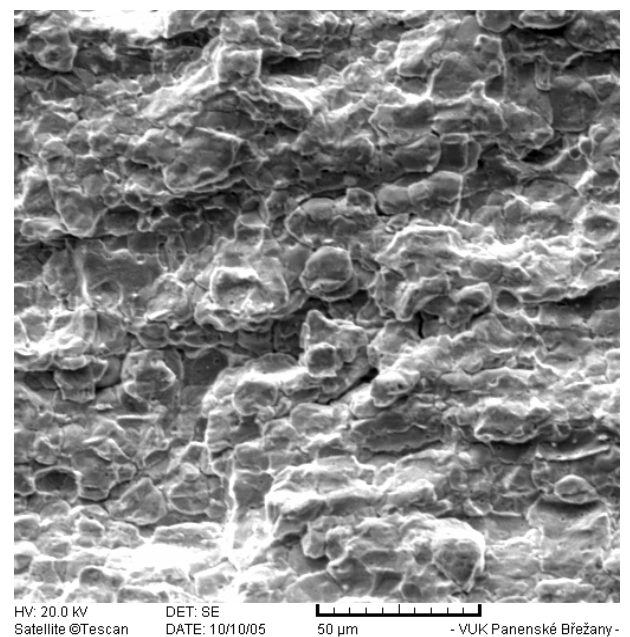
**Fig. 8** SCC brittle part of the crack [10]

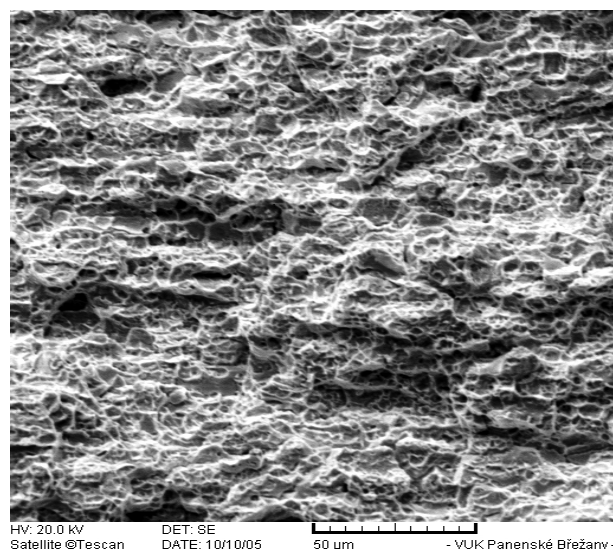
**Fig. 9** Ductile part of the crack related to the SCC initial crack [10]

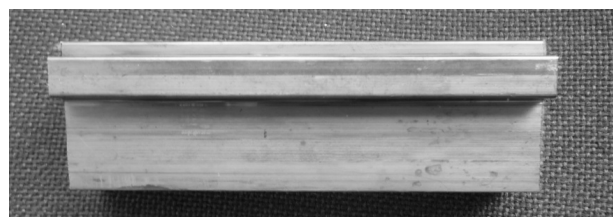
**Fig. 10** T-profile from CuCrZr alloy before heat treatment and machining [10]

As opposed to the aluminum alloys, the occurrence of SCC cracks in copper alloys due to heat treatment of precipitation hardenable alloys is a relatively rare phenomenon. The cause is residual stresses that arise during cooling from the solution annealing temperature. Unlike tensile residual stresses after cold drawing, the residual stresses on the surface after rapid cooling are compressive. Compressive stresses are not dangerous from the point of view of SCC failure. However, under certain circumstances, an SCC violation may occur. An example is a low-alloyed age hardenable Cu-CrZr alloy. In Fig. 10 is a hot extruded T-profile, which has been machined to its final shape before soldering the contacts after heat treatment. After some time after machining and soldering the contacts, a crack appeared on the surface on both sides along the whole part (Fig. 11). It was an intercrystalline network of SCC cracks (Fig. 12). After cooling from the solution annealing temperature, compressive stresses remained in the profile on the surface. However, due to the removal of the material, part of the profile was redistributed so that there were tensile stresses on the surface, which was the cause of SCC cracks. To prevent the formation of SCC cracks, it is necessary to choose the procedure during heat treatment so that residual stresses are removed or minimized [10].

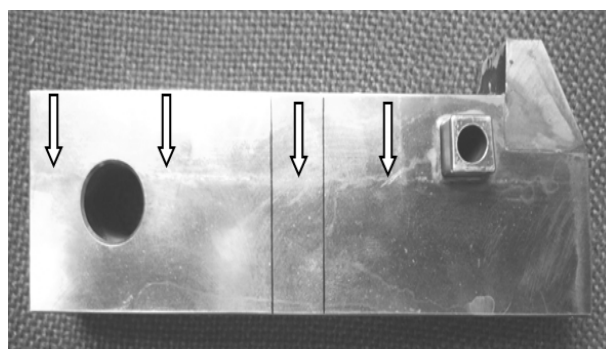
**Fig. 11** Position of the SCC crack in the T-profile after heat treatment and machining with marked position for crack metallography [10]

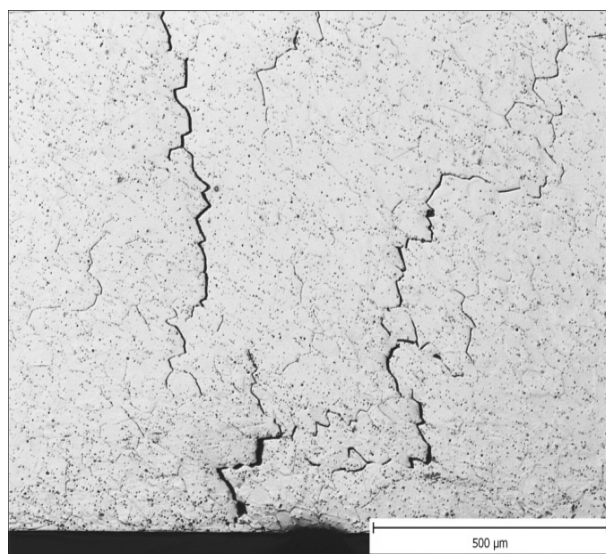
**Fig. 12** Intercrystalline SCC crack in the T-profile after heat treatment and machining (Fig. 10) [10]

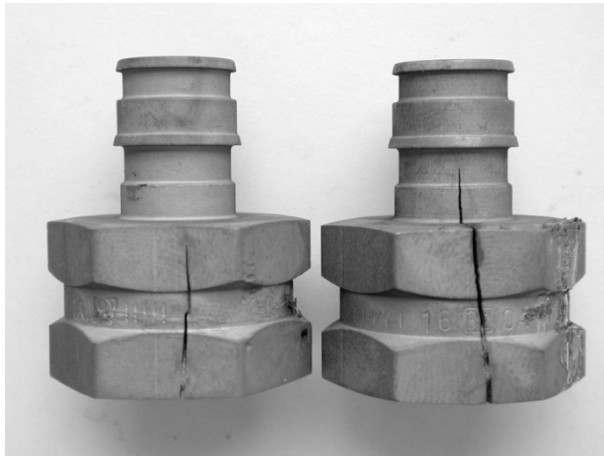
**Fig. 13** SCC cracks of CuZn40Pb2 fittings due residual, assembly, and operating stresses [10]

A typical and very common case of SCC cracks are fittings made of hexagonal bars from machinable brass with a higher Zn content (CuZn40Pb2). The bars are cold drawn to the required dimensional tolerances after hot extrusion. After cold drawing, tensile stresses remain on the surface. During machining, they are usually redistributed. In combination with the stress applied to the fitting during assembly, SCC cracks then form, usually in the thin threaded part of the fitting (Fig. 13 and 14). The applied stresses during assembly can be caused by excessive tightening or by a larger volume of sealing material in the thread. The effect of the deformation during the cold calibration drawing on the uneven hardness along the cross section of the hexagonal rod is evident in Fig. 15. This figure shows how the course of hardness changes due to drawing and heat treatment. The preventive measure against the occurrence of SCC cracks is annealing to remove the internal stresses of the cold-drawn rods and to observe the specified conditions during the assembly of the fitting.

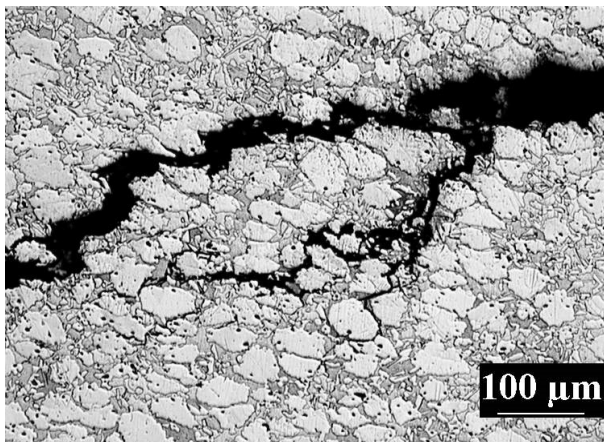
**Fig. 14** Intergranular SCC crack in the brass fitting [10]

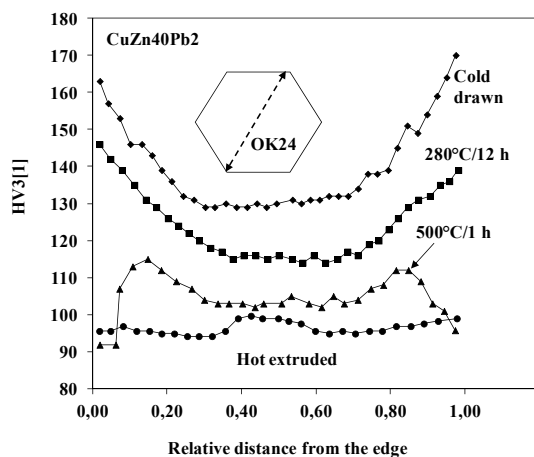
**Fig. 15** Influence of cold drawing and heat treatment on hardness of 24 mm brass hexagon bar (CuZn40Pb2 alloy) [10]

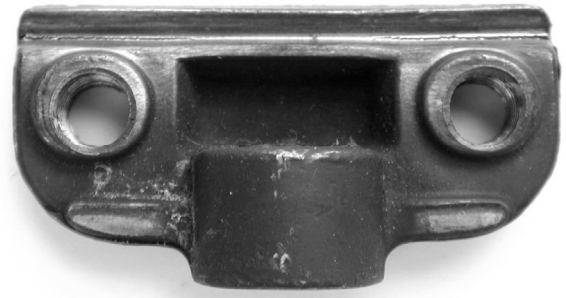
Another case of the formation of SCC cracks, which were caused by the stresses applied during assembly, are brass clamps made of CuZn40Pb2 alloy. Clamps were used for fastening tram overhead contact line. As the clamps were not tightened with a torque wrench during the assembly, they gradually began to crack under the assembly and operating stresses. The

SCC crack was caused by the notch effect in the groove of the clamp for fixing the overhead line. (Fig. 16). In the case of the static strength test of the clamp, the fracture occurs at the same location of the clamp, but with large plastic deformations at the fracture location (Fig. 17). The absence of plastic deformation around the crack thus confirmed that it is an SCC failure [10]. To avoid the formation of SCC cracks in operating conditions, it is therefore necessary to optimize the assembly forces.

**Fig 16** Due to assembly and operating stresses visible SCC crack in the groove of the CuZn40Pb2 clamp [10]

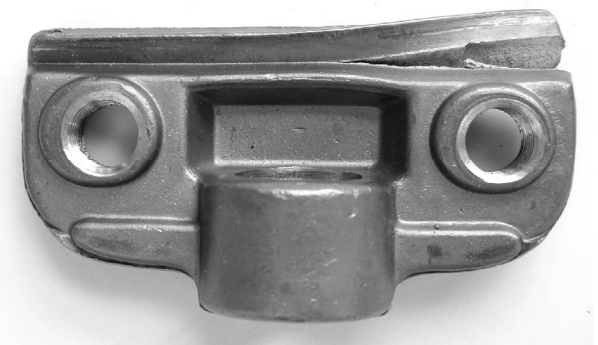
**Fig. 17** Crack of the CuZn40Pb2 clamp after static loading [10]
