Use of Electron Microscopy in the Analysis of the Influence of Roughness on the Corrosion Behavior of Selected Ti Alloys

Titanium alloys are among the biocompatible materials that are used for biomedical implants. From the point of view of the reactivity of the human body, it is important to know the state of the surface of these materials, which in technical practice is represented by the term surface integrity, which includes a complex of evaluated properties. One of the classic approaches is the evaluation of the surface roughness and the properties of the stable oxide layer, which influence the formation of the connection of the implant with human tissues and influence its acceptance. Another frequent approach is the use of optical metallography, especially for the assessment of material thickness, distribution and character of corrosion attack. Less common is the use of electron microscopy in the evaluation of the surface, which in this case is affected by the action of corrosion. Samples of both pure titanium and Ti6Al4V alloy were divided into sets according to surface roughness and subsequently exposed to corrosion for different periods of time. The presented article is de

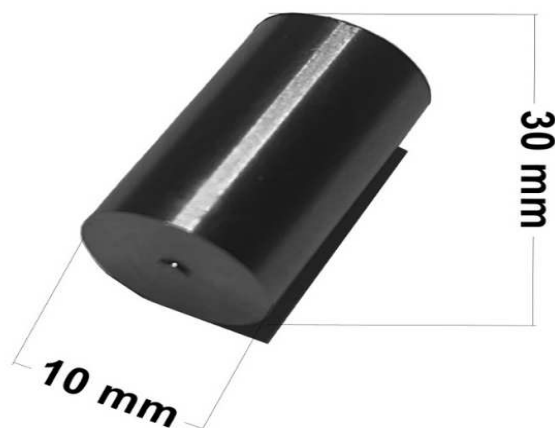
Fig. 1 Sample cuttings off from the titanium rod

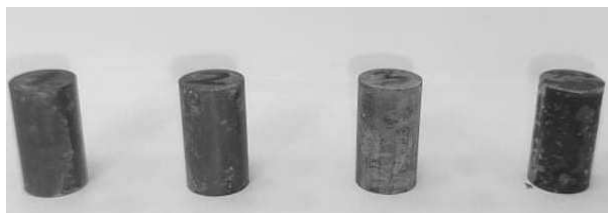
Fig. 2 Prepared rolls

Both types of delivered material were prepared and delivered in the form of rods. The material was machined to the required roughness (Ra 3.2, Ra 1.7 and Ra 0.3) complete with equipment and conditions under which it was machined and subsequently cut into rolls of the same size: length – 30 mm and diameter – 10 mm (fig. 2).
