Fractographic Analysis of Strontium-Modified Al-Si Alloys

The research described in this contribution is focuses on fractographic analysis of the fracture area of AlSi7Mg0.3 alloy with modified strontium. Modification is an effective tool for improving the mechanical properties of aluminum alloys and affecting the microstructure of the material. The aim of the paper is to revise the microstructure of the modified AlSi7Mg0.3 alloy and to determine its strength properties. Within the experiment, the character of the refraction was evaluated and the presence of foreign particles and elements in the material fracture was monitored. Optical microscopy identified structural parameters of the castings just below the fracture surface as well as the course of the fracture line. Using a scanning electron microscope, the fracture area of the sample was analyzed, the EDS analysis was performed and the results of these analyzes were evaluated. An increased number of O, C and F elements occurred on the surface of the samples. The occurrence of these elements most likely results in a material breakage, which also confirms the results achieved by the static tensile test. On the basis of the obtai

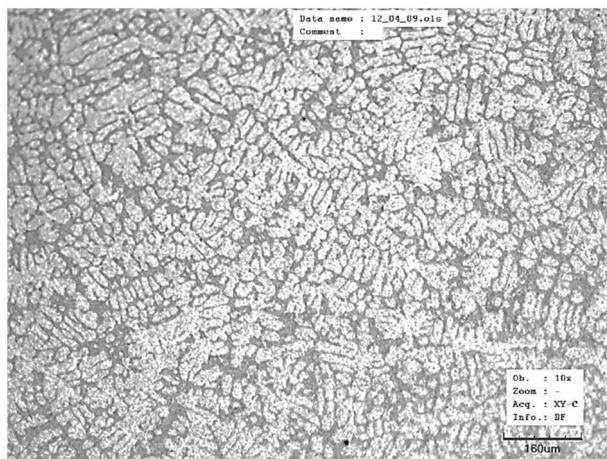
Fig. 1 Microstructure of alloy AlSi7Mg0.3

evaluation in the region of the adjacent fracture it can be noted that this is eutectic silumin with a plurality of individual types of structural components. The basic components of the microstructure are α - solid solution and silicon in the form of finer and coarse hexagonal plates, which appear in the plane of the metallographic thin section appears as angular or partially rounded irregular needles of different sizes with a size in the range of 10 - 40 μm (Figure 1).

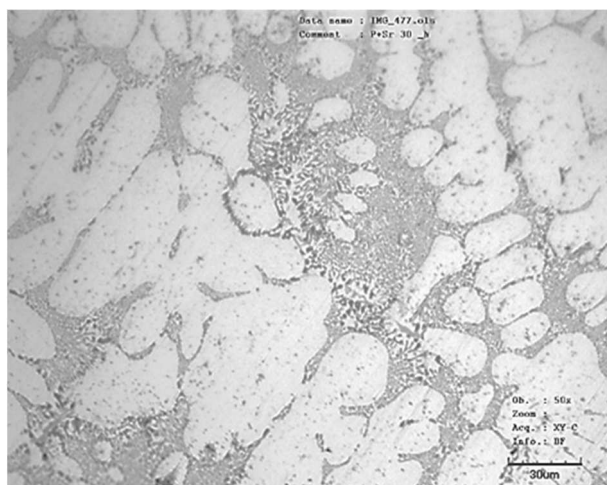
Fig. 2 Detail of the microstructure of the material under the fracture line AlSi7Mg0.3

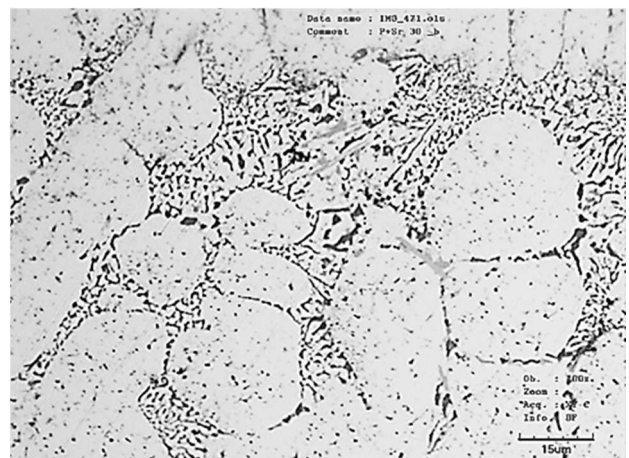
Fig. 3 Microstructure of alloy AlSi7Mg0.3 modified Sr

After the addition of strontium to the base material, the size of the needles of the eutectic silicon is increased, resulting in the expansion of the eutectic phase plates, and several thin plates are formed to form the long needle Si phases [8-11]. Thanks to the addition of beryllium, the modifying effect is prolonged. The morphology of eutectic silicon particles (rounded particles) is observable in all the samples examined. Together with the modifier, the needles of the eutectic silicon thickened and the distance between them was reduced (Figure 3 and Figure 4). The morphology of eutectic silicon particles is observable in all the samples examined. The microstructure of the fracture line in the fracture area is fractured (Figure 5). Secondary cracks are visible as well as internal (Figure 6).

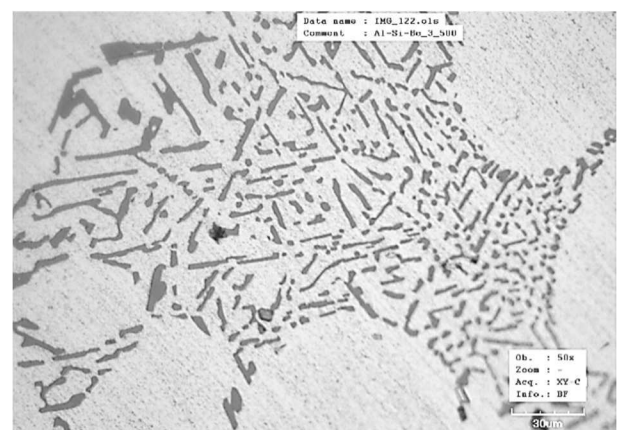
Fig. 4 The microstructure of the AlSi7Mg0.3 alloy with the addition of Sr and Be

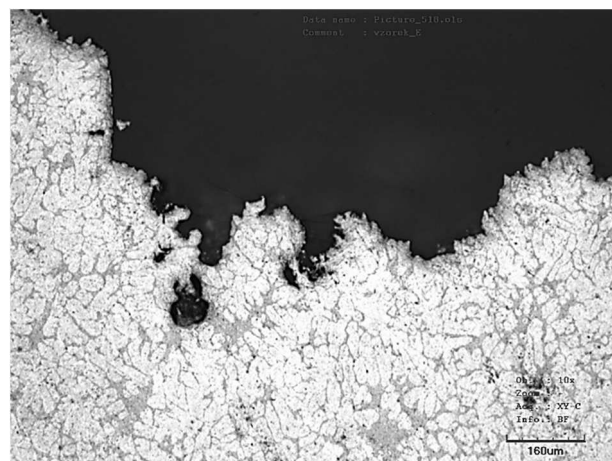
Fig. 5 Refractive area with a fission break

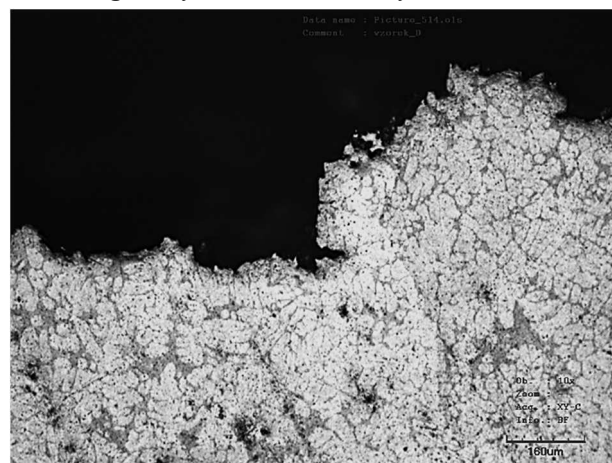
Fig. 6 Refractive area with a fission break

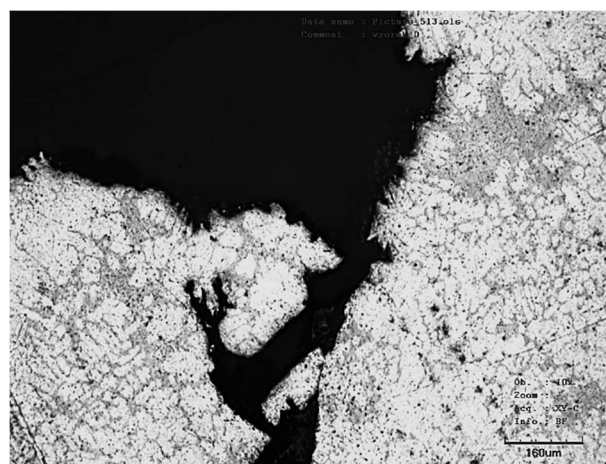
The major crack profile reflects the morphology of the primary dendritic structure. The major crack exceeded the two-phase areas (α -solid solution + silicon) and separated the dendrite of α -solid solution (Figure 7). Cracks of the

Fig. 7 Refractive area with a fission break

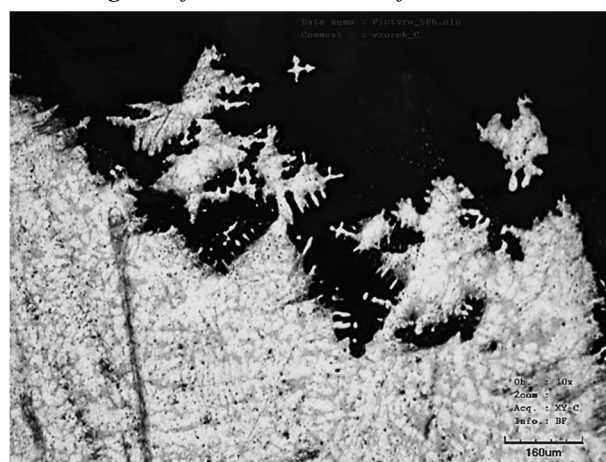
deformed α -solid solution are visible in Fig. 8. Secondary cracks are visible in the eutectic zones.

Fig. 8 Refractive area with a fission break

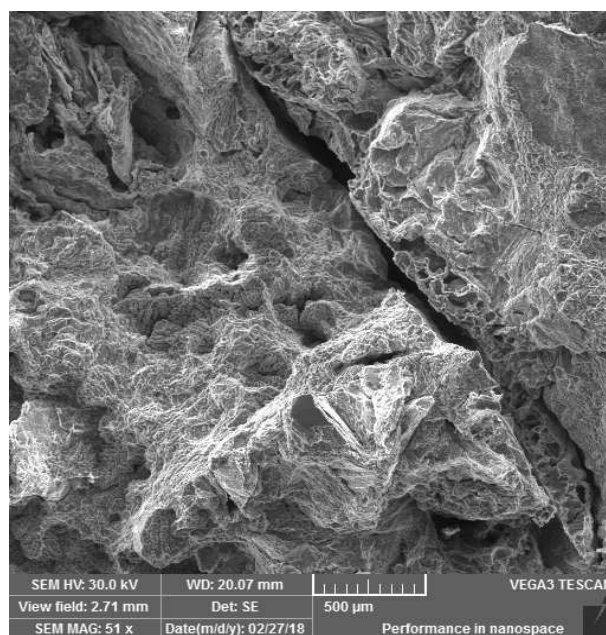
Fig. 9 SEM analysis - Fission intercrystalline fracture

In Fig. 9 is predominantly an interdendritic disruption of the test specimen. In the detailed view of the fracture area, it is possible to distinguish areas characterized by a characteristic fault with the evident fissionable violation. EDS analysis in this area shown the presence of O and C in large quantities, which caused total brekage and crack propagation across the entire cross section of the casting.

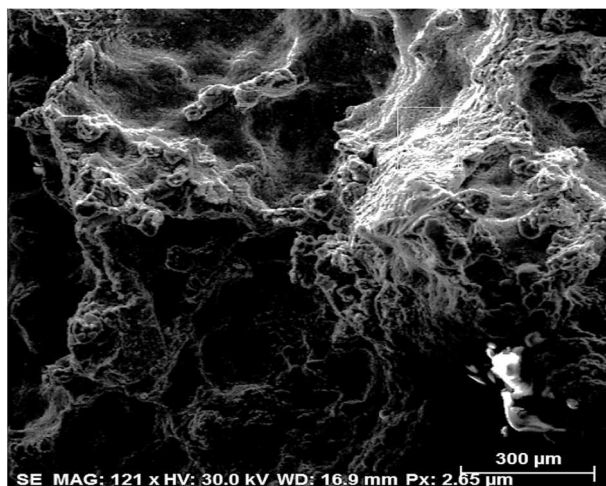
**Fig. 10** EDS surface analysis**Tab.4** EDS analysis

Figure 10 shows a predominantly interdendritic disruption of the test specimen. Detailed view of the fracture area, it is possible to distinguish the areas characterized by a characteristic violation and the exposed dendrite on the fracture surface. EDS analysis of light fragments of the fracture break on the fracture surface shows the presence of O and C in large quantities. As a result of the high content of these elements is the total violation and the spread of cracks through the entire cross-section of the casting.

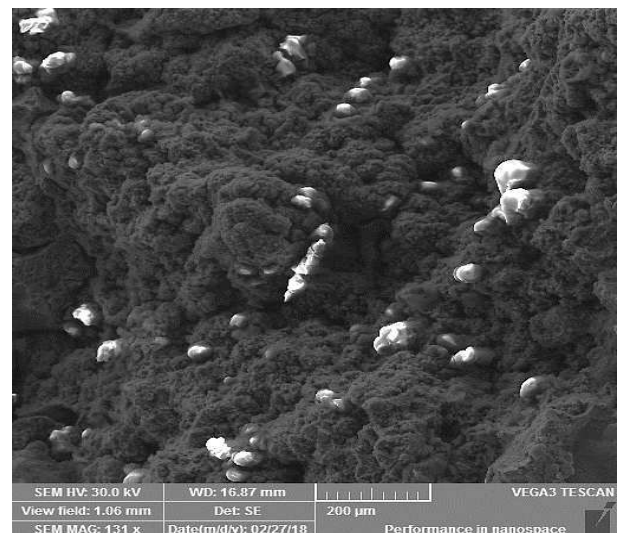
**Fig. 12** SEM analysis - light spherical particles - oxides and exposed dendrites on the fracture surface

The analyzed area in Fig. 12 shows predominantly interdendritic failure of the test specimen. In the detail view on the fracture surface can distinguish the area with the appearance of a bright spherical particles (oxides) and it is possible to observe the exposed dendritic cells. The surface EDS analysis on the fracture area identified the presence of O, C and F where, in terms of the stoichiometric ratio, it can be deduced that the oxides and residues of the refining salt are present. The amount of unwanted ele-

ments are reflected in large quantities, resulting in the formation and spread of fracture. A spherical rounding of particles containing O at the surface of the fracture was documented on the analyzed area from the bottom of the casting, which also caused the violation of the test specimen.

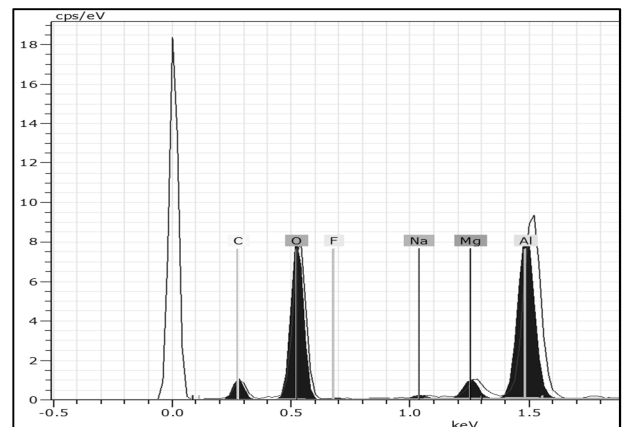
**Fig. 13** Spectrum of analyzed chemical elements of the area EDS analysis (area in Figure 12)**Tab.5** EDS analysis

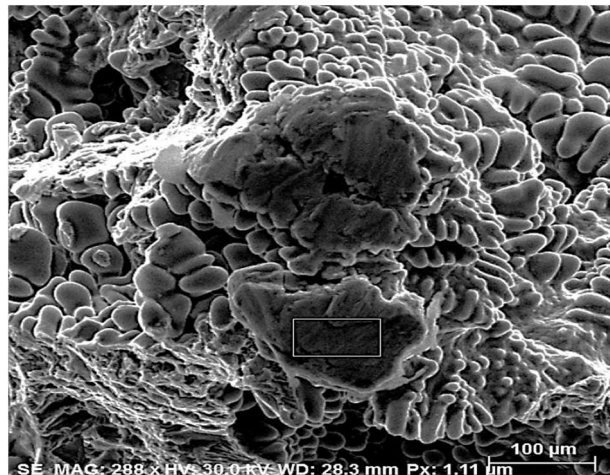
Fig. 14 SEM analysis - exposed dendrites on the fracture surface

In Fig. 14, exposed dendritic cells and interdendritic porosity can be observed. The surface EDS analysis of light fragments of the fracture break on the fracture surface shows the presence of O (5.99 wt.%) and C (24.24 wt.%), where in the terms of stoichiometric ratio can be said that it is the presence of the oxide membrane on the surface of the smooth flat plate caused a total breakage of the casting.

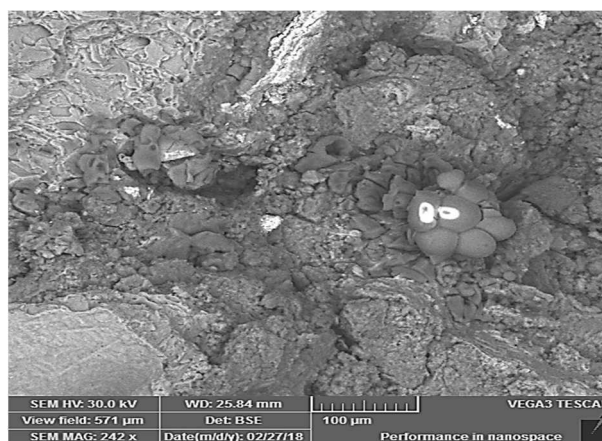
Fig. 15 documents predominantly interdendritic failure of the test bar. In the detailed view of the fracture area, areas with a characteristic morphology break can be distinguished. In the middle part of the cast surface, spherical particles containing O (59.45 wt.%) on the surface of the fracture can be seen, which also contributed to crack propagation and subsequent fracture.

Fig. 15 SEM analysis - interdendritic violation, ductile violation with hole morphology

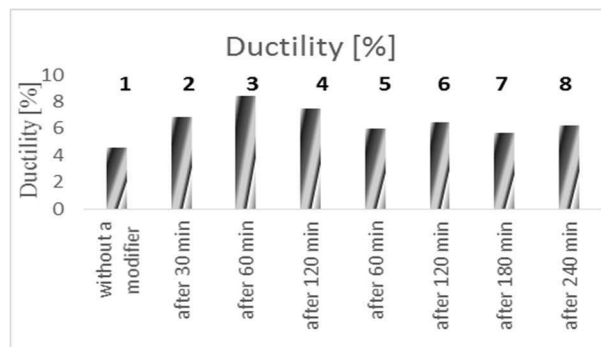
Fig. 16 Comparison of ductility of all materials

1) AlSi7Mg0.3; 2) AlSi7Mg0.3 + Sr (0.04%); 3) AlSi7Mg0.3 + Sr (0.04%); 4) AlSi7Mg0.3 + Sr (0.04%); 5) AlSi7Mg0.3 + Sr (0.04%) + Be (0.15); 6) AlSi7Mg0.3 + Sr (0.04%) + Be (0.15); 7) AlSi7Mg0.3 + Sr (0.04%) + Be (0.15); 8) AlSi7Mg0.3 + Sr (0.04%) + Be (0.15)

Samples A, C, D revealed residuals of the refining salt and the presence of oxides, resulting in a significant decrease in tensile strength: e.g. A - 50 Rm, which is 30% Rm; e.g. C - 81 Rm, which is 60% Rm; e.g. D - 96 Rm, which is 65% Rm of elongation versus experimental samples B, B1, B2, E, F (Table 6).
