Application of the Weld Deposits on Function Surfaces of the Forest Machines Components

Daniela Kalincová, Miroslava Ťavodová, Veronika Ľuptáčíková

Faculty of Environmental and Manufacturing Technologies, Technical University in Zvolen. Študentská 26, 960 53 Zvolen. Slovak Republic. E-mail: kalincova@tuzvo.sk

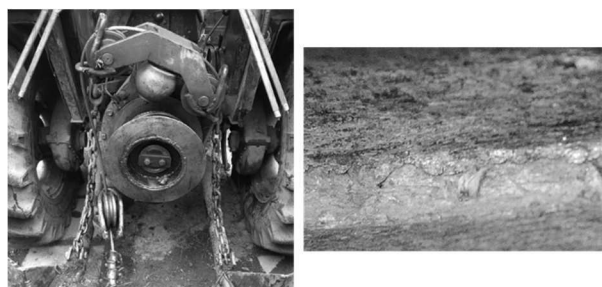
of contact fatigue is degradation of the surface layers, namely the peeling off the layers from surface of the groove, it results to change of its dimensions and premature replacement of the component [3]. Fig.1 illustrates a winding drum mechanism with a directional pulley, however the state of pulley after load in service.

Fig. 1 Winding drum with directional pulley and detail groove pulley after wearing

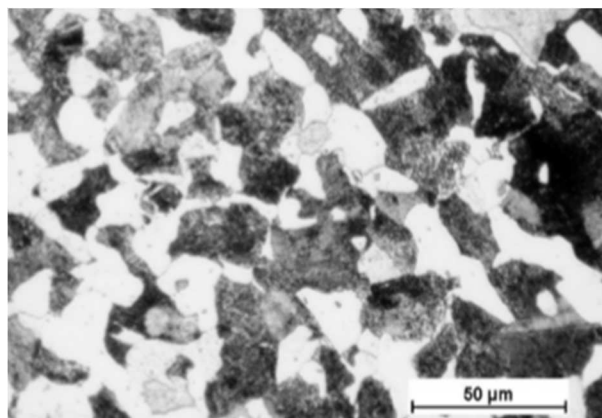
The pulleys are made of structural carbon steels C45E. In Fig. 2 is microstructure of the steel in original state.

Fig. 2 Microstructure of the steel C45E

By input analysis of the pulley - measuring of the material hardness and evaluating its microstructure, we have

found the material is not heat treated and the ferritic-pearlitic structure of the material is not enough satisfactory for abrasion wear resistance and fatigue process on the contact surfaces. The average value of the hardness this steel is 205HB_{2.5/187.5}.

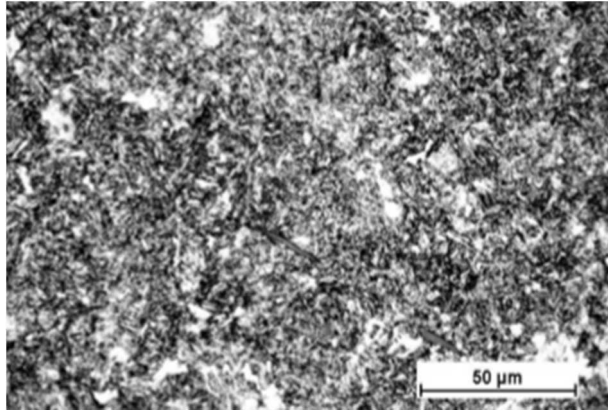
Fig. 3 Microstructure of pulley after hardening and tempering

microstructure (Fig. 3) is formed of the tempered martensite and troostite. We have evaluated of the pulley mechanical properties too. We have tested hardness and toughness of material. The average hardness value after heat treatment of steel is 22HRC ($R_m = 800\text{MPa}$). The toughness of the material in original state and after heat treatment was tested by the Charpy impact test according to standard STN EN ISO 148-1: 2017. The values are as follow: energy for destruction of the samples - material without heat treatment: $K = 18\text{J}$, material after heat treatment: $K = 25\text{J}$.

As the first variant, we have suggested the heat treatment for change of the material microstructure. According to the authors who studied the abrasive wear of the component surfaces according to their structure [4,5,6], higher resistance to abrasion wear have fine-grained structures after heat treatment, than the ferritic-pearlitic heterogeneous structure of the original state. Therefore, as the first step for improving of the pulley material characteristics, we have realised hardening and tempering and then we compared the lifetime of the two pulleys in operating tests. The hardening was done at a heating temperature of 820°C with cooling in oil, followed tempering at temperature of 600°C with cooling in air. The

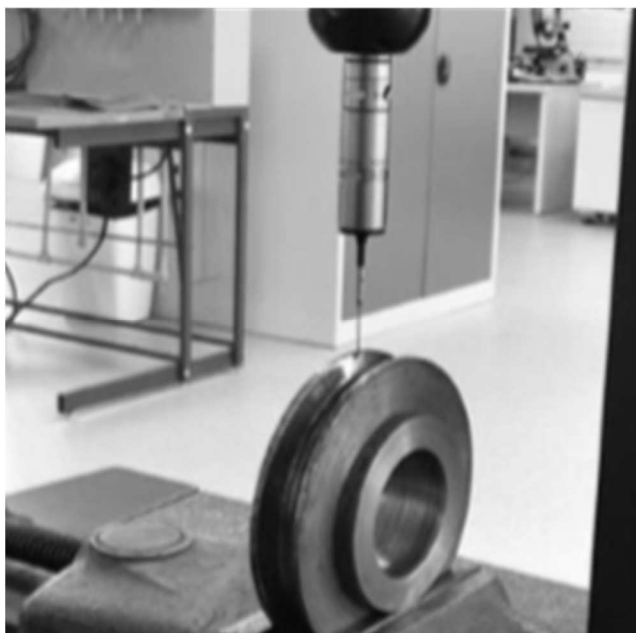
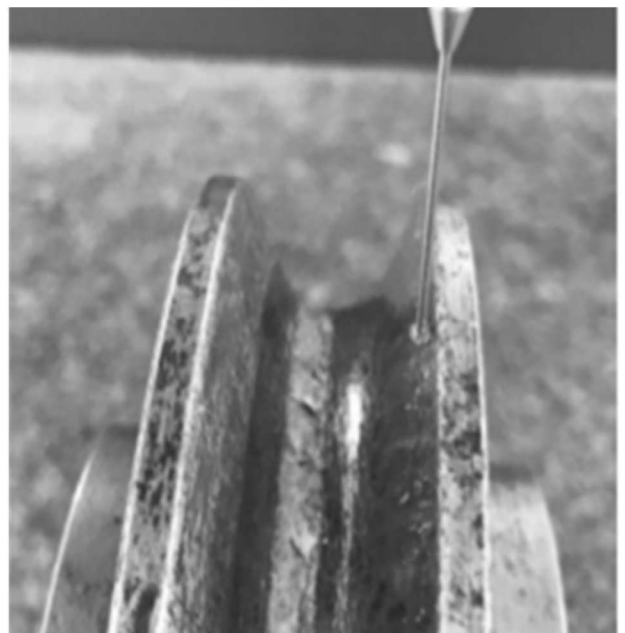
Fig. 4 Measurement of the pulley profile

Experimentally, both pulleys were loaded for 320 hours and then we have compared the measurable properties. Using the weighing method (weighing pulleys on the weight of CAS, AD-1, with measuring range 200g to 30kg and accuracy $e = 10\text{g}$), we found decreasing of material weight after abrasive wear. The weight of the new, untreated pulley - 3810g, the one of the worn, untreated pulley - 3760g, difference - 50g. The weight of the new hardened pulley - 3820g, the weight of the worn hardened pulley - 3790g, difference - 30g. The state of the groove after wear in terms of dimensions and change groove profile of the both pulleys were evaluated by measuring, using the Walter 3D device (Fig. 4). Using of the 3D measuring gives higher accuracy and higher quality of production too [7]. The measurement results are shown in Fig. 5. We can declare, the profile hardening pulley is less worn as pulley without heat treatment.

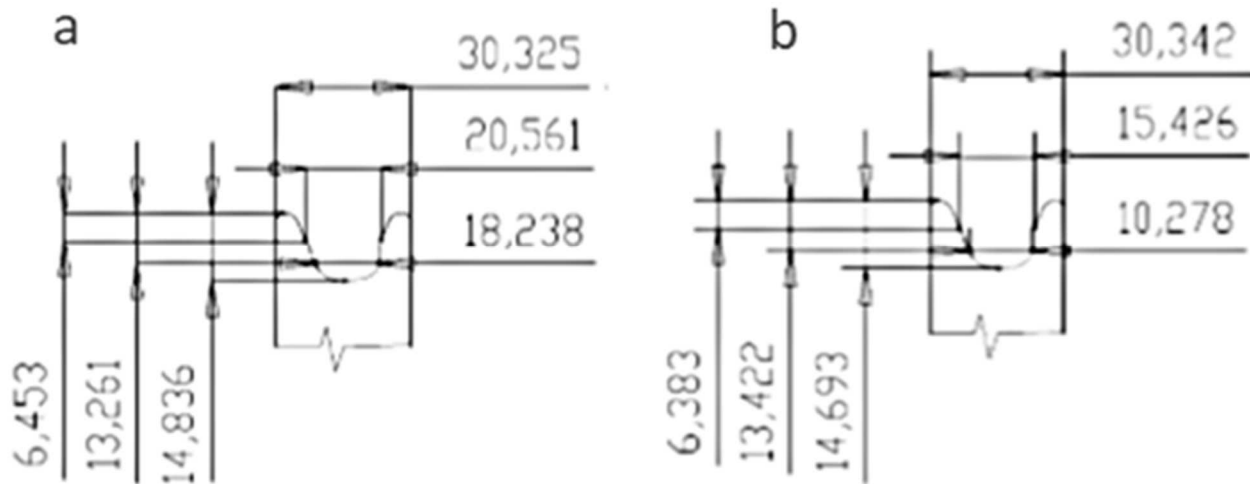
Fig. 5 Diameters of the pulleys groove profile: a – pulley without heat treatment, b – pulley after hardening

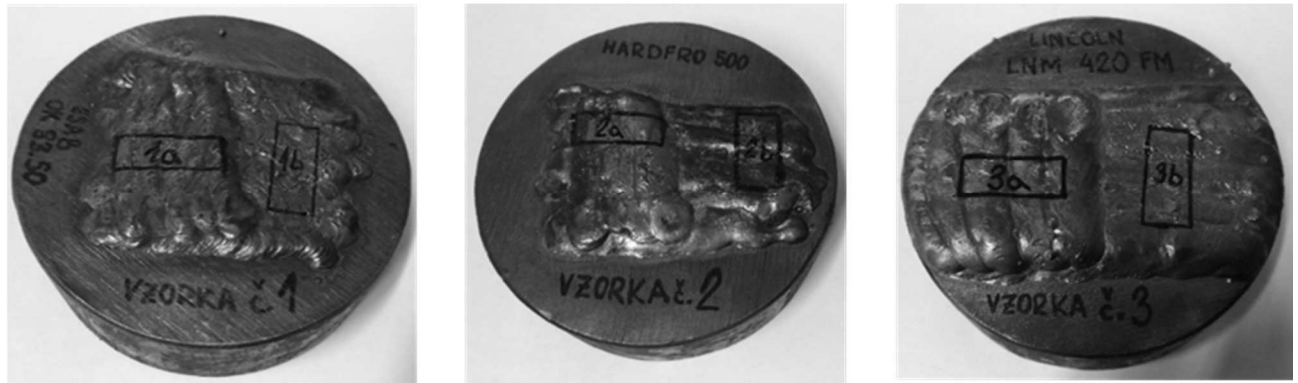
For experiment three types of material to create of the weld deposits were chosen. Those were applied to plate from cross cut of the round rod from steel C45E. The samples are shown in Fig.6.

Sample No. 1 – electrode ESAB OK 83.50, diameter Ø 2.5 mm, manual arc welding

Sample No. 2 – electrode HARD FRO 500 diameter Ø 3.2 mm - manual arc welding

Sample No. 3 – welding wire LINCOLN LNM 420 FM, diameter Ø 1.2 mm, welding semiautomatic – MAG method.

Fig. 6 Samples No. 1, 2, 3 - weld deposits (a-double layer, b- single layer)

Electrode ESAB OK 83.50 is a rutile electrode (content of elements in wt %: 0.40% C, 0.7% Mn, 0.4% Si, 6.0% Cr, 0.6% Mo, rest Fe) for repair of worn parts of earth and agricultural machinery and forestry technique. Preheating of base material - temperature 250°C, hardness of the weld deposit 50-60 HRC, weld deposit is stable to temperature approx. 500°C [10].

Electrode HARD FRO 500 is a basic electrode, is intended to form of the wear-resistant layers (content of elements in wt %: 0.35% C, 0.5% Mn, 5.5% Cr, max. 5% Mo, rest Fe). Hardness of welding deposit is 50-54 HRC.

Welding wire LINCOLN LNM 420 FM - solid wire (content of elements in wt %: 0.5% C, 0.4% Mn, 9.0% Cr, 3.0% Si, rest Fe), is intended for hard wear resistant layers, weld deposit has ferritic-martensitic structure, high resistance to corrosion, abrasion and impact deformation, hardness 55-60 HRC [13].

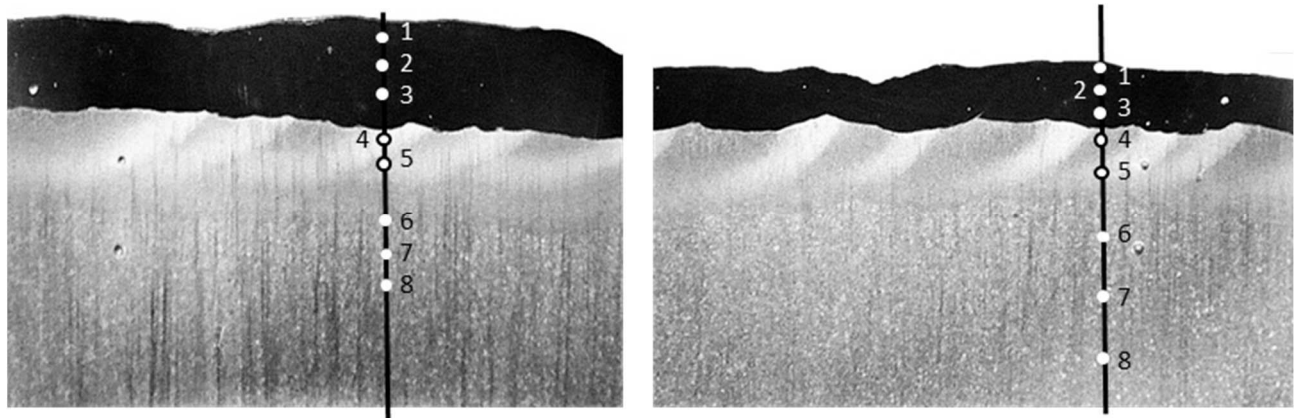
cross-section was done after macrostructure etching. The thickness of weld deposit in the double layer is from 3 to 3.5 mm, the single layer thickness is about 2.5 mm. We have used HV5 method for measurement of hardness according to standard STN EN 6507. There are the places of measurement in Fig. 7. The values are processed in Table. 1 and 2, and displayed in Fig. 8.

Fig. 7 Macrostructure – places of the measurement a) double layer, b) single layer weld deposit

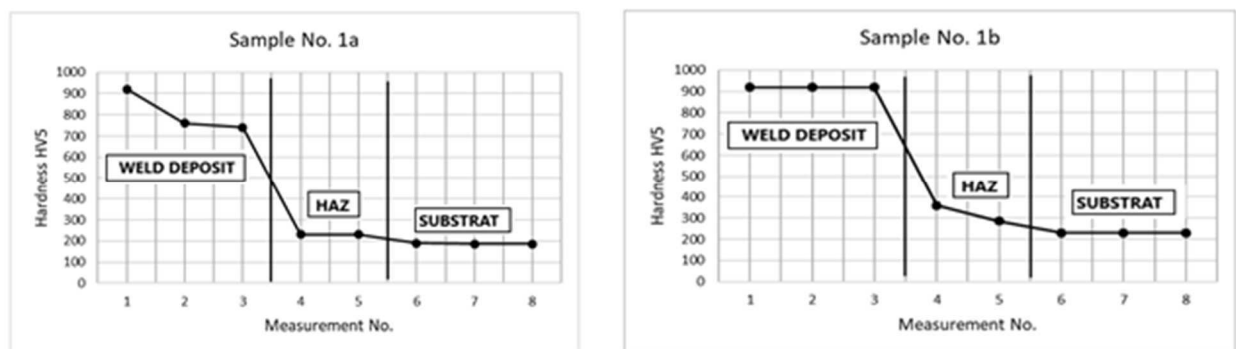
Fig. 8 Graphs - the course of hardness – Sample 1a and 1b

The graph in Fig. 8 - Sample 1a: it can be seen, the hardness values of the double layer weld deposit are 920 - 740HV5, in the single layer one - 920HV5. The lower values in the heat affected zone were found in the double layer weld deposit, because of annealing. All weld deposits (Samples 2a, 2b, and 3a, 3b), have alike values of hardness as is reported by the manufacturer of weld electrodes. On the surface double layer weld deposit (Samples 1a) were measured hardness values from 52 to 54HRC, on the single layer one were measured hardness values

from 50 to 52HRC.

Place	Weld deposit			HAZ		Basic material		
Measurement No.	1	2	3	4	5	6	7	8
Hardness HV5	920	760	740	230	230	190	185	185

Place	Weld deposit			HAZ		Basic material		
Measurement No.	1	2	3	4	5	6	7	8
Hardness HV5	920	920	920	360	285	230	230	230

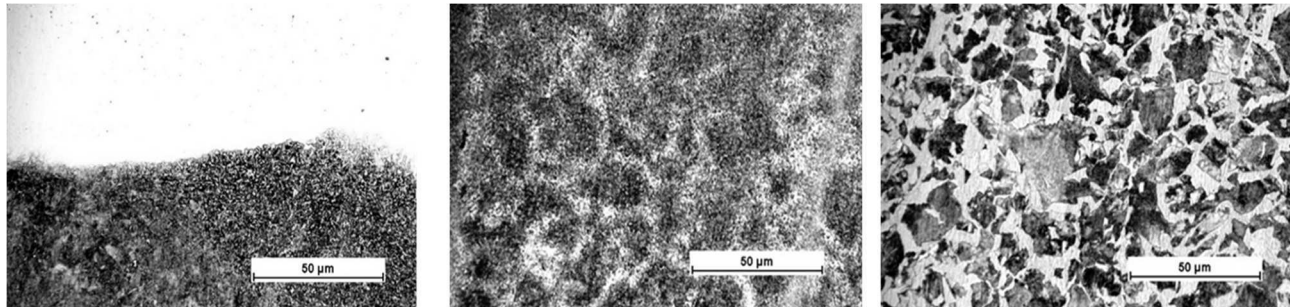
Fig. 9 Microstructure of Sample 1a – melting zone; HAZ - heat affected zone; basic material

There were no errors at the melting zone, there is the slight mixing of the basic material and weld deposit. The weld metal is clean, and does not contain non-metallic inclusions of larger dimensions or cavities. In the HAZ, which was heated to the partial recrystallization area, there is a network of unmodified ferrite and fine granular

perlite. The basic material has ferritic-pearlitic structure, the ferrite is around original austenitic grains.

Samples for microstructure evaluation were prepared as classic, they were etched by the 2% Nital. The structure has evaluated by the light microscope Union Versamet. At evaluating the quality of weld deposits, we have focused on the state of melting zone, metal mixing and weld defects in area, where could be cause defects during load. In Fig. 9 there is microstructure of melting zone - Sample 1a. The weld electrode has a high Cr content, so weld deposit is not etched.

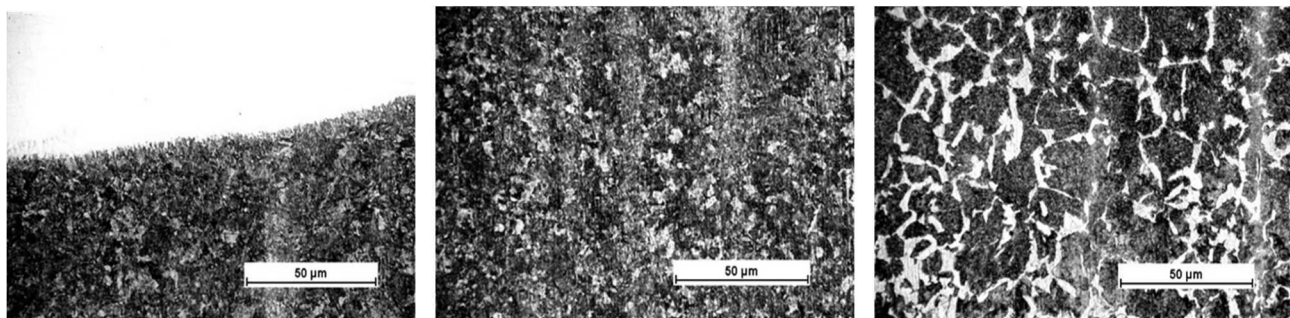
Fig. 10 Microstructure Sample 1b – melting zone; HAZ; substrat

In the melting zone there were a finely mixed materials, there were not inclusions, cavities, as well cold joints in the weld deposit. In the HAZ there is a fine-grained ferritic-pearlitic structure. In the basic material is ferritic-pearlitic structure with a smaller share of the ferrite on the borders of original austenitic grains - Sample 1b. This indicates the heat input during welding was different in the observed samples and it has influenced of the phase transformations during heating and cooling of the basic material.

In Fig. 10 is the melting zone of the single layer weld deposit, HAZ, and the basic material microstructure of Sample 1b.
