## Dependence of the Resistance of the Integrated Layers on the Wear of Ceramic Cutting Tool

The article focuses on the issue of the applied integrated resistance layers. Conductive layers are applied on the non-conductive material of cutting insert made from nitride ceramics. The layer is applied so that the cutting edge and adjacent surface create closed conductive circuit for each cutting edge separately. Throughout turning process come about wear of cutting edge and therefore wear of resistance layer. It results in decreasing of cross – section of resistance layer and increasing values of resistance. The records are carry out after individual cuts. The aim is to find the dependence between the course of wear and the course of electrical resistance during machining ductile iron EN-GJS-700-3.

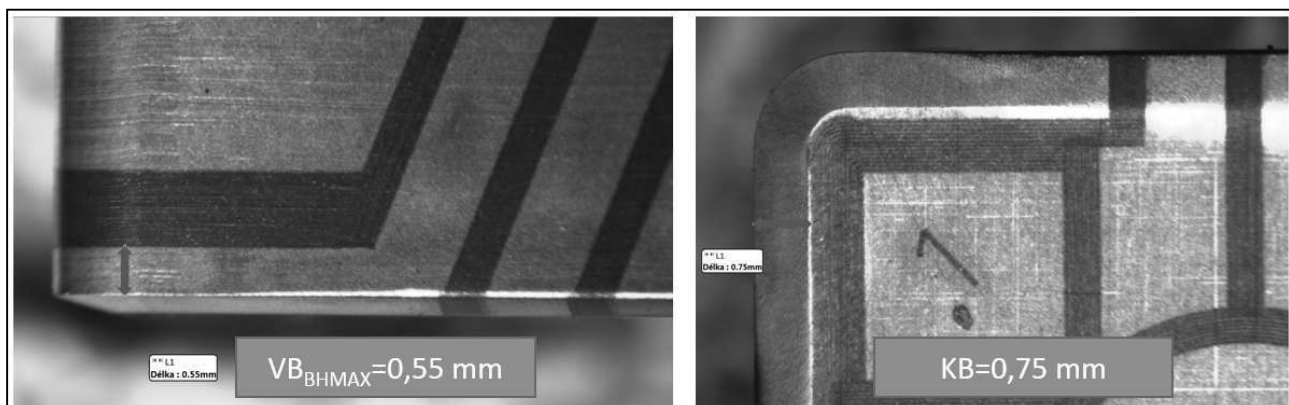
**Fig. 1** Size of the resistance layer on flank and face rake of the insert

Experimental determination of the wear can be measured with the use available methods that are divided into direct and indirect methods. Direct methods contain the method of apply resistance layers. The exchangeable cutting insert is coated very thin resistance layer, which becomes thinner during machining. These layers are based on coatings reaching the tenth of micrometre thickness. When the layer is completely worn, the electrical circuit breaks. Its width on both flank and rake face of insert corresponds to the size of the wear criterion. [5] (see in Fig. 1)

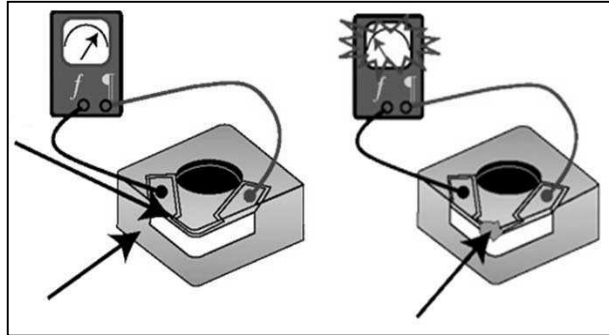
Fig. 2 VBD circuit diagram

process liquid. The electrical resistance, which is recorded all the time of machining, is output of loop. The loop is made up special tool holder with contact and connected

data-logger (Fig. 2). As the wear of resistance layer increases, its surface decreases and electrical resistance increases – reduction of cross-section conductor. When the resistance film is completely removed, resistance value should be show infinity and becomes unmeasurable. The final wear is evaluated on basis of direct microscopic method with the use workshop microscope.

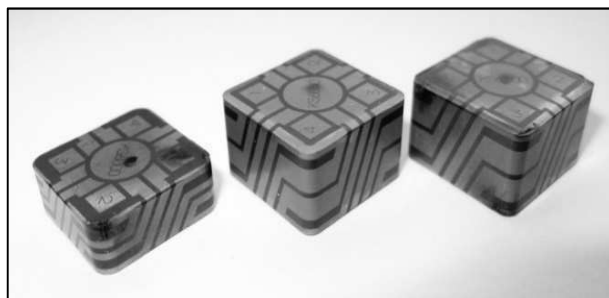
Fig. 3 Ceramics inserts with applied resistance layer

Experimental activity deals with the determination possible dependence between the wear of cutting tool on the electrical resistance during machining process. The resistance layers' titanium nitride (TiN) of thickness 0,3  $\mu\text{m}$  were applied on the insert made from cutting ceramics, marked KS 6000 (see in Fig. 3), which is made on  $\text{Si}_3\text{Ni}_4$  silicon nitride. The insert has very good resistance against mechanical wear of cutting edge and it is suitable used for machining grey cast iron and it is applicable in interrupted cutting process. The resistance layer was removed in certain places by laser technology to avoid creating a separate electrical circuit. The width of individual belt on flank and face of insert defines the amount of wear. On the flank surface is value 0.55 mm and on rake face surface there is value 0.75 mm. The ceramics cutting tools based on silicon nitride are mainly specified for machining of cast iron. When the steel is machined, the affinity can occur and thus destruction of the measurement and the loss of value of the results. This is reason why the machined material was selected ductile iron EN GJS 700. It is material designed for mechanically stressed machine parts dynamically and abrasionally. Its machinability is difficult, and abrasion is high. [6] This material has higher mechanical properties which is desirable for short-term tests of cuttability of exchangeable cutting inserts. It causes faster entrance of the wear of cutting tools. [7, 8]

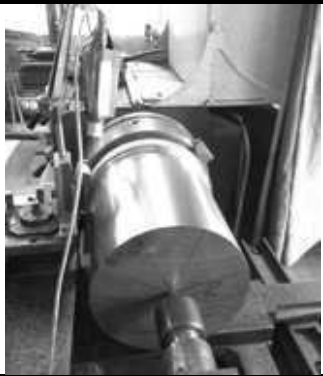
Tab. 1 Design of experiment

From the publications dealing with the issue, it is confirmed that electrical circuit will be cut off when cutting tool is completely cut off. The circuit closes when the tool is cut again. The circuit is again measurable. The tests were realized in condition of the continuous cut. Table 1 describes diagram of testing, the semi-finished product was machined in three cutting speeds, in constant feed rate and cut depth.

Cut	A – full material, continuous cut	
Dimension of semi-finished product	$\varnothing 270 \text{ mm}$ , $L = 295 \text{ mm}$	
Cutting conditions	$v_c [\text{m} \cdot \text{min}^{-1}]$	325, 515, 645
	$f [\text{mm}]$	0.1 mm
	$a_p [\text{mm}]$	2 mm

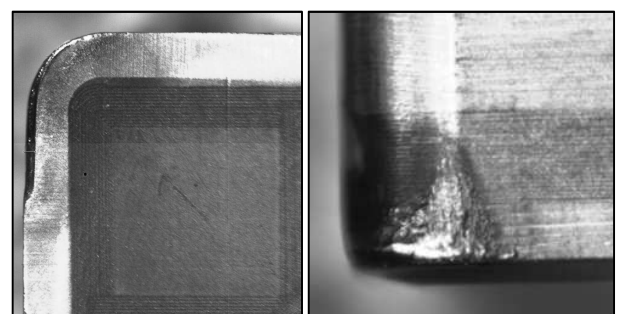
Fig. 4 The wear on rake face and flank of cutting tool

Wear inspection on the cutting tool was realized with the use workshop microscope Intracomicro with digital camera with adequate magnification. The all experiment A1 – A3 didn't achieve critical wear on flank surface or rake face surface, the electrical circuit didn't interrupt. The tests were prematurely terminated because of the inserts breakage and thus damage to the resistance layer. The tested inserts showed especially wear on the flank surfaces as well as on face rake surfaces (see in Fig. 4).

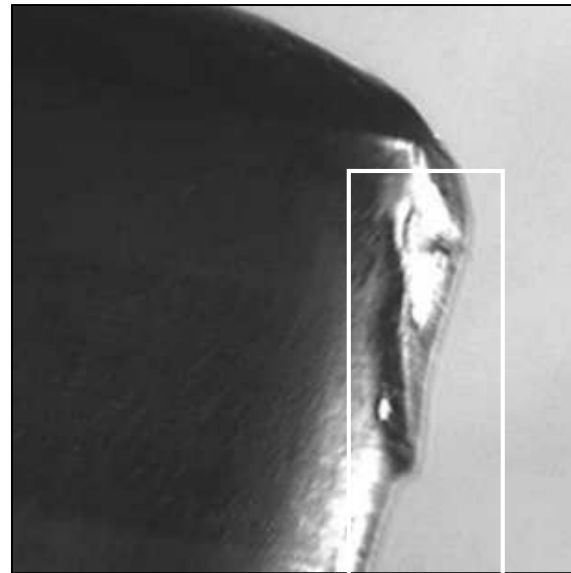
Fig. 5 Applied material layer

The electrical resistance values could be influenced by the resulting layer on the flank surface of cutting tool. There is no loss of cutting material. It could be adhering of material to the surface of insert, known as build up edge (see in Fig. 5). The negative effect of this form of wear distorts the behaviour of resistance layer. From theory of physics is known, that with increasing cross-

section of conductor the resistance decreases. In the case, the resistance decreases due to the influence the increasing volume of the resistance layer. These phenomena caused local extremes in charts and one-time jumps.

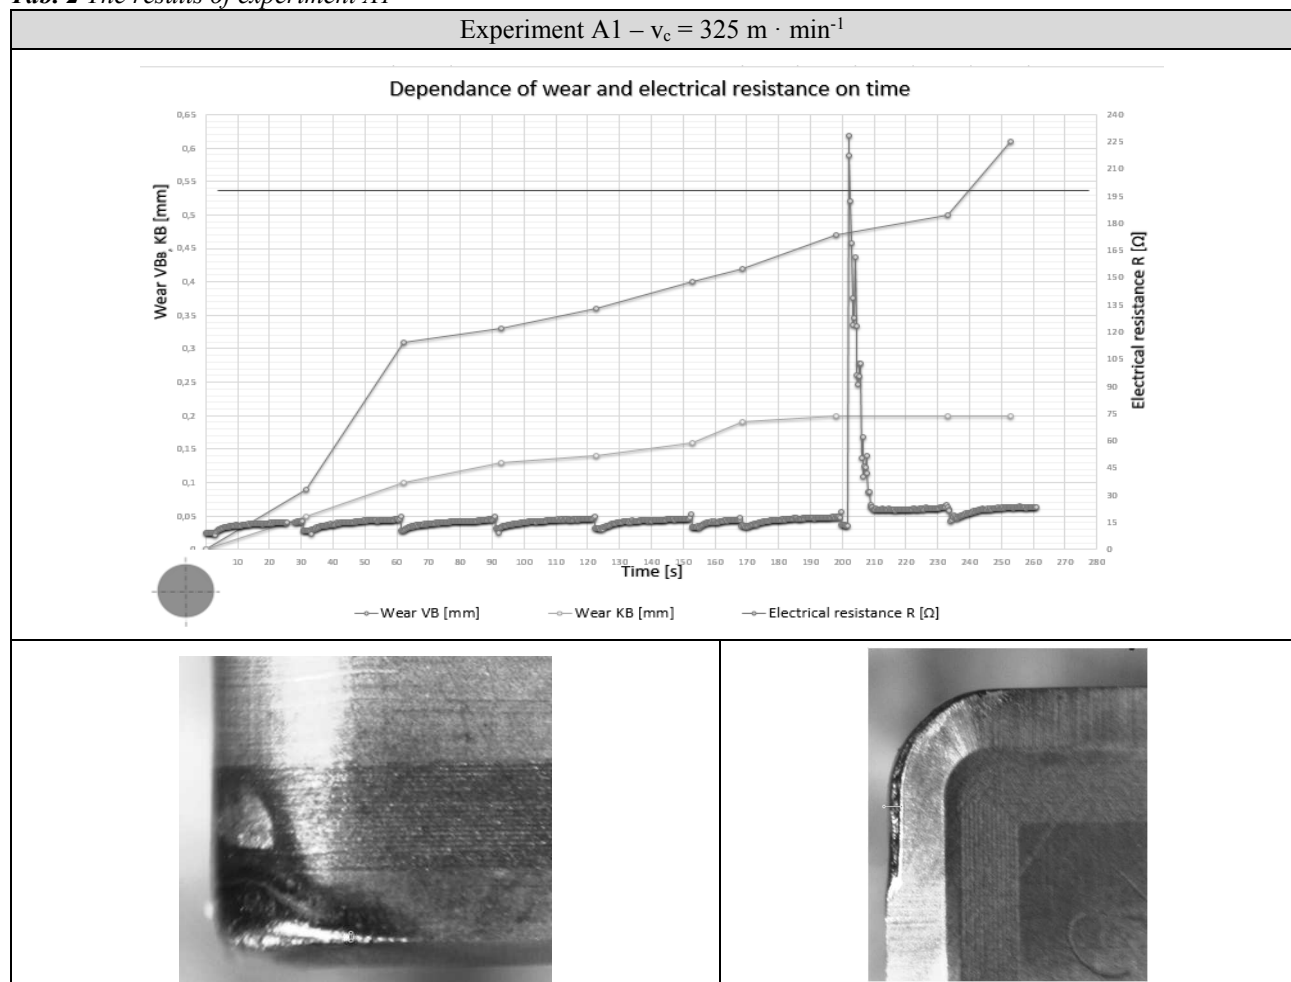
Tab. 2 The results of experiment A1

Machining of ductile iron in condition of interrupted cut had typical process of wear, which confirms theory of machining. In short time interval was achieved sharp increase of the wear, then its linear increase. The machining for the lowest cutting speed caused, that the values of the electrical resistance were between 10 to 16  $\Omega$ . Regular protrusions are caused by exit from the cut and subsequent start of the next machining. In time 201 s there was significant outflow of electrical resistance, and then the resistance stabilized. This deviation is caused by breaking of adhering layer on the flank of cutting tool. Removing of build-up edge caused reduction of cross-section of resistance layer and increasing of values of electrical resistance (see in Tab. 2). Test was finished due to insert destruction.

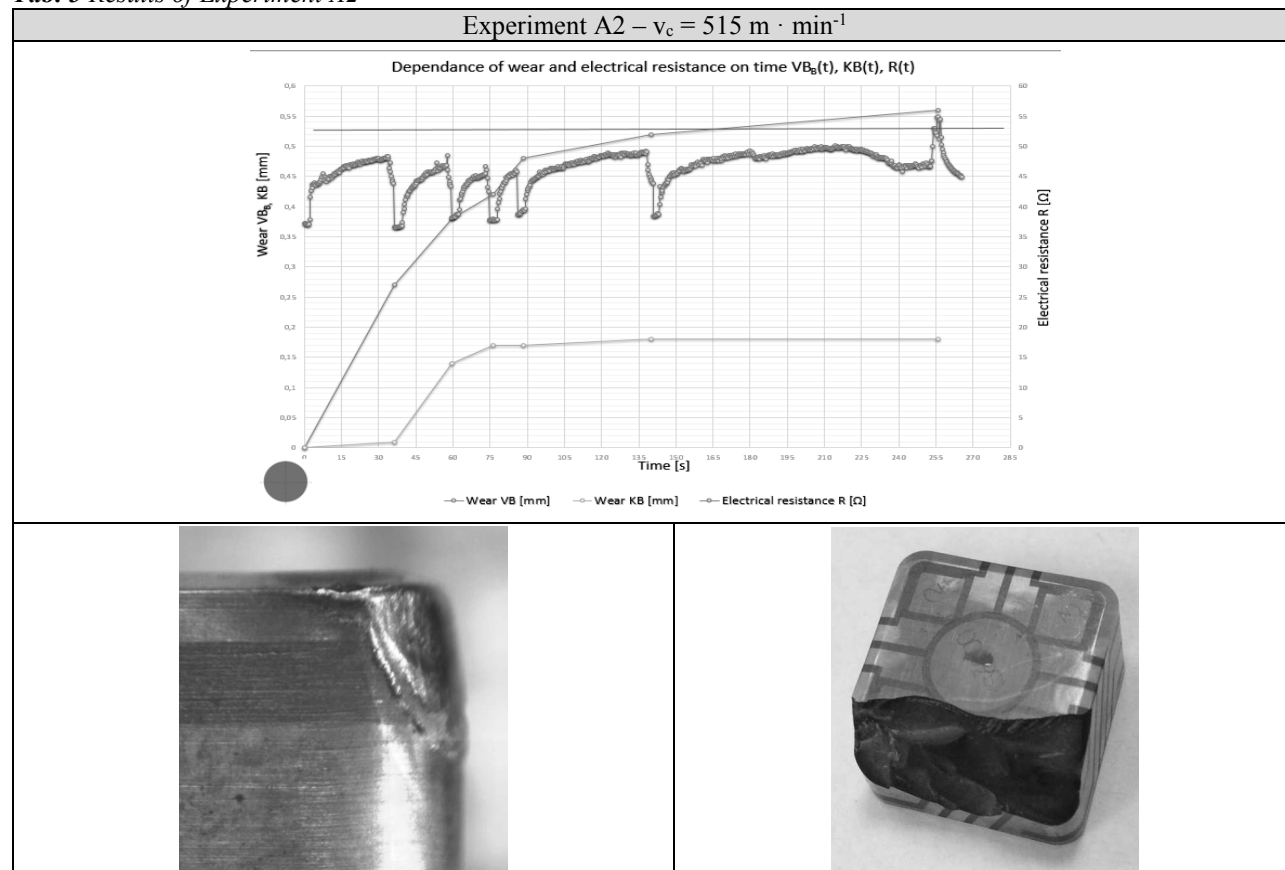
**Tab. 3 Results of Experiment A2**

Flank wear of cutting tool for higher cutting speed ( $v_c = 515 \text{ m} \cdot \text{min}^{-1}$ ) has steep increase, especially at the beginning of turninn. Compared with previous case, there has also been a signifacant increase in electrical resis-

tence. Again, we may see drops caused by ending and beginning of the new cut (see in Tab. 3). At the end of machining there are minor increase of electrical resistance along with the increase of temperature in cutting point. Longer machining time brought damage of cutting edge and test was stopped.

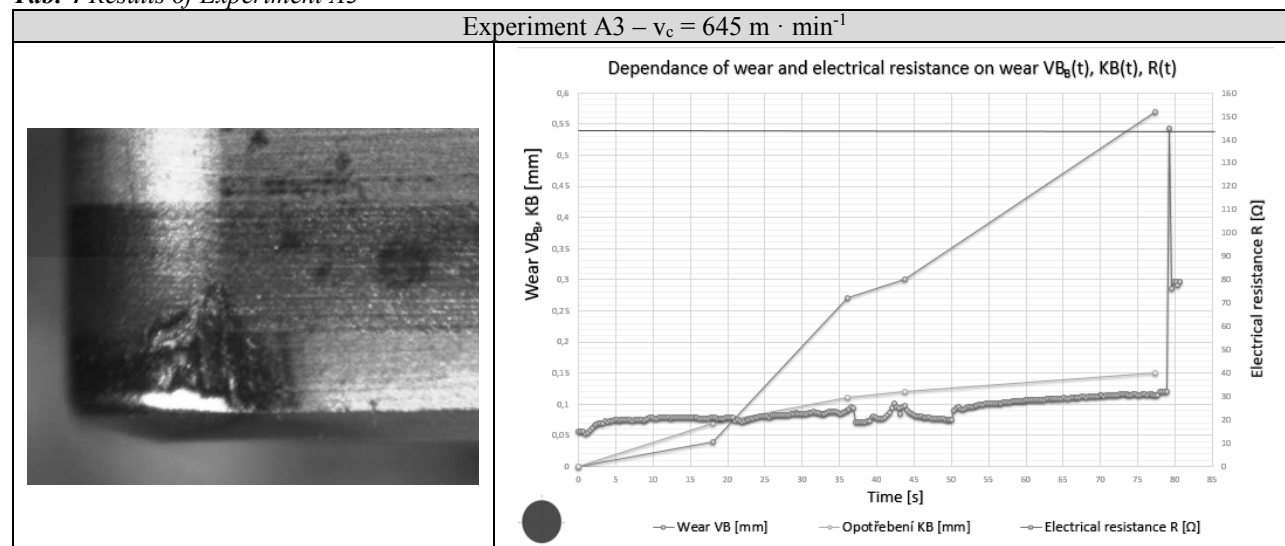
**Tab. 4 Results of Experiment A3**

Test which was realized at the highest cutting speed showed a typical progress of the flank wear with linear increase of values. Continuous wear was measured on the rake face of cutting tool. The resistance layer was covered with build-up edge (see in Tab. 4). The end of machining

was detected sharp deviation of electrical resistance, which was caused by breaking of adhering layer from flank rake. The following process was not stable, because came about gradual destruction of the insert.
