Hydrogen Embrittlement of Ferritic-Perlitic and Martensitic Pipe Steels

This study investigates the susceptibility of two pipeline steels, ferritic–pearlitic CSN 12022 and martensitic L80, to hydrogen embrittlement. Electrolytic hydrogen charging increased the absorbed hydrogen content approximately fivefold in both steels, with the martensitic grade showing higher uptake due to its dense dislocation network and carbide distribution. Tensile tests demonstrated that hydrogen had little influence on yield or ultimate tensile strength but caused a severe reduction in ductility. Elongation dropped from 39 % to 13 % in CSN 12022 and from 25 % to 11 % in L80. Fractographic analysis confirmed a transition from ductile dimple fracture to quasi-cleavage fracture in the hydrogen-charged condition. These findings confirm that microstructure strongly affects hydrogen embrittlement: ferritic–pearlitic steel undergoes a more dramatic relative loss in ductility, while martensitic steel retains higher strength but exhibits significant hydrogen-assisted cracking. The results highlight the importance of considering hydrogen effects in the design and application of steels for energy and gas transpor

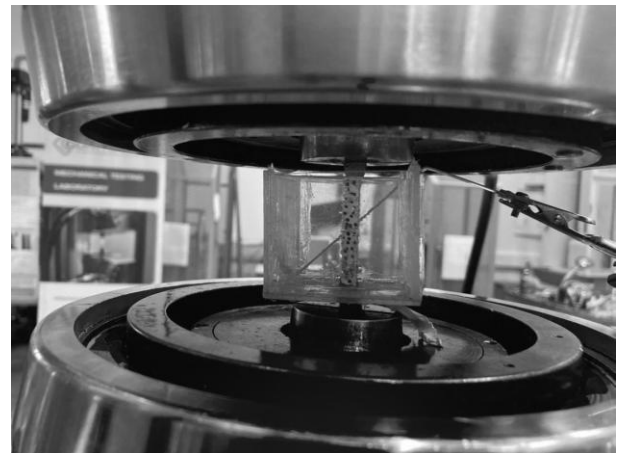
The microstructure was observed on a Nikon Eclipse MA 200 metallographic light-optical microscope. Hydrogen charging of the test specimens was performed by electrolysis. A small plexiglass container was attached around the gauge section of each specimen and filled with electrolyte (Fig. 1). The hydrogen charging process took place directly on the tensile testing machine with hydraulic grips. Charging was conducted for 30 minutes prior to the tensile test and continued throughout the test until specimen failure. The electrolyte used was a solution of 0.1 M H_2SO_4 with an addition of 2 g/l of cyanate. A two-electrode setup was used, with a platinum electrode and a DC laboratory power supply. During the entire test, the electric current was maintained at 0.1 A. One side of the test specimen was coated with a speckle pattern for deformation tracking using the DIC system. The resulting current density was approximately 25 mA/cm². A detailed view of the clamped test specimen with the electrolyte and container just before the start of the tensile test is shown in Fig. 1. The hydrogen content was measured using a Bruker G8 Galileo elemental fusion analyzer.

Fig. 1 Close-up of the container with electrolyte and the clamped test specimen

Tensile tests on hydrogen-charged samples were carried out using the same testing machine as for the initial state. Deformation was measured using the Aramis DIC system (see Fig. 1). The crosshead displacement rate was again set to 0.45 mm/min. A total of

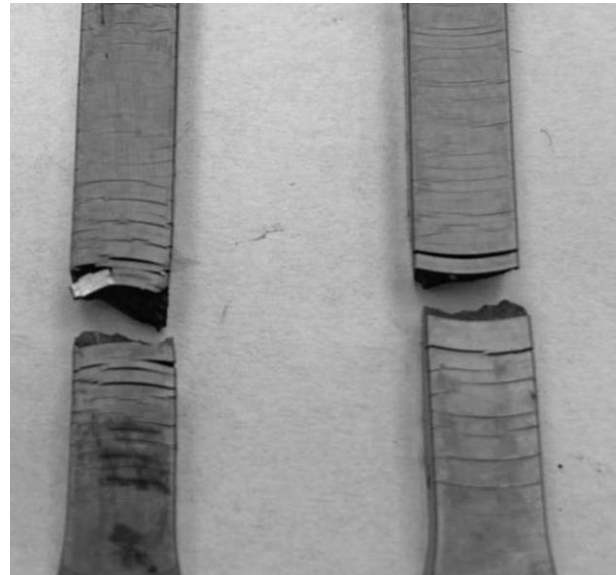
The test specimens after the static tensile test on samples without hydrogen and hydrogen-charged samples at room temperature are shown in Fig. 7 and 8. After each test, the specimen was immediately rinsed with clean water, dried with a hot air gun, and then preserved with WD-40 oil to prevent corrosion of the fracture surface and specimen surface. In the L80 specimens, a large number of cracks were observed in the necking area (see Fig. 9) suggesting a high brittleness of the hydrogen-charged martenzitic steel.

Fig. 9 Close-up of the fracture area of the L80 test specimens

Fractographic observations further support these conclusions, showing a transition from ductile dimple fracture in uncharged samples to quasi-cleavage fracture after hydrogen charging. While both steels exhibited this transition, the martensitic grade displayed more frequent secondary cracks in the necking area, consistent with hydrogen-assisted cracking reported in pipeline steels [15, 16]. These results underline that, despite its higher strength, the martensitic steel L80 is not immune to hydrogen embrittlement and in fact may show higher sensitivity than the lower-strength ferritic-pearlitic CSN 12022.
