Changes in Steam Pipeline Properties after Long-term Exposure

Jaroslava Svobodova, Libor Benes, Jaroslav Brabec

The article deals with a practical problem solution of the steel 15 128 steam pipeline properties change after prolonged exposure. Steam pipelines made of steel are stressed for a long time at higher temperatures and pressures and under conditions that are not constant throughout the pipeline operation. During operation, it occurs in the degradation processes, which are accompanied by changes in structure and mechanical properties. In terms of mechanical properties, it is mainly important the impact strength. The paper examines steam pipeline after long-term exploitation and results from microstructure evaluation, fractographic analysis, and comparison of impact strength test results.

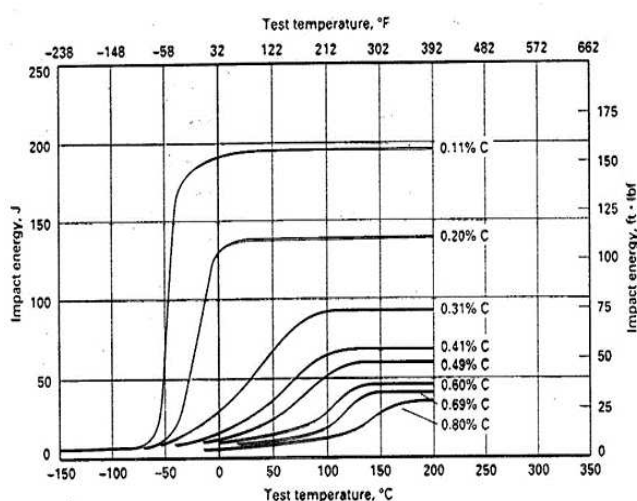
Fig. 7 Dependence of impact strength on temperature for carbon steels in normalized annealing state

If the criterion for determining the transition temperature from brittle to the ductile state taking 50% portion of cleavage facets on the fracture surface, then we can determine the transition temperature of this steel after given exposure to approx. 42 °C. This temperature is in good agreement with the KCU3 criterion with a required value of 50 J.cm⁻², Figure 1, where the transit temperature was determined approx. 40 °C. The measured impact strength samples values of 15 128 steel after heat treatment are in good agreement with the published values for carbon steel with 0.2 % C in the normalized state, Figure 7.
