## Microscopic Wear Analysis of Indexable Inserts after Machining of 34CrNiMo6 Steel

Machining is an important part of the manufacturing process in the engineering field. Turning is one of these areas. At present, almost exclusively exchangeable cutting inserts are used in production machining. The article describes the research in the field of their wear, where the electron microscopy was used to evaluate the results. Electron microscopy is a very important aid in research in many areas not only of human activity and also is the important aid in the field of mechanical engineering and manufacturing technologies. The results thus obtained can make in a given area it clearer and better document the resulting situation. Within the experiments, selected cutting inserts (WPP10S, WPP20S) were used and the given material was machined (34CrNiMo6 steel). The cutting speed was different depending on the type of insert (WPP10S 120 and 140 m·min<sup>-1</sup>, WPP20S 80, 100 and 120 m·min<sup>-1</sup>). The electron microscope Tescan Vega 3, which is available in the workplace where the experiment was conducted, was used to evaluate the resulting tool wear. As part of experiments was also rea

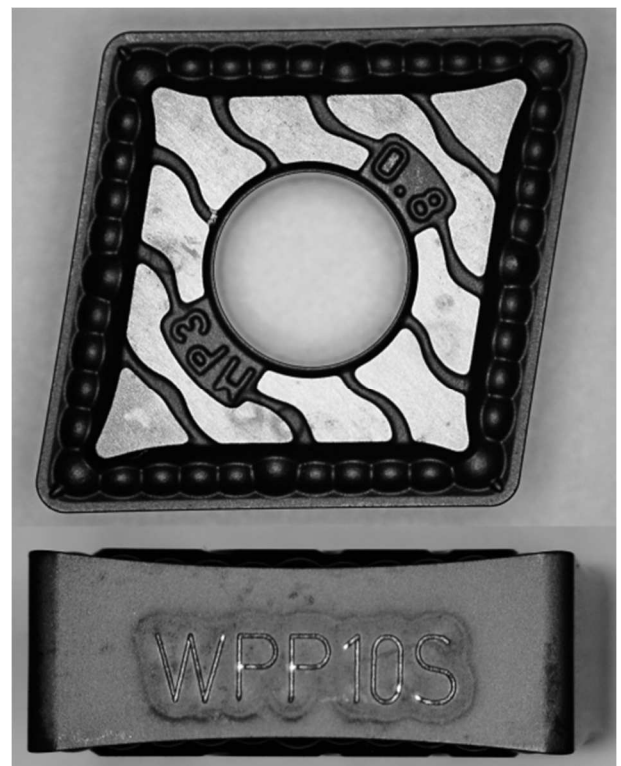
**Fig. 3** WPP10S insert

Fig. 3 shows cutting insert WPP10S, Fig. 4 shows an EDS analysis of this unused insert and Fig. 5 shows EDS analysis fracture of this insert. The bottom coating of 11 µm thickness was formed by TiCN according to EDX analysis. The top coating consists of Al<sub>2</sub>O<sub>3</sub> and is 8 µm thick. [23, 24]

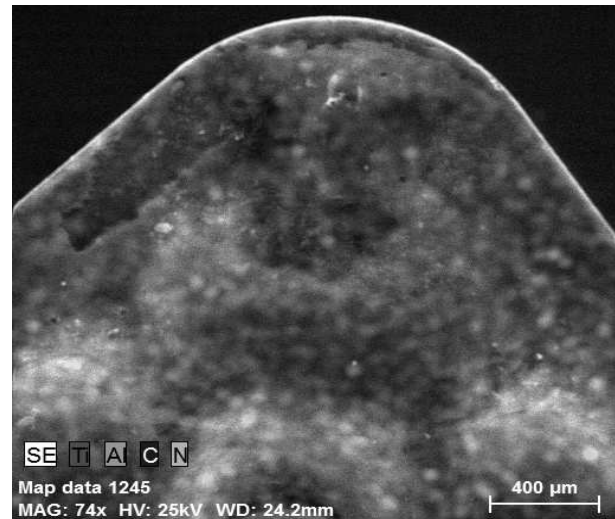
**Fig. 7** EDS analysis, unused WPP20S (front)

Fig. 6 shows cutting insert WPP20S, Fig. 7 and 8 show EDS analyzes for this insert, again showing that the substrate is composed of tungsten carbides, titanium carbides, and cobalt binder. The bottom coating then has a thickness of 18  $\mu\text{m}$  and is made up of TiCN. The topcoat from  $\text{Al}_2\text{O}_3$  has a thickness of 15  $\mu\text{m}$ .
