Analysis of Fractured Weldment of Hadfield Steel

This contribution is divided into two sections. The first one deals with identifying the cause of fracture in a ring, which fractured after weld surfacing. Optical and scanning electron microscopy and hardness testing were employed. Chemical composition was determined using the GDOES and EDX methods. Although weld surfacing has led to fracture in the base material, the actual problem was in the inadequate microstructure of the base material. Microscopic analysis revealed that it was heterogeneous. It contained distinctive segregation bands with bands of complex carbides and pearlite colonies, which are undesirable. The microstructure of this steel should be fully austenitic. In order to remove the heterogeneities, solution annealing was proposed and carried out successfully. The second section of this paper explores the options for revealing the microstructure of Hadfield steel. Etching reagents from the literature and authors' experience were put to test.

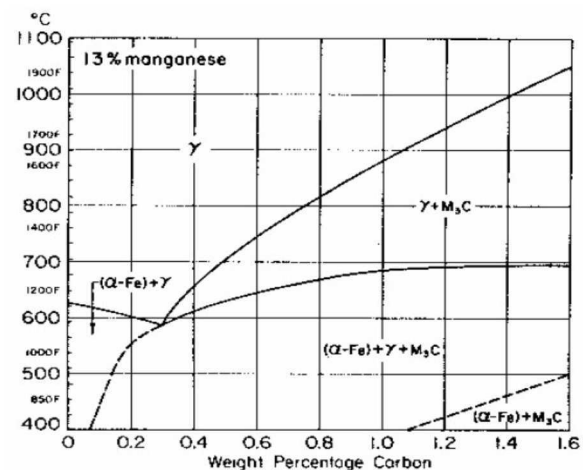
Fig. 3 Section through the Fe-C-Mn ternary diagram for 13% Mn [8, 9].

Microstructure observation was another step in the investigation. When analysing the microstructure, one can refer to the Fe-C-Mn equilibrium diagram for 13% manganese level, which is shown in Fig. 3. At higher temperatures, homogeneous austenite is present in the entire cast part. When temperature decreases very slowly below A_{cm} , binary carbides $(Fe,Mn)_3C$ precipitate as envelopes around austenite grains. In addition, the carbides often form in interdendritic regions. They may also grow as needles into the austenite phase. The silicon content and the time at temperature play an important role here. Silicon reduces solubility of carbon in austenite, leading to precipitation of carbides. At silicon levels above approx. 0.8% wt., carbides grow more rapidly. The steel then exhibits a behaviour which is normally associated with higher levels of carbon. By contrast, at less than 0.3% wt. Si, the temperature of carbide formation may decrease. Eventually, carbides may take the form of needles within austenite grains. The longer the time at temperature, the greater the number of needles. The needles grow from the phase interface between austenite and carbide envelopes

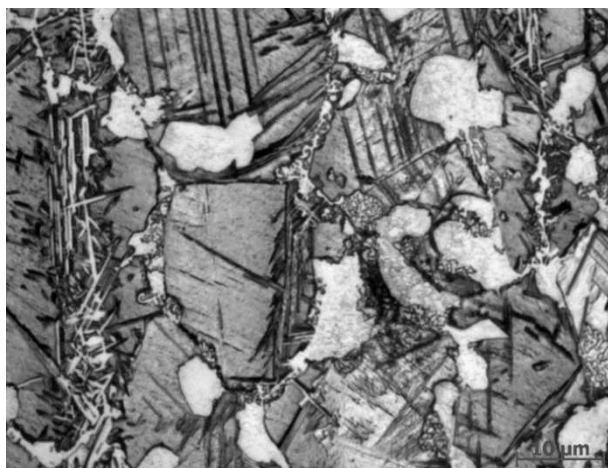
Fig. 8 Microstructure upon etching with Adler's reagent

Adler's reagent is recommended for etching high-alloy and corrosion-resistant steels and cobalt and nickel alloys [10]. As seen in Fig. 8, this etchant highlighted austenite grains, carbides along grain boundaries and carbide needles in the grain interior. Pearlite colonies were revealed incompletely. A solution that consists of 50 ml HCl + 25 ml C_2H_6O + 0.1 ml H_2O_2 is excellent for revealing fully-austenitic microstructure [6]. A microstructure revealed using this etchant is shown in Fig. 9. Almost all microstructural constituents were highlighted, except for

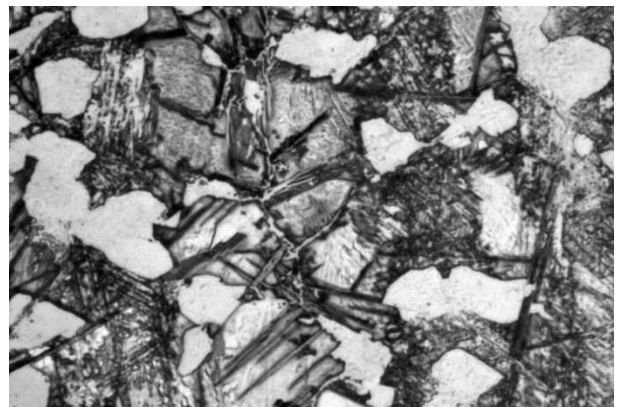
Fig. 9 Microstructure after etching with 50 ml HCl + 25 ml C_2H_6O + 0.1 ml H_2O_2 .

pearlite colonies. Klemm I is used for etching unalloyed or low-alloy steels, cast iron, manganese steels and zinc and its alloys [10]. It was chosen for its ability to highlight manganese segregation. The result is shown in Fig. 10. The shade of colour of the segregation band differs from the surroundings, probably due to an oxide film. With this reagent, the other microstructural constituents became visible as well. Murakami's reagent is mostly used for etching tungsten, tungsten-nickel alloys and for chromium steels [10].

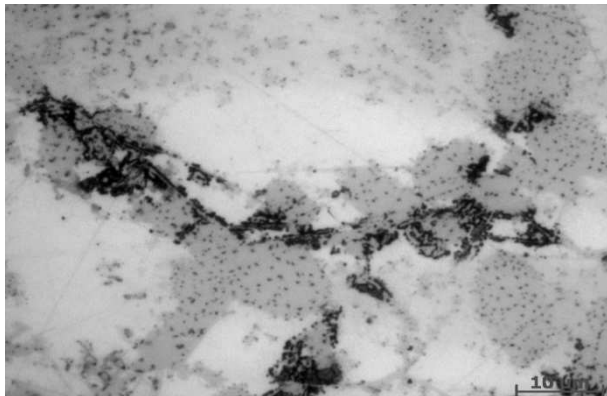
Fig. 11 Micrograph after etching with Murakami's reagent

The reason for choosing this etchant was the ability to reveal chromium carbides, Fig. 11. The etch highlighted grain boundary regions with carbides. However, they were identified by EDX analysis as manganese carbides

and not chromium carbides. The grey regions were probably pearlite colonies. Nital is the most commonly-used etching reagent for steels. Most often, these are carbon and low-alloy steels. A nital-etched microstructure is shown in Fig. 12. All microstructural constituents were revealed successfully. However, the use of nital on this steel leads to an oxide film. The film can be removed by swabbing with or immersing in 10% HCl solution [3]. Vilella's reagent is used for etching ferritic chromium steels, austenitic chromium-nickel steels and austenitic cast steels [10]. An example of a microstructure etched with this reagent is shown in Fig. 13. Except for poorly-resolved pearlite colonies, all microstructural constituents are visible [11, 12, 13].
