Analysis of Al-Si Layer on Steel Sheet during Thermo Mechanical Processing Using Microscopic Methods

Sylvia Kusmierczak, Michal Slavik

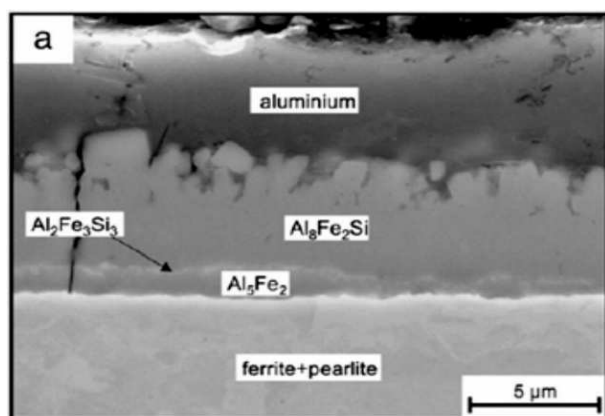
In Fig. 1 it is possible to see the interface of the surface layer AlSi10Fe3 and the steel 22MnB5, which contains several transition layers. The total thickness of AlSi10Fe3 is $30\mu\text{m}$. After hot pressing (conditions: $T_{\text{AUS}} = 920^\circ\text{C}$, $t_{\text{AUS}} = 6\text{ min}$, cooled in the tool) it is characterized by a

martensitic microstructure 22MnB5 addition ($10 \div 12$) micron thin layer of Al-Si enriched Fe_α incurred during the diffusion of Al at austenitizing 22MnB5. Direct correlation shows that the more diffuse the Al into the steel, the Al-Si layer enriched Fe_α stable on cooling and does not change to martensite. AlSi10Fe3 is characterized by the fact that fragile intermetallic phases of the Al_xFe_y type ($\text{Al}_{13}\text{Fe}_4$, Al_5Fe_2 , Al_2Fe and AlFe) are generated, and the most important ones are shown in Fig. 2. In the surface layer there is a particularly fragile intermetallic phase Al_5Fe_2 , which has low fracture toughness ($1 \text{ MPa}\cdot\text{m}^{1/2}$). The formation of brittle intermetallic phases promotes the initiation and propagation of cracks during forming [6-8, 11].

Fig. 1 The interface between 22MnB5 and AlSi10Fe3 after thermal spraying [6]

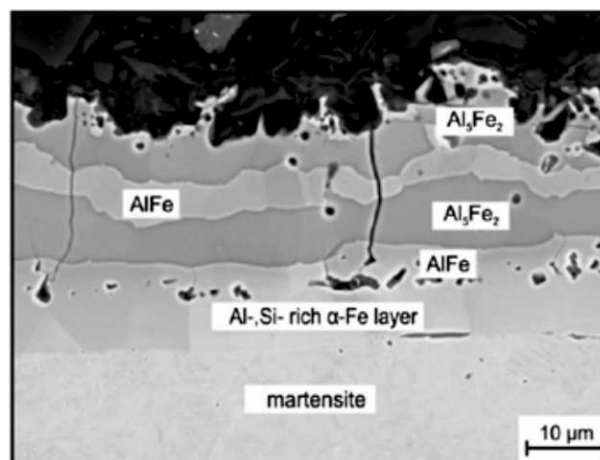
Fig. 2 Interface between 22MnB5 and AlSi10Fe3 after hot pressing [6]
