Degradation Structures of the Steels Applied in Energetics

Keywords: Degradation, Steels, Energetics, Microstructure, Carbides

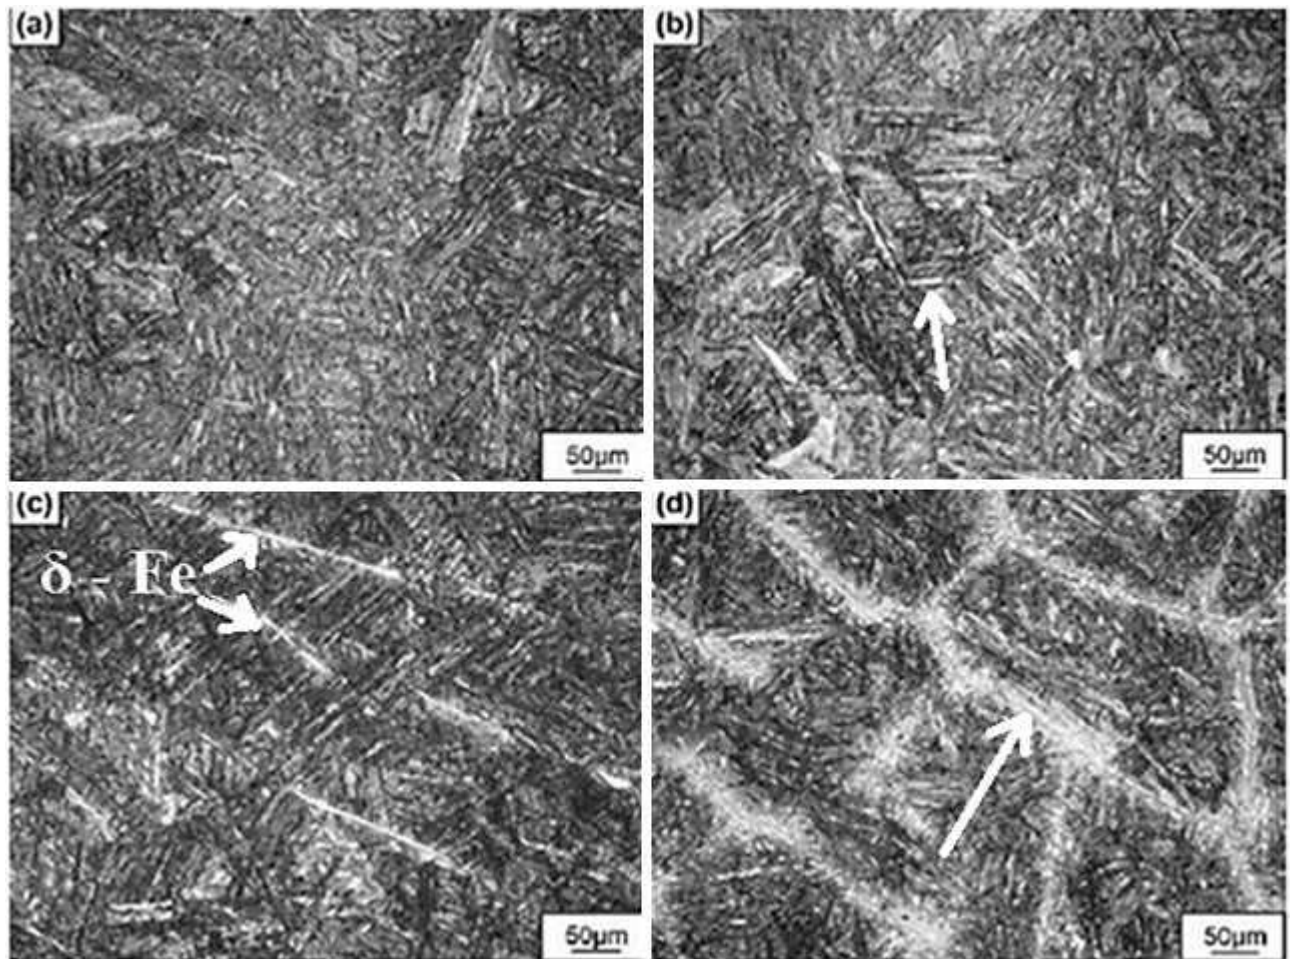
With the presence of δ ferrite in the structure of low-carbon martensitic anticorrosive steels due to degradation processes it occurs to the significant increase of the transit temperature and the change of failure mechanism (ductile - brittle). The character of the structure with different amount of degradation is shown in Figure 2 [2-4].

Fig. 2 The stages of the low-carbon martensitic anticorrosive steel structure degradation (a) tempered martensite, (b) elementary stage of degradation, crystallographically oriented thin needles of δ ferrite in the tempered martensite matrix, (c) advanced degradation stage, crystallographically oriented coarse needles in the tempered martensite matrix, (d) final stage of degradation, line network of δ ferrite along the elementary austenitic grain boundaries

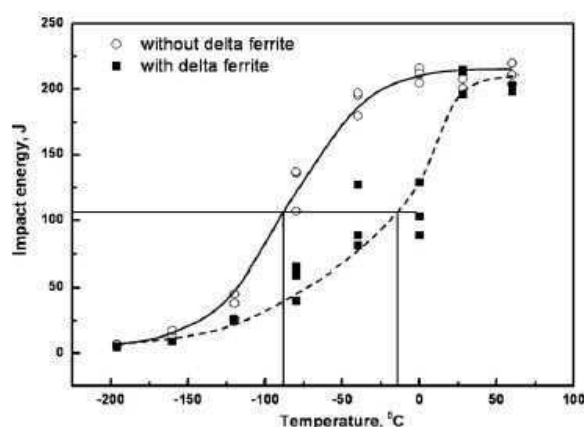
Fig. 3 The effect of the δ ferrite on the impact resistance [2]

The effect of the δ ferrite on the impact resistance of the anticorrosion low-carbon martensitic steel 13Cr4Ni with a significant shift of the transit temperature to the plus thermal zones is shown in Figure 3.

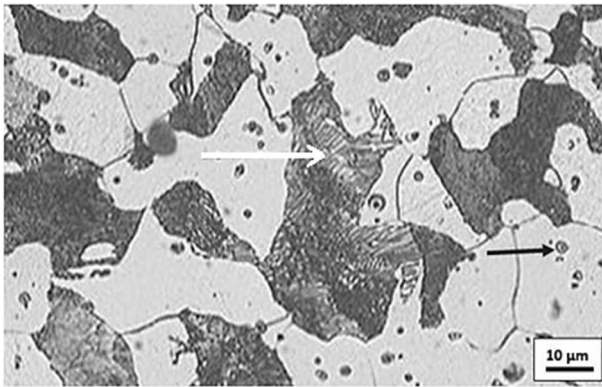
Fig. 4 15 128 steel structure character, initial state

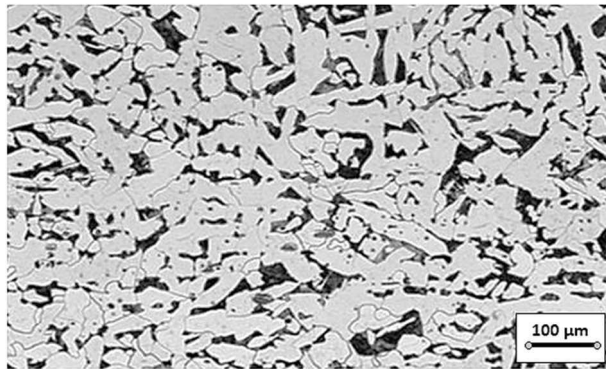
The boiler overheaters, in whose construction are applied steels 15 111, are also a part of the heat energetic equipment. They are supplied in state after normalization at temperatures 960 - 990°C and tempering at temperatures 650 - 730°C. If in the exploitation process of this pipelines occur to the temperature overrange above the A_{c3} temperature of this steel, the following cooling from this temperature causes bainitic transformation, degrading the original structure. The effect of this transformation is the significant reduction of the steel plastic properties and creation of the surface cracks. Figure 9 presents the original structure, Figure 10 shows the structure after bainitic transformation - upper bainite. The next Figure 11 documents the detail of upper bainite structure and on the Figure 12 are surface cracks incurred in the consequence of the initial ferritic-pearlitic structure degradation to the upper bainite [8, 9].

Fig. 9 15 111 steel structure character, initial state

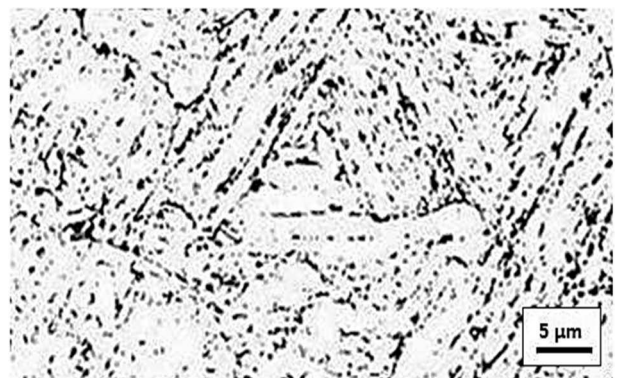
Fig. 13 17 119 steel lamellar martensitic structure

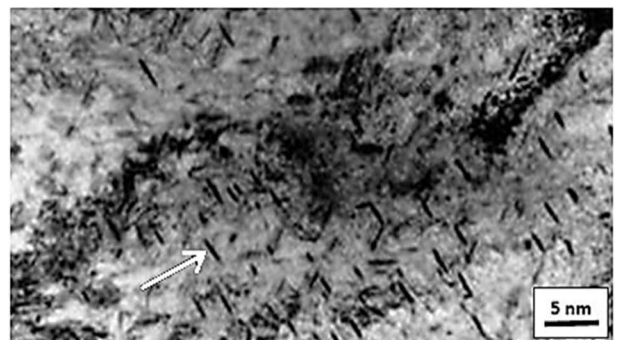
Fig. 14 Crystallographically oriented carbides in 17 119 steel martensitic plates
