## Experimental Measurement of Defects Propagation for a Passenger Car Tire Casing under Dynamic Loading

The given paper deals with the defects propagation in car tires for passenger vehicles under dynamic loading. The occurrence of defects has the significant influence on the lifetime and quality of the tire, especially during its operation as a part of the vehicle. The given defects are closely connected with a safety in road traffic. The aim of the study was to carry out a non-destructive analysis of the car tire for the purpose to analyze the defects propagation as well as to introduce the defects classification and their location along with the whole course of rupture as a result of increasing speed, loading and the number of hours or kilometers driven. During the analysis, we used a non-destructive method for detecting defects using a non-destructive analyzer that works on the principle of shearography. The experimental measurement was carried out for 12 car tires. The measurement results are displayed from the non-destructive analyzer in the form of protocols from measurement and video display. The evaluation of the results of the measurement for the propagation of defects

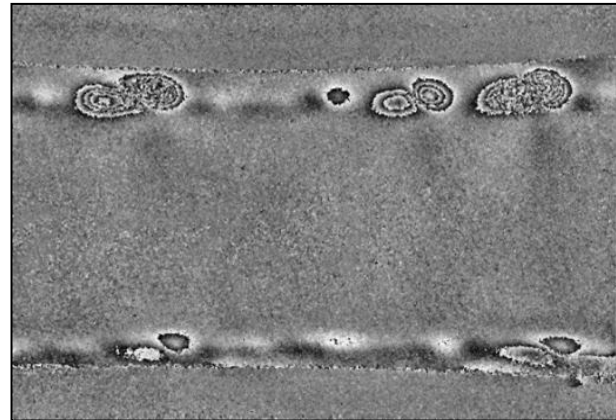
Non-destructive analyzer enables us to recognize the tire structure defects quickly and easily – it is connected with closed separations (Fig. 4), the propagation of which is going to be observed by the dynamic test. For the tire impurity searching and the tire control, the charge-coupled device, which uses simple cycle scanning, is utilized as one of the integral and important parts and it can be seen in the Fig. 5.

**Fig. 4** The defect – monitor display

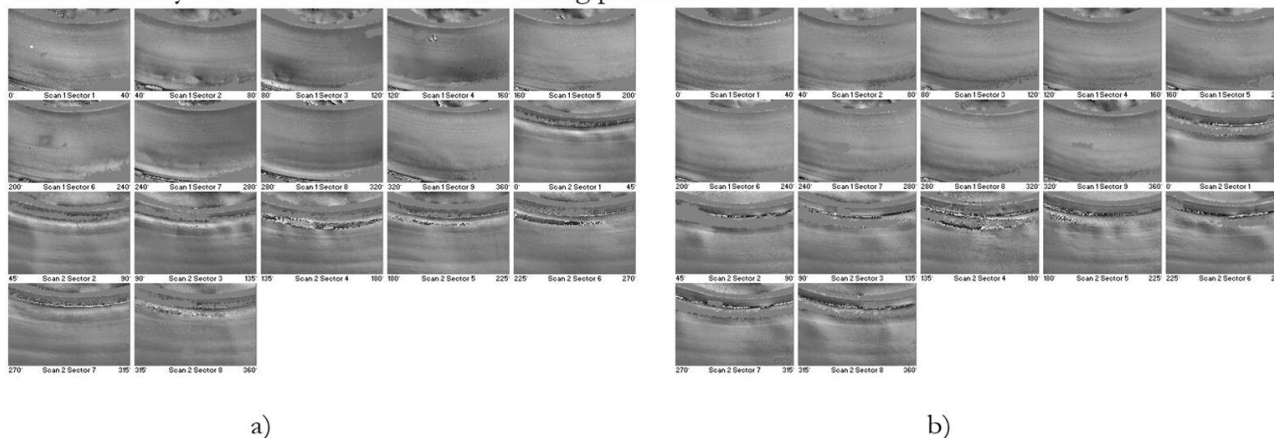
During the first testing, when the casing had not been subjected to any test yet, the defects were not detected in the casing with the non-destructive analyzer (Fig. 27). Subsequently, the given casing was further tested, using a 75 kN drum fatigue testing machine. After 20 hours, the first small local defects in the shoulders started to occur in the casing (Fig. 28).

**Fig. 27** The first measurement of V001 tire – before the dynamic test, using the serial interferometric diagnostics; (a) Serial side (with DOT designation), (b) Non-serial side (without DOT designation)

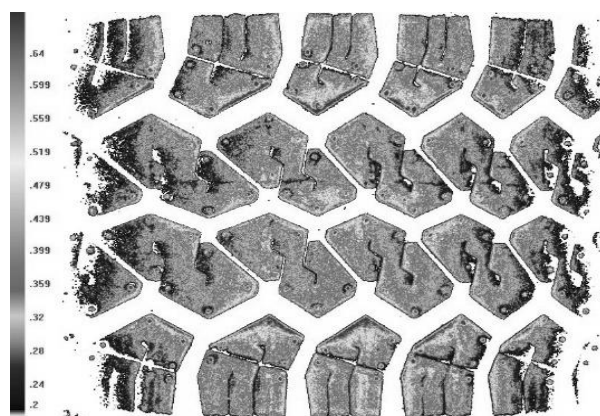
The tire loading was 14 225 N and inflation was 575 kPa. The average specific tire pressure was 353 kPa.

**Fig. 32** The tire footprint for V001 tire – before the dynamic test

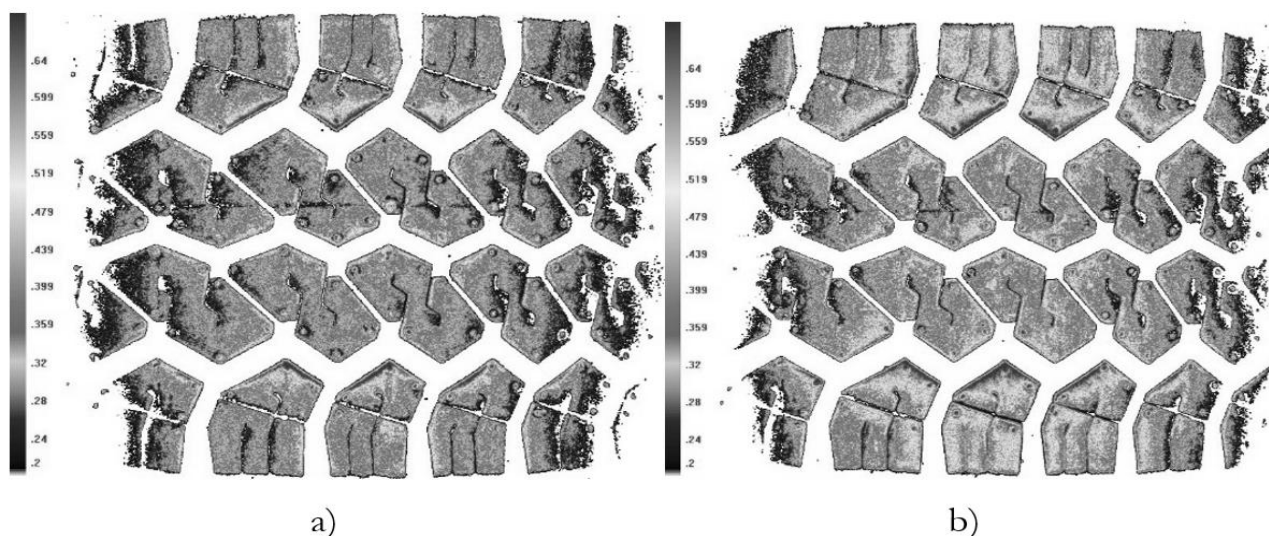
**Fig. 33** The tire footprint for V003 tire; a) before the dynamic testing, b) after 20 hours of dynamic testing

The tire loading was 14 225 N and inflation was 575 kPa at average specific tire pressure. Before the testing, the average specific tire pressure for V003 was 343 kPa and after the in-service for 20 hours the average specific pressure was increased to 390 kPa.

for 800 km, the pressure distribution was changed. The pressure was increased at the crown area as well as at the area of the outermost tread profiles. This was the typical behavior for all tire variants except for V008 and V009, where the pressure was higher before the test than after the test. From this distribution of pressures, it can be assumed that shoulder defects can occur during in-service and that the highest wear can occur in the outermost tread profiles of the tire.

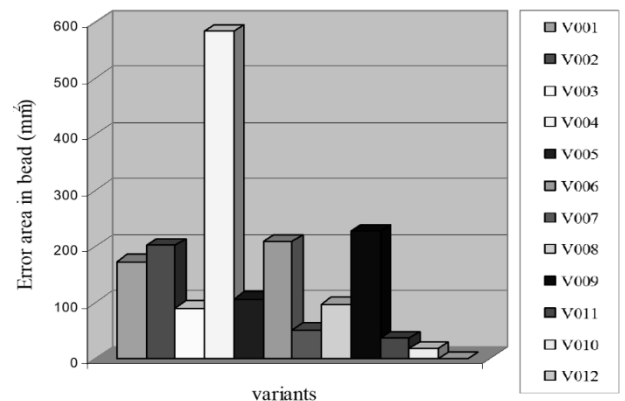
In relation to the investigated variants, the Figures from 38 to 41 represent the graphs of the comparisons of the defects for the bead, shoulder and whole casing area after 40 hours (about 1,600 km). The comparison was made for 40 hours dynamic testing while the lowest performance was obtained with V004 and V010 and the highest performance was achieved with V011 and V012.

**Fig. 38** The representation of the defects zone at the area above the bead after in-service for 40 hours (cca 1,600 km), considering the each tire variant

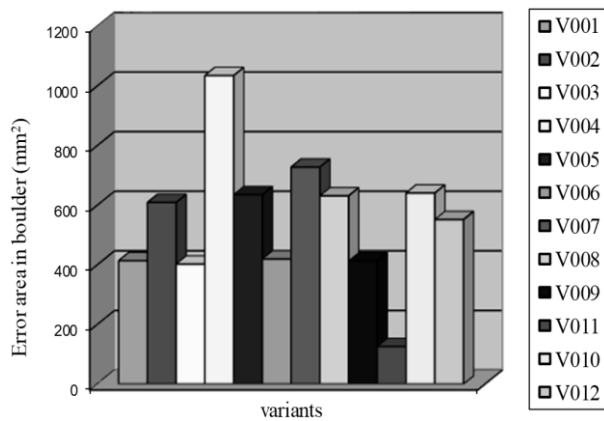
**Fig. 39** The representation of the defects zone at the area of the shoulder after in-service for 40 hours (cca 1,600 km) considering the each tire variant

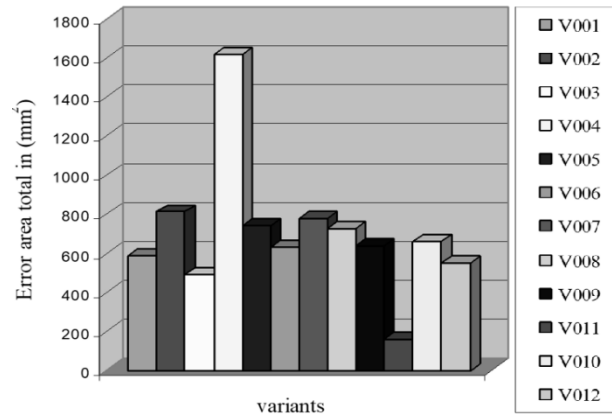
**Fig. 40** The representation of the defects zone for the tire as a whole after in-service for 40 hours (cca 1,600 km) considering the each tire variant

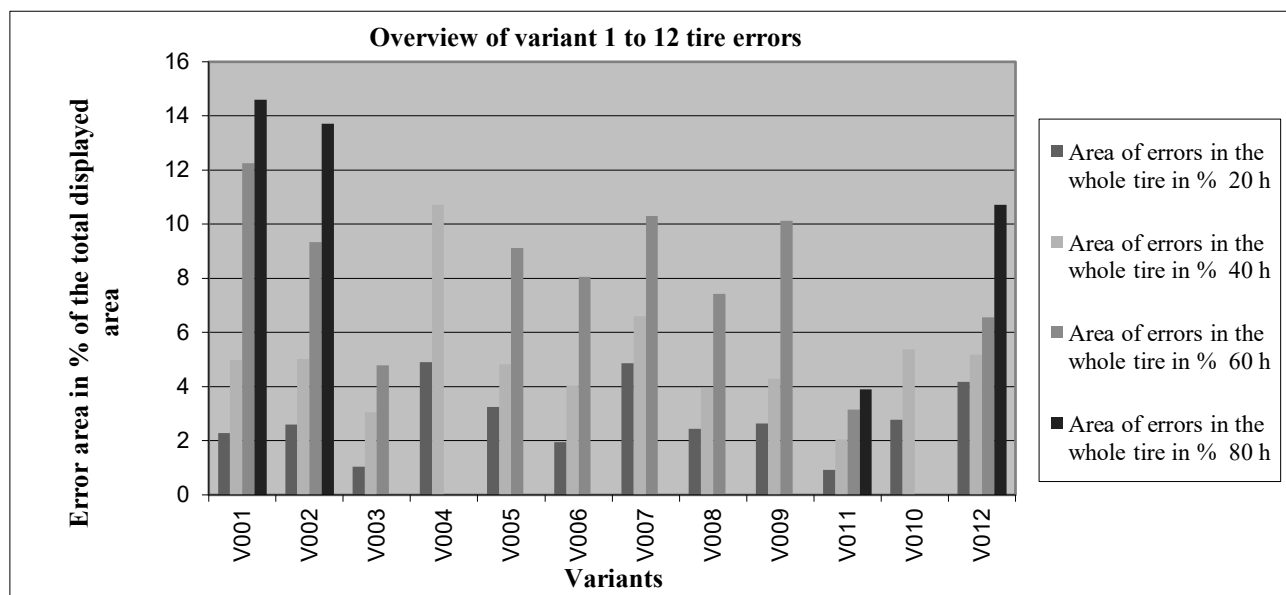
**Fig. 41** The comparison of the different tire variants after the in-service for 800 km, 1600 km, 2400 km, 3200 km and 4000 km, depending on the % of defects for the whole tire
