The Use of Concentrated Heat Stream to Repair AlZn10Si8Mg Alloy Castings

The present paper discusses the possibility to use three different sources of concentrated heat stream to repair superficial defects on AlZn10Si8Mg alloy castings. Simulated defects were prepared on specimens taken from a production casting made with the use of low-pressure casting method. The energy sources used to repair the defect were those known as MIG/MAG, TIG, and ML (micro-laser) methods. As the filler, an AlSi5 welding wire was used. The quality of repair was assessed based on both destructive and non-destructive testing. To evaluate porosity of the performed overlay welds, the computer X-ray tomography technique was employed. Metallographic examination was used to assess macro- and micro-structure of overlay welds, measure geometrical parameters of the welds and the heat-affected zone, and determine values of SDAS microstructure parameter. Hardness of overlay welds and the casting material was measured with the use of Brinell hardness machine.

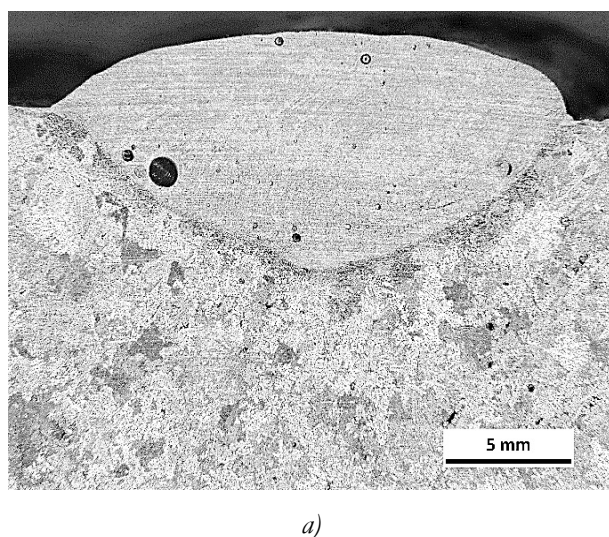
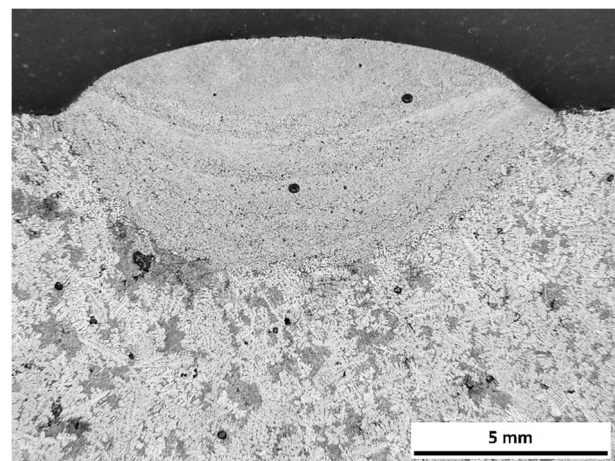
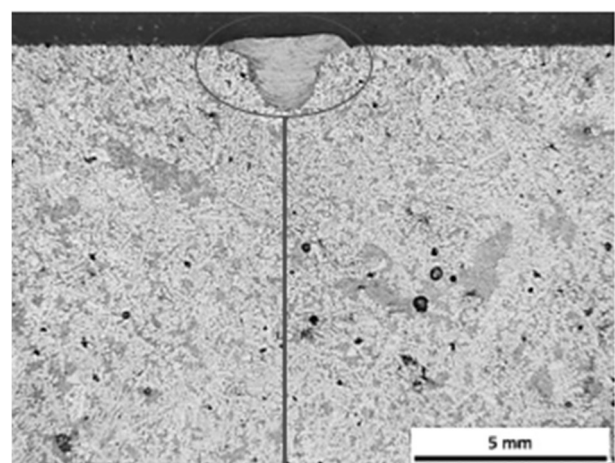
Figure 5 shows example views of macrostructure observed in AlZn10Si8Mg0.3 alloy casting areas after the process of repairing simulated casting defects with the use of MIG, TIG, and ML method.

Fig. 5 Example views of macrostructure of AlZn10Si8Mg0.3 alloy casting areas with a simulated casting defect repaired with the use of: (a) MIG method; (b) TIG method; and (c) ML method

Results of microscopic examination are consistent with images and measurements obtained with the use of X-ray tomography. The highest porosity characterizes the overlay weld made with the use of MIG method. The pores are characterized with large size, reaching the diameter of up to 3 mm. In case of the

overlay weld made with the use of TIG method, the void fraction and pore diameters were significantly less. In overlay welds made with the use of ML method, no porosity at all was observed.

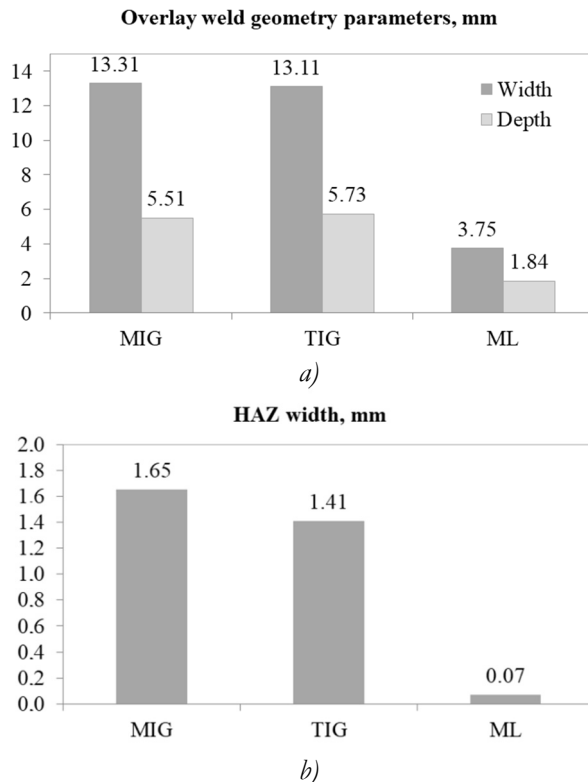
Results of measurements of the geometry of overlay welds and the width of the heat affected zone (HAZ) are given in Figure 6.

Fig. 6 The effect of casting repair method on: (a) overlay weld geometry; (b) HAZ width

Results of the research indicate that when either MIG or TIG method is applied, the geometry of overlay welds is similar. It turned out that dimensions of overlay welds are more than four times greater than dimensions of the simulated casting defect. Application of ML method enabled to repair the simulated defect by filling it precisely. It turned out also that in case of using the micro-laser technique, the heat-affected zone width is more than twenty times less than that obtained when MIG and TIG welding methods were employed.

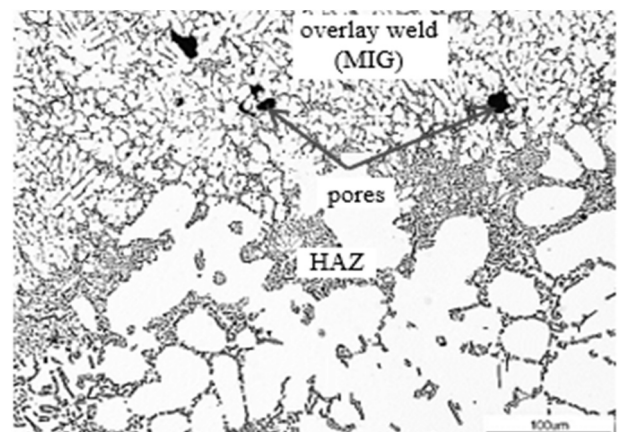
Fig. 8 Example of microstructure of the areas of simulated casting defect repaired with the use of MIG method. HAZ–overlay weld, $\times 100$ magnification. Etched in 10% NaOH

The microstructure of AlZn10Si8Mg0.3 alloy castings comprises phase α dendrites, the eutectic (α + Si precipitations), and intermetallics (Figure 7a). The material of a casting fabricated with the use of the low-pressure casting method is characterized with presence of porosity (Figure 7b) which manifests in deterioration of mechanical properties of the casting and make it difficult to repair it with the use of welding techniques. Example microstructures from the overlay weld–HAZ area obtained when MIG, TIG, and ML welding methods were used are presented in Figures 8, 9, and 10, respectively. In the area of overlay weld

made with the use of MIG method, numerous pores of diversified size are visible presence of which was revealed by tomographic examination. In the region of overlay weld made by means of TIG technique, significantly less pores were observed characterized with smaller size. In case of the overlay weld made with the use of ML method, no porosity was found.

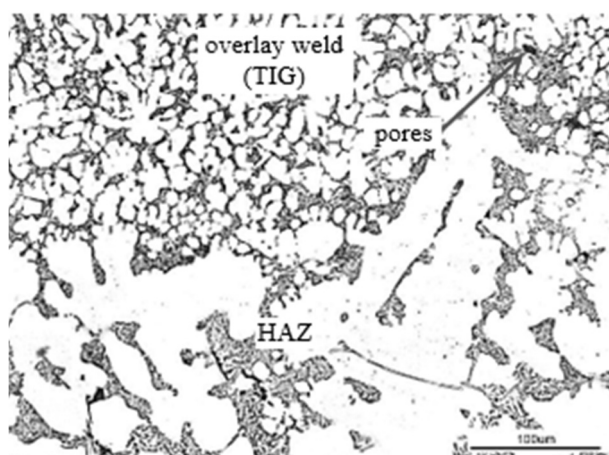
Fig. 9 Example of microstructure of the areas of simulated casting defect repaired with the use of TIG method. HAZ-overlay weld, $\times 100$ magnification. Etched in 10% NaOH

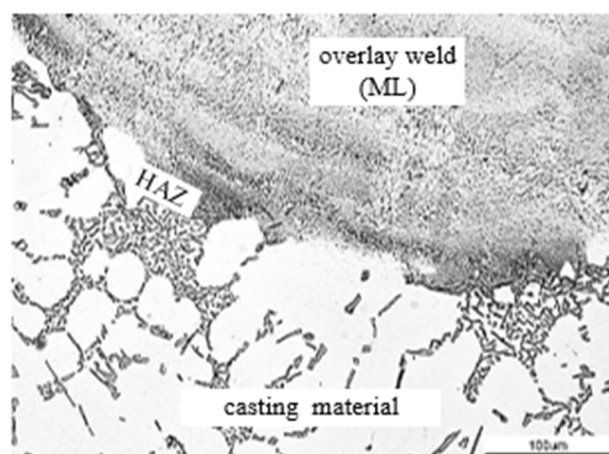
Fig. 10 Example of microstructure of the areas of simulated casting defect repaired with the use of ML method. Casting material-HAZ-overlay weld, $\times 100$ magnification. Etched in 10% NaOH

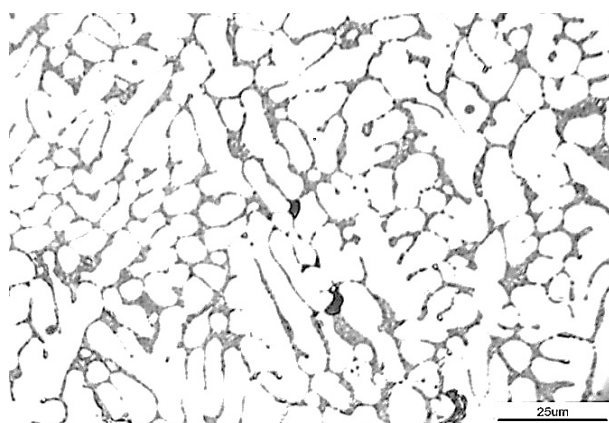
Fig. 11 Example of microstructure of the areas of simulated casting defect repaired with the use of MIG method. Overlay weld, $\times 400$ magnification. Etched in 10% NaOH

Example microstructures from areas of overlay welds made with the use of MIG, TIG, and ML methods are presented in Figures 11, 12, and 13, respectively. Analysis of the microstructures in individual

areas indicates that in the case of the overlay weld made by means of the micro-laser (ML) technique, the highest refinement of phase α dendrites was obtained. That was the effect of rapid crystallization and introduction of the quantity of heat less compared to this required when MIG or TIG methods are used.

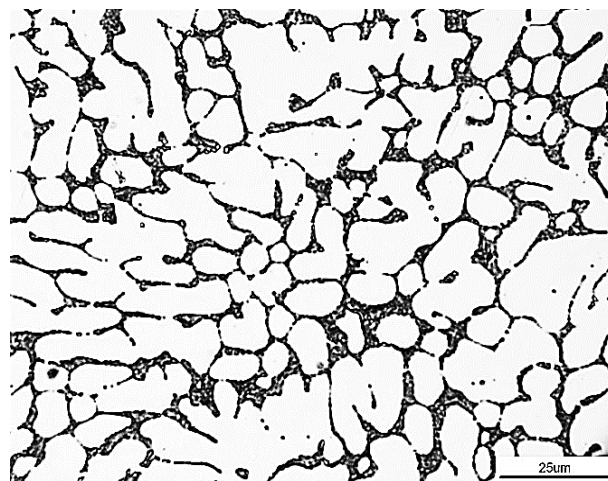
Fig. 12 Example of microstructure of the areas of simulated casting defect repaired with the use of TIG method. Overlay weld, $\times 400$ magnification. Etched in 10% NaOH

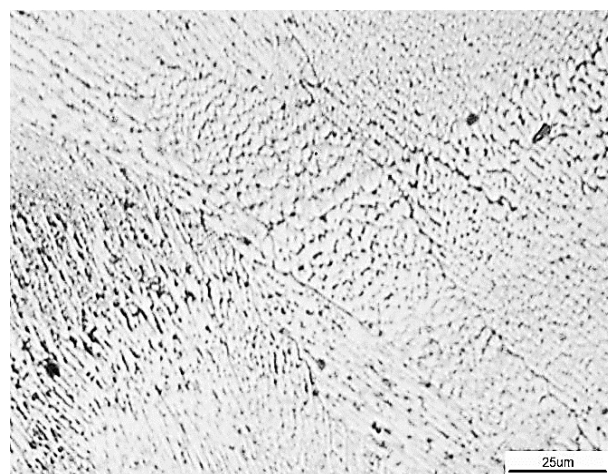
Fig. 13 Example of microstructure of the areas of simulated casting defect repaired with the use of ML method. Overlay weld, $\times 400$ magnification. Etched in 10% NaOH

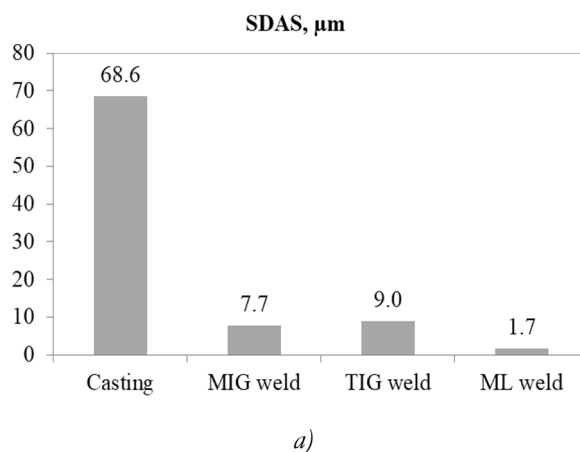
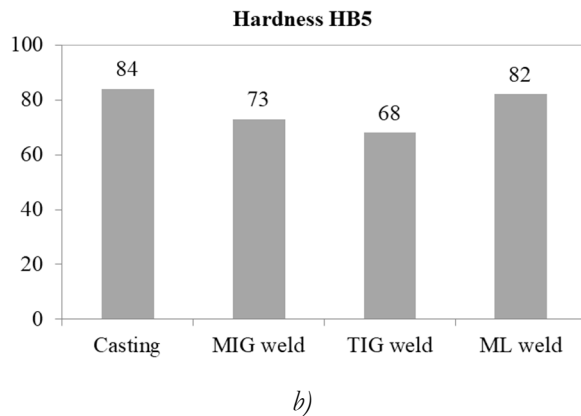
Fig. 14 Results of measurements of (a) SDAS structural parameter and (b) hardness for casting material and the material of overlay welds made with the use of different welding methods

Results of SDAS structural parameter and hardness measurements taken for both the casting material and the material of overlay welds made with the use of welding methods characterized with different intensity of the concentrated heat stream are presented in Figure 14.
