## Material Properties of Firefighter Ladder Composed from AA6063 and Few Other Aluminium-Based Alloys

The sectional fire ladders, made of aluminium alloy AA6063, belong to the basic equipment of the fire department of the Czech Republic. The use of these materials facilitates the deployment of ladders for firefighting, but it also brings with it certain pitfalls. During the use of ladders in extinguishing fires, their thermal influence and subsequent changes in mechanical properties may occur. This is highly dangerous and can lead to people falling from these ladders due to a significant reduction in the mechanical properties of the material.

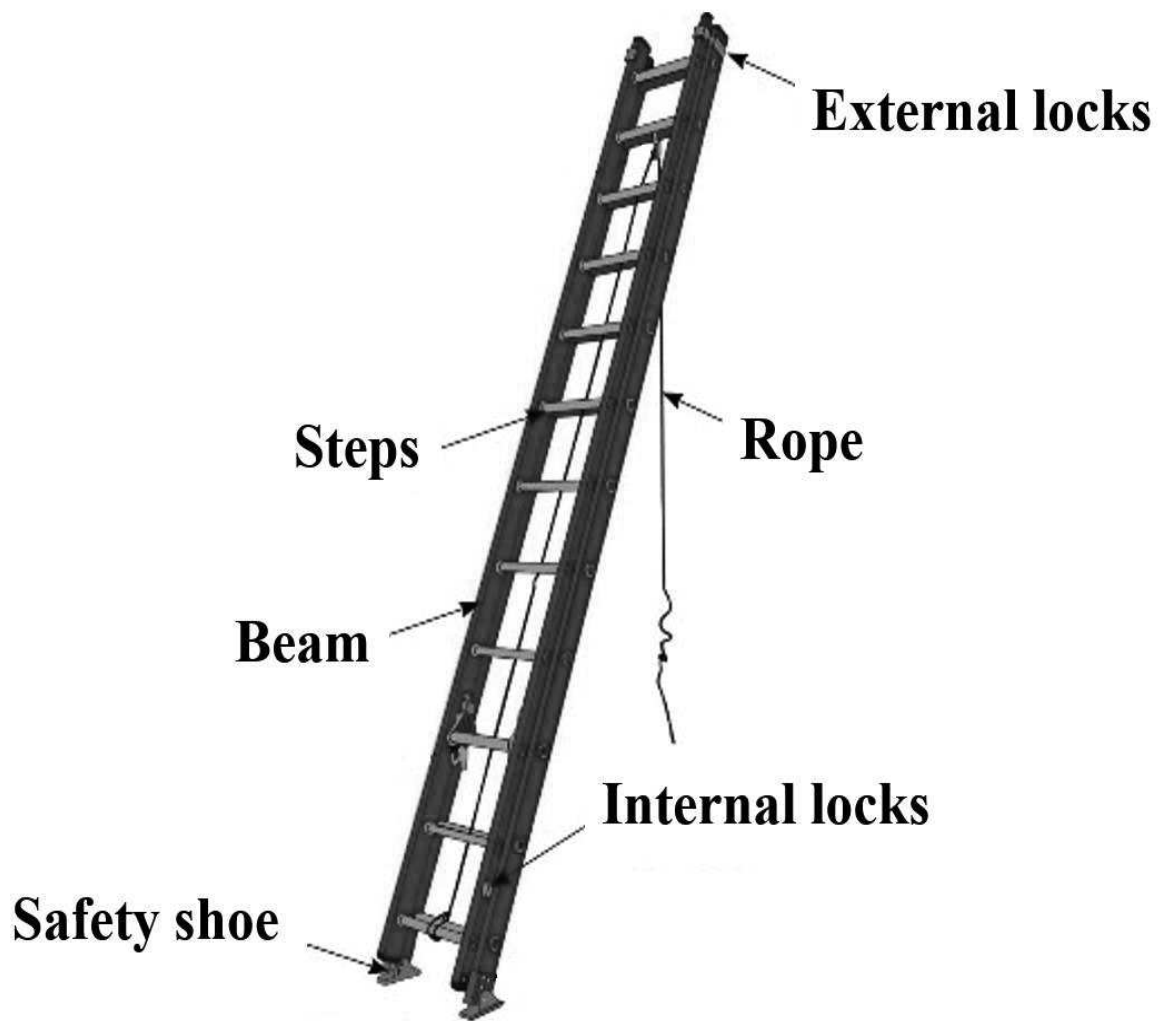
*Fig. 1 Description of the one part of the sectional ladder [10].*

welds. The illustration of ladder parts is in Fig. 1. Ladder locks are welded to the beams by the method TIG

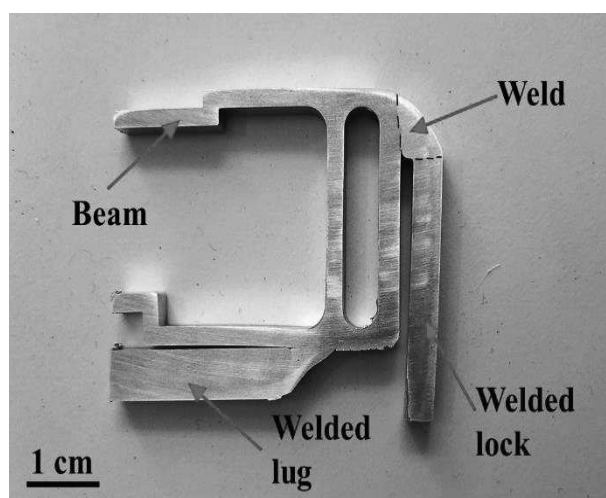
*Fig. 2 Cross-section of the ladder beam - one half.*

The cross-section of the ladder beam is displayed in Fig. 2.

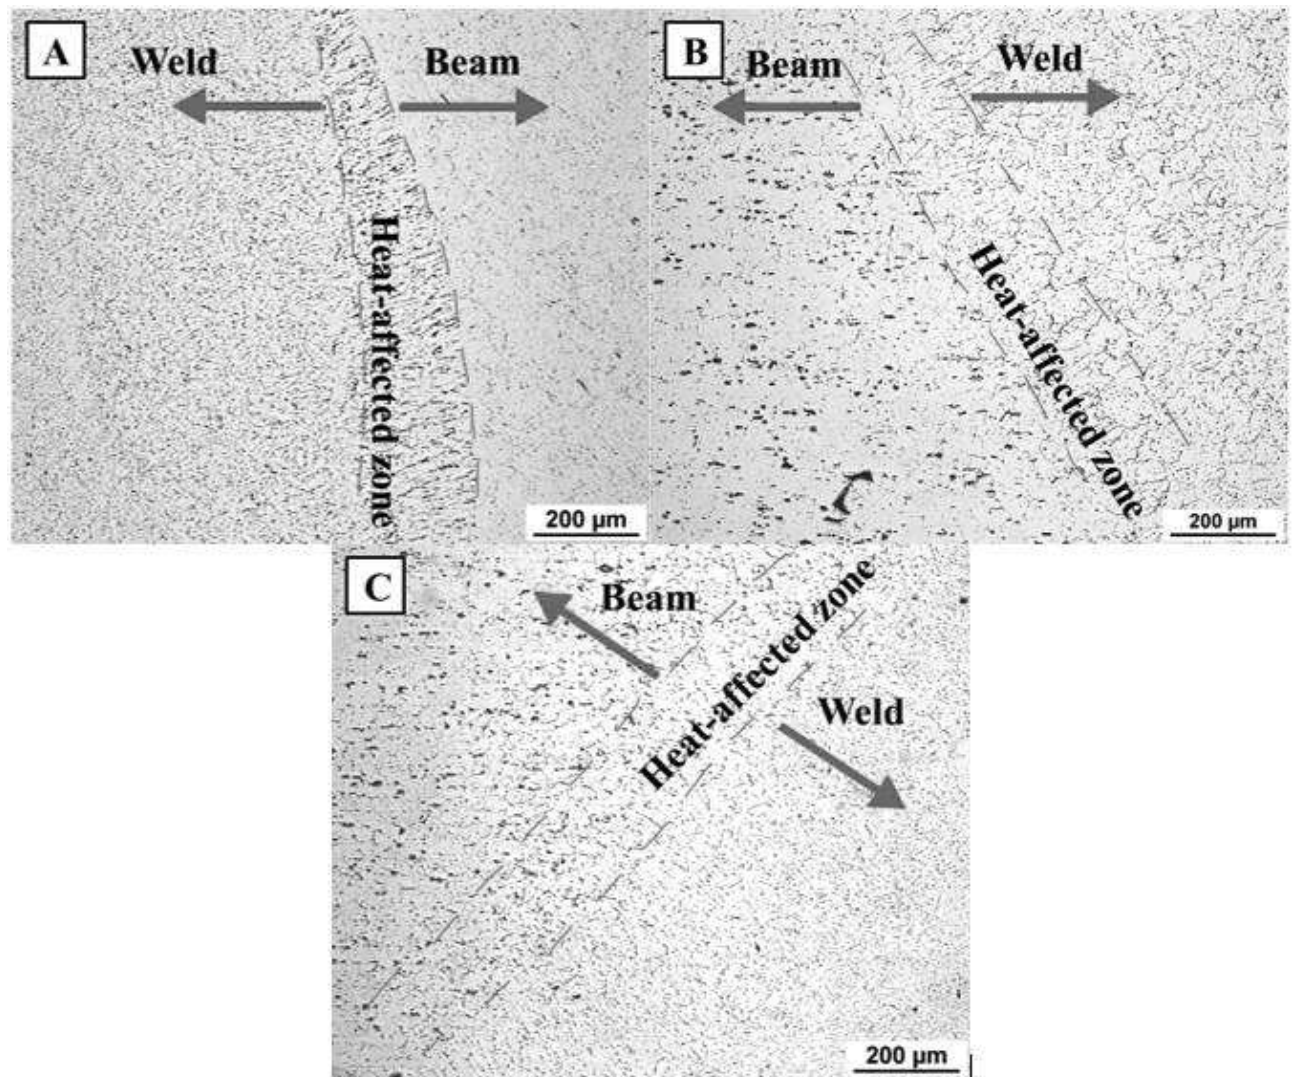
**Fig. 3** Cross-section of material A) basic material of beam; B) annealed to 200 °C; C) annealed to 300 °C.

Fig. 3 shows the microstructure on the interface of beam material and weld. The microstructures for the material in initial conditions and after annealing at higher temperatures are compared. The microstructure of weld is different from the basic material of the beam. This is due to the different composition of the material, as already indicated in Tab. 1.

A heat affected zone is visible between the microstructure of the beam and the weld. Weld is composed of primary  $\alpha$ -Al solid solution and secondary phases at the dendritic interface. The dark spots in Fig. 3 indicate secondary phases. These phases are characterized by an increased amount of Mg and correspond to the Al<sub>3</sub>Mg<sub>2</sub> phase (Fig. 4). The heat-affected zone contained both Al<sub>3</sub>Mg<sub>2</sub> phase and AlFeSi phase. N. Yamamoto et al. [11] also reported the formation of intermetallic phase Al<sub>3</sub>Mg<sub>2</sub> in the heat-affected zone of welded Al alloy.

The microstructure of materials annealed at 200 °C and 300 °C observed using OM (optical microscopy) is shown in Fig. 3B and Fig. 3C. The neglectable change in the grain size of the material of the beam was observed during the annealing at 200 °C. However, the grains more significantly coarsened at 300 °C

up to the average value  $61 \pm 35 \mu\text{m}$ . Especially increased occurrence of grains with a size above  $100 \mu\text{m}$  was recorded.

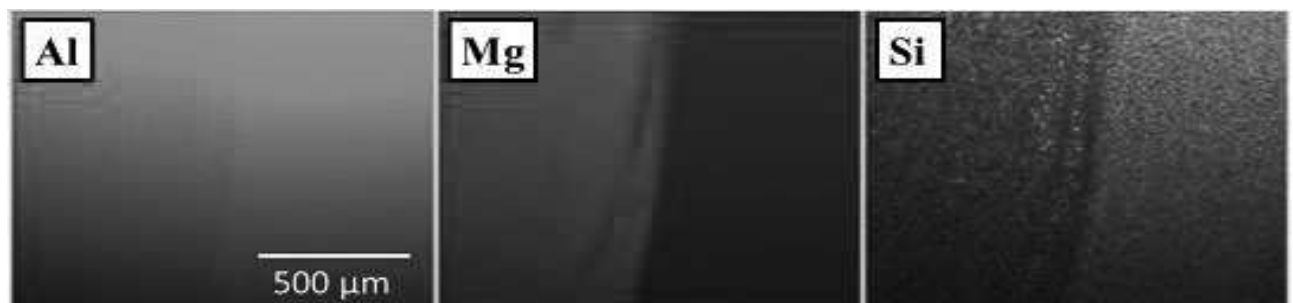
**Fig. 4** Distribution of elements at the interface of the ladder beam (right side) and weld (left side).

Ladder beam is composed of a solid solution of magnesium and silicon in aluminium. Intermetallic phases such as  $\text{AlFeSiMn}$  and  $\text{AlFeSi}$  appear in the alloy according to the EDS analysis. In article by M. Shakoori Oskooie et al. [12] were visible fine precipitates which are located both within the Al grains and on the grain boundaries. The analysis indicated that the particles are  $\text{Mg}_2\text{Si}$ ,  $\text{AlFeSi}$  or  $\text{Al}_6\text{Mg}_3\text{FeSi}_2$  [12]. These phases have a positive effect on the yield strength of the material but can harm the resulting

for the components like beam and ladder lock. This is caused by microstructure coarsening (Fig. 4) and also by coarsening of precipitates and intermetallic phases. An almost neglectable decrease in HV1 after annealing was observed for ladder lock. This component is prepared from an alloy containing about 2.5 wt. % of Mg. The higher amount of intermetallic phases containing Mg probably stabilize the microstructure and suppress the decrease of mechanical properties after exposure to the elevated temperatures.

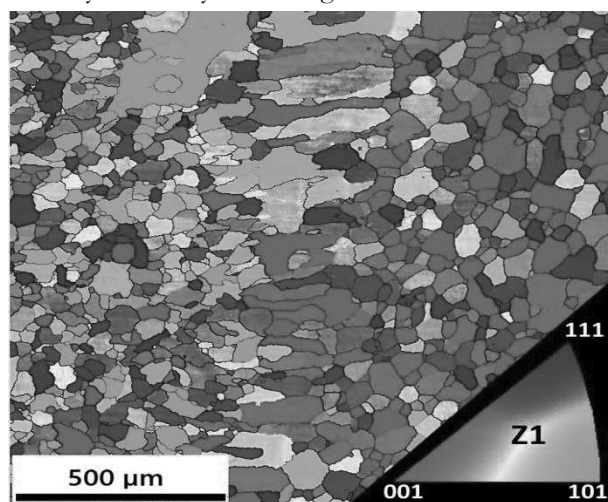
**Fig. 5** IPF map obtained using EBSD (basic material). Z1 axis is parallel to the axis of beam.

In Fig. 5 an inverse pole figure map (IPF) of microstructure obtained using electron backscattered diffraction method (EBSD) is displayed. Heat affected zone between weld and beam with specific elongated grains in the direction of the heat gradient is evident. It is also evident that recrystallized grains in the right side of Fig. 5 are textured with 001 direction parallel to the axis of the beam. This is a consequence of extrusion which is used during the manufacturing of these parts. On the contrary, the left side of Fig. 5 represents microstructure of the weld which is characterized by randomly oriented grains.

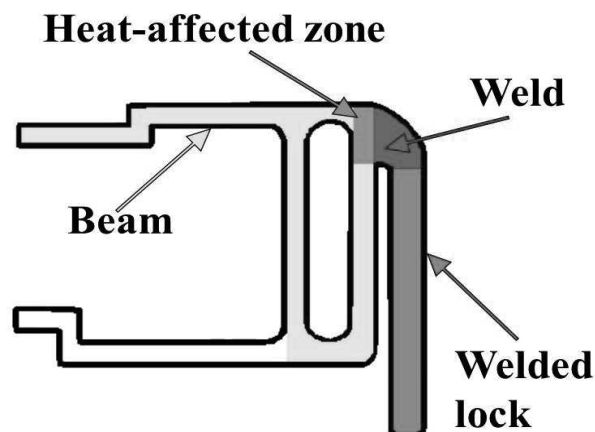
**Fig. 6** Color representation of the areas with similar hardness values on the cross-section of the ladder beam.

The yellow area shows the measurement of the hardness of the original beam, the orange area represents heat-affected zone by weld, the red area represents weld and the green area shows the ladder locks. Differences in hardness are attributed to the different chemical composition of the individual components and also probably to various processing of these components. The measured hardness values are summarized in the following Tab. 2.

In the vicinity of the weld (orange area in Fig. 6) the hardness values of the original materials (beam, lock) is decreased due to a large heat-affected zone around the weld. The high welding temperature caused the coarsening of the grains and also the formation of the casted microstructure compared to the relatively fine recrystallized microstructure of extruded beams. Generally, the hardness of the material in various areas does not decrease after annealing at 200 °C. Instead, a slight increase may be observed for components like beam and ladder lock. Such an increase is attributed to the ageing process which can be active at 200 °C. This suggests that specified parts of the original ladder are in underaged conditions. Similar behaviour of aluminium alloy was presented in the article by J. Kubásek et al. [13]. A significant decrease in HV1 is observed after annealing at 300 °C especially

The hardness was measured in the entire profile of the ladder beam. It was found that the individual areas of the material had different hardness values. Areas of various hardness values are graphically illustrated in Fig. 6.
