Hydrogen Embrittlement of 11SMn30 Free-Cutting Steel

The main objective of the work was to describe the laboratory methods suitable for the hydrogenation of free-cutting steels. Furthermore, to study the hydrogen embrittlement of 11SMn30 free-cutting steel. Hydrogenation and subsequent mechanical testing of hydrogenated steel is not a common laboratory method as it requires precise and expensive equipment and is time-consuming and dangerous as hydrogen is highly reactive and explosive. Currently, several theories of hydrogen embrittlement mechanisms of steels describe the causes of material degradation by hydrogen. However, those theories are not universally valid; individual accounts have been developed and describe hydrogen embrittlement only for specific conditions and may fail in their descriptions under others. In this work, the hydrogenation of free-cutting steel 11SMn30 steel by two different methods (immersion and cathodic) was investigated to induce embrittlement and to compare in particular the fracture surfaces after the Charpy impact test. The results reported in this paper indicate that manganese sulphide inclusions are not the main cause of hydrogen embrittlement in

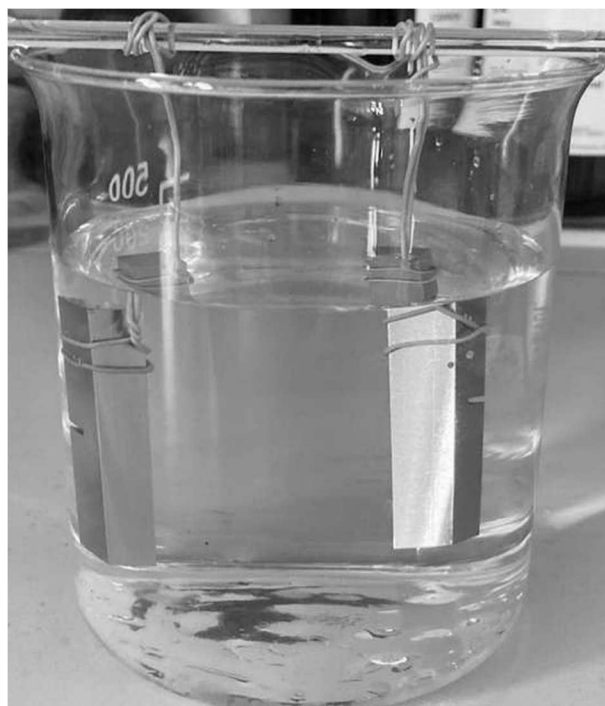
Fig. 2 Set up for immersion hydrogenation of specimens in NH_4SCN water solution

For immersion hydrogenation, a solution of 20% NH_4SCN in distilled water was used, which, according to the authors Tagaki S. and Toji Y., hydrogenated the material intensively within 50 hours. The solution was prepared by mixing 500 g of ammonium thiocyanate with 2 litres of distilled water. The beakers used had to be sized to accommodate the placement of the samples in the solution. Immersion hydrogenation of the specimens was carried out in the fume cupboard for 50 hours [12].

The immersion hydrogenation method was chosen based on theoretical knowledge of hydrogen embrittlement, which states that during immersion hydrogenation, the amount of hydrogen adsorbed to the material is sufficient to induce embrittlement. At the same time, this procedure is more practical than cathodic hydrogenation. Tagaki S. and Toji Y. [12] state that the use of ammonium thiocyanate is the most suitable choice for immersion hydrogenation. Its advantage is, among other things, that the loss of materials in g/cm² is practically zero regardless of the immersion time. From an experimental point of view, immersion hydrogenation is simple and fast (Fig. 2).
