Effects of Laser Shock Peening Technology on Stress Corrosion Cracking of Austenitic Steel

This article deals with the treatment of surface properties of austenitic steels using Laser shock peening (LSP) technology. It is a process in which the surface of the material is strengthened by a pulsed laser beam. The laser pulse generates a strong compression shock wave after impacting the component surface. This spreads through the material and introduces residual compressive stresses into the surface layer. These stresses improve the technical properties of the material, improving resistance to stress corrosion cracking. The aim of the tests was to influence the austenitic steel 08CH18N10T by LSP technology, to carry out a corrosion test under the action of a boiling MgCl_2 salt solution, and to subsequently evaluate these tests. MgCl_2 -based salt is one of the candidate coolant media for new types of Generation IV nuclear reactors.

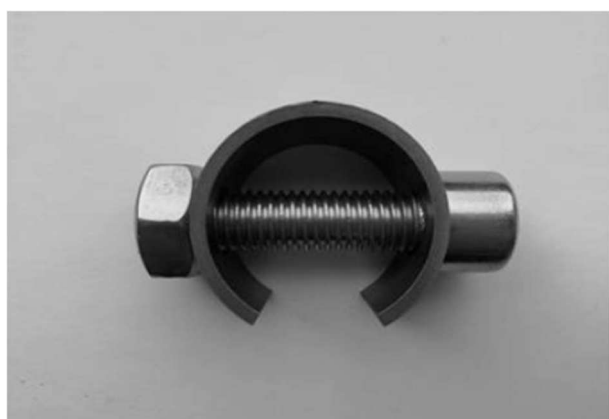
Fig. 4 Prepared sample

Prior to the start of the experiment, the individual samples were degreased in acetone, a clamping screw was threaded through them, and the sample was subjected to a constant load. With a torque wrench, the clamping screw was tightened to a tightening torque of 0.250 Nm. See Fig. 4. This value was determined based on the yield strength so that no plastic deformation occurred in the material. The samples were marked A for the starting material, i.e., without LSP

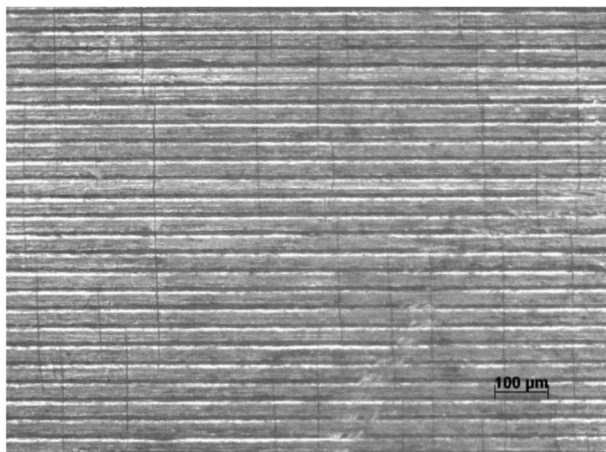
Fig. 7 Sample A2 after 20 hours in a MgCl_2 bath

The samples marked A2 and B2 were tested first. After baseline preparation and documentation, the samples were placed in a boiling MgCl_2 bath for 20 hours. Throughout the test, the samples were immersed in a still boiling MgCl_2 solution. At the end of the predetermined experiment time, each sample was removed from the corrosion solution, cleaned, and checked for light microscopy for cracks, and photo documentation was obtained. See Fig. 6 to Fig. 9.

The initial test found that the unreinforced LSP sample showed traces of corrosion cracking after 20 hours of exposure to the boiling MgCl_2 solution compared to the consolidated LSP sample, where no cracks were visible. To determine the time of the first occurrence of cracks on the surface of the material, another pair of samples A4 and B4 were tested. The samples were in a boiling bath of MgCl_2 for 24 hours and were removed from the solution every 3 hours during the ongoing experiment. to determine after which time of action of the corrosion solution MgCl_2 corrosion cracking cracks develop on the surface of the material. Subsequently, the surface was checked under a stereomicroscope and photo documentation was obtained. As the cracks of corrosion cracking appeared in the unconsolidated sample A4 after 3 hours of the action of the corrosion solution MgCl_2 , the testing of the unconsolidated piece of pipe marked A was started. The objective of this was to find out after what time the corrosion cracks would develop on the surface of the sample pipe. The sample was placed in a boiling bath for another 10 minutes and then examined under a light microscope. These individual steps were repeated until the first cracks of corrosion cracking were detected. It was after 120 minutes of exposure in a boiling MgCl_2 bath. The test was not continued after this.
