## Experimental Evaluation of Vibration Responses to Progressive Gear Damage in Planetary Gear

This study presents a systematic experimental analysis of vibration responses in a planetary gearbox (type A2000) under both undamaged and artificially induced fault conditions. The primary aim was to identify specific frequency-domain signatures of various types and severities of gear defects—such as pitting on the flanks of gear teeth, missing teeth, unbalance of the carrier, and damage to the ring gear—through spectral analysis of vibration signals. Measurements were conducted in both loaded and unloaded states using non-contact torque sensors and a multi-channel diagnostic system (SKF IMx-S) with tri-axial accelerometers. The results demonstrate a strong correlation between the severity of gear damage and the amplitude and structure of sidebands around the gear mesh frequencies. Notably, the presence of pitting consistently increased the sideband amplitudes, while unbalance induced distinct harmonics in the frequency spectrum. Damage to the ring gear and central gear exhibited overlapping features but were distinguishable in the acceleration envelope spectrum. The findings provide a

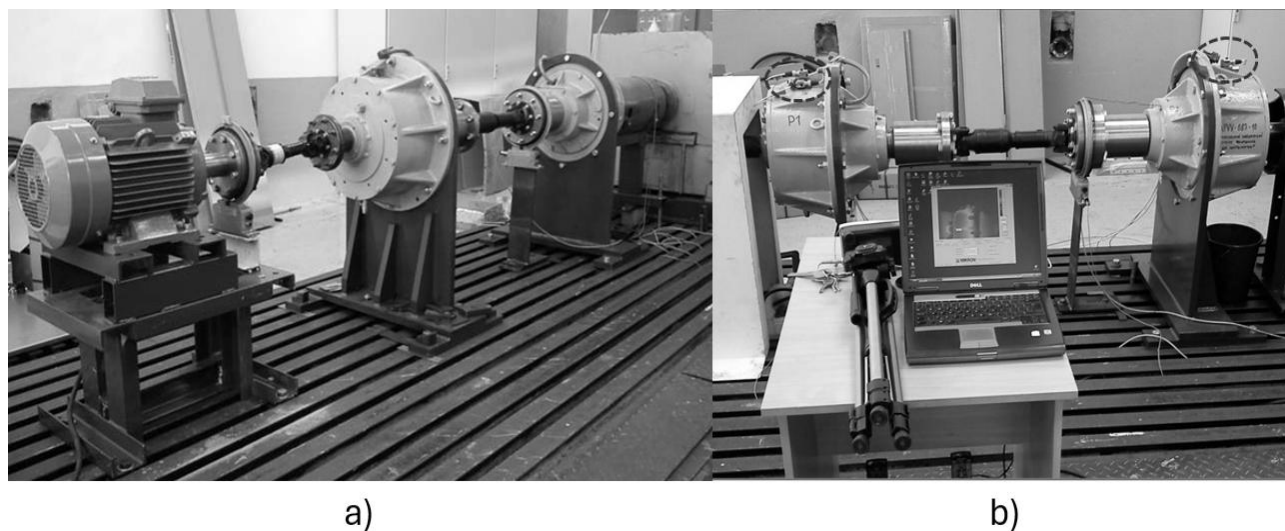
**Fig. 1** Test rig assembled in the laboratory of the Department of Design and Machine Elements, University of Žilina; a – final assembly of test rig; b – test rig with highlighted sensor positions

As shown in Figure 1, the test rig consisted of a 2-pole asynchronous motor (ABB M2QA 160M2B) rated at 15 kW, operating at 440 V and 60 Hz, and controlled via an ABB frequency inverter. The motor was followed by the first A2000 planetary gearbox, which was directly connected to a second identical gearbox. These were mounted in opposing configurations, resulting in an overall gear ratio of 1:1. A dynamometer was placed at the end of the drivetrain to provide loading conditions and to close the power loop.

For measurement purposes, two non-contact torque and rotational speed sensors (HBM T10F) were installed—one on the motor output shaft and the other on the input shaft of the first gearbox stage. The placement of both sensors is highlighted in Figure 1.
