Experimental Investigations Towards Hole Accuracy in Micro-drilling of Carbon Fibre Reinforced Polymer Material

Keywords: CFRP, Delamination, Hole Accuracy, Micro-drill, Uncut Fibre

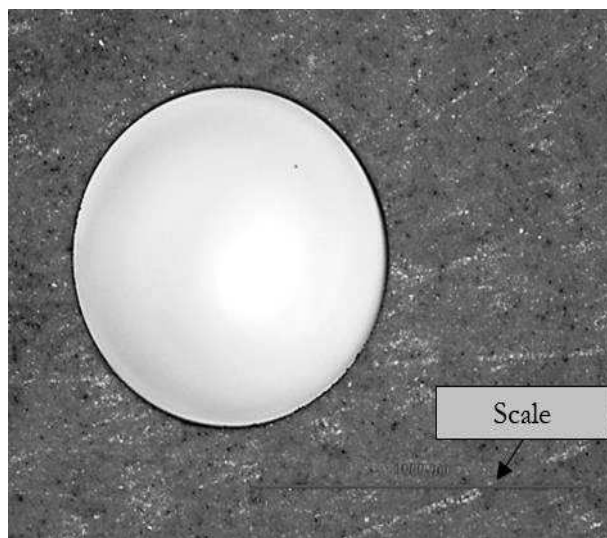
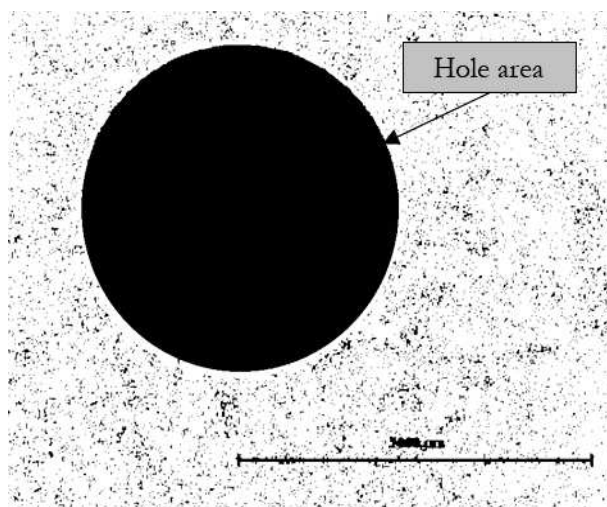
Fig. 1 Image of micro-drill hole area with 100 times magnification under (a) Microscope Nikon ECLIPSE LV100 and (b) Image J

Figure 1 presents an image of a hole on the CFRP composite panel fibre using a microscope and Image J software with 100 times magnification. It is compulsory to have the scale on the image captured using microscope (Figure 1a) as the scale is required when setting the actual scale in Image J software so that the value measured reflects the actual value.

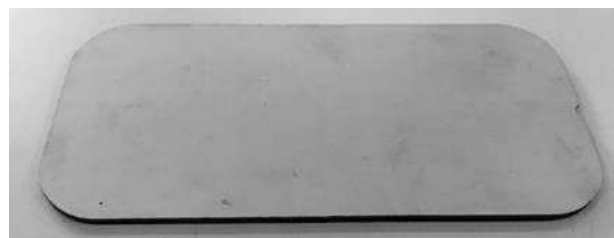
Fig. 2 Laminated CFRP composite

The laminated CFRP composite with a dimension of 184 mm x 86 mm x 3.8 mm was the workpiece of this experiment, as shown in Figure 2. The panel is made of 26 unidirectional pre-impregnated plies with stacking sequence of [45/135/902/0/90/0/90/0/135/452/135] s. It contained 57.42% nominal volume of fibre based on the carbon fibre of AS4, and the resin was epoxy. Figure 3 illustrates the cross-sectional view of the CFRP panel. Next, the tool employed was the HSS carbide twist micro drill bit with 0.9 mm diameter and 3 mm shank diameter. It is 10 mm in length and consists of 4 flutes. Figure 4 presents the image of the micro drill bit and its dimensions.

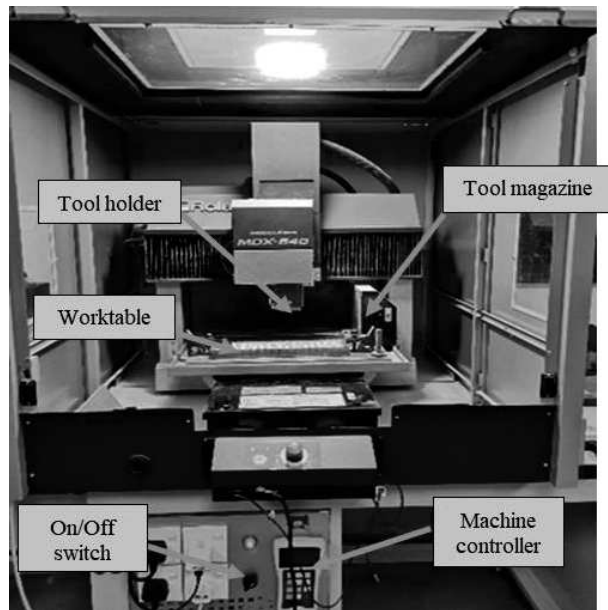
Fig. 5 CNC Router MODELAPRO11 MDX-540

Figure 5 portrays the overall setup of the 3-axis CNC Router MODELAPRO11 MDX-540 machine for the micro drilling process of the CFRP material. The feasible range of the spindle speed for this machine is from 400 to 12,000 min^{-1} . The dynamometer was installed on the worktable to capture the thrust force value along the drilling process. In order to avoid damage of the dynamometer, the holding fixture held the CFRP panel to ensure there is a gap between the bottom part of the workpiece and the dynamometer during the machining process. Next, the drilling process was conducted using the optimum parameter obtained from a previous study, as shown in Table 1.

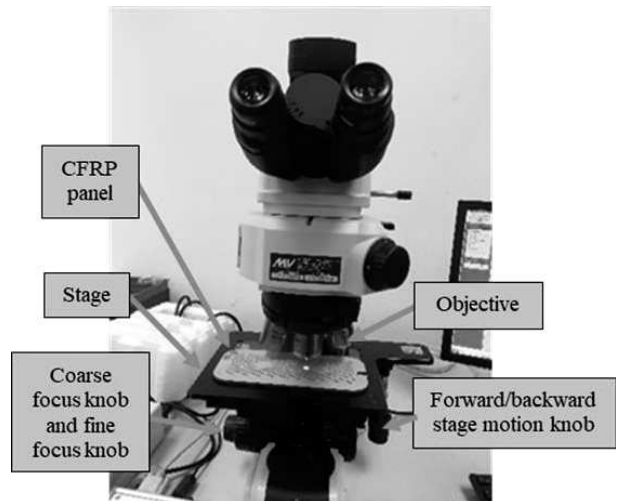
Fig. 6 Nikon ECLIPSE LV100 microscope

To obtain the accuracy of holes, a selected number of drilled holes were evaluated: hole numbers 2, 60, 120, 180, 240, and 300. The images of the holes, with 100 times magnification, were captured using Nikon ECLIPSE LV100 microscope with the Solution DT software, as displayed in Figure 6. Next, the Image J software was employed to measure the hole accuracy, as shown in Figure 7.

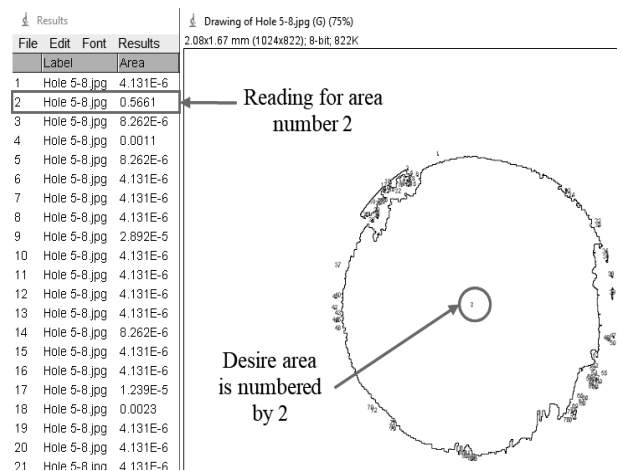
Fig. 7 Measuring hole area by using Image J software

Equation 1 was applied to measure the nominal value of the hole area with a diameter of 0.9 mm. The actual hole area calculated using the Image J software was then divided by the nominal value of the hole area to obtain the percentage of hole accuracy.

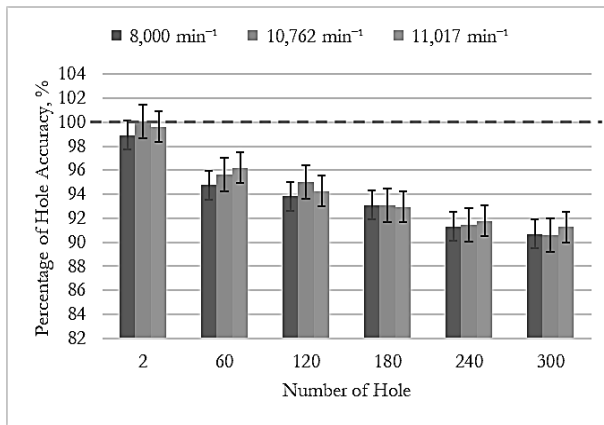
Fig. 8 Comparison of entry hole accuracy results

Hole number 1 was selected to be measured at the beginning of the micro-drill test. However, after the evaluation process, an error for hole number 1 was caused by machining factors. Therefore, hole number 2 was selected as the replacement. Figure 8 shows a comparison of hole accuracy results for the 3 parameters.

Based on Figure 8, the spindle speed of 10,762 min⁻¹ for the hole position number 2 achieved the highest percentage of hole accuracy (100.07%). The area was higher than the nominal area; in other words, the hole was overcut by 0.07%. However, an acceptable tolerance of 99.11% to 100.89% was present. The lowest entry hole accuracy for the same parameter was 90.59% for the 300th hole. At the 60th hole, Parameter 3 displayed the highest hole accuracy of 96.2%, however, the outcome was not within the tolerance range (i.e., the hole was undersized).

Overall, the results indicate that the hole accuracy decreased as the number of holes increased. Only two holes fell between the acceptable tolerance range: the 2nd hole for both Parameter 2 and Parameter 3. This was due to the formation of uncut fibres and delamination on the area of the holes. When the drill bit had cut the CFRP, the carbon dust left on the face of the drill bit had disturbed the cutting process. Other than that, the tool began to wear out, leading to an inconsistent cutting rate along the CFRP structure. Figure 9 presents the image comparison of hole area between the 2nd and 300th hole under a microscope with 100 times magnification. Uncut fibre and delamination captured at the 300th hole have contributed to lower hole accuracy.

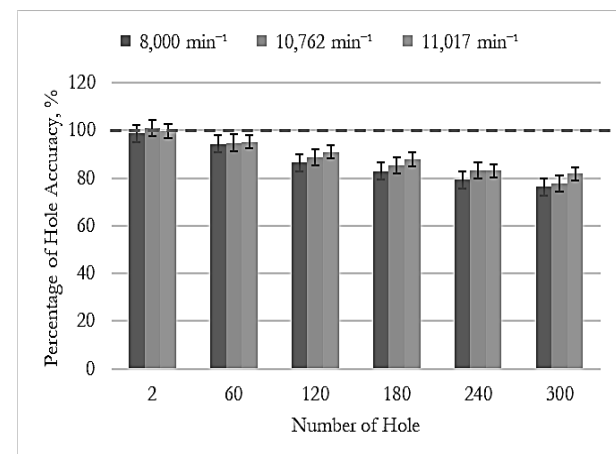
Fig. 10 Comparison of exit hole accuracy results

According to Figure 10, the highest hole accuracy was obtained from Parameter 3 for hole number 2, with a 99.71% of hole accuracy. Parameter 2 captured an oversized hole with a 100.91% of hole accuracy. The result is similar with the entry hole outcome where Parameter 2 contributed to an oversized hole at position 2. Parameter 1 produced an undersized hole with a 98.76% of hole accuracy. At the 60th hole, Parameter 3 captured a higher hole area compared to Parameter 2 and Parameter 1. This trend continued until the 300th hole, excluding the 240th hole where Parameter 2 produced a slightly larger hole area compared to Parameter 3.

However, Parameter 1 always provided the lowest hole accuracy. The lower spindle speed produced higher thrust force. Higher thrust will expedite tool wear and increase the risk of uncut fibres and delamination [26]. Figure 11 presents a comparison of the exit hole image at the 2nd and 300th holes where the condition of the 300th exit hole was extremely poor due to delamination and uncut fibres.
